Alberta Transportation Southern Region Geohazard Assessment 2013 Annual Inspection Report Site S4: Highway 2:08, Willow Creek December 2013 Page 8

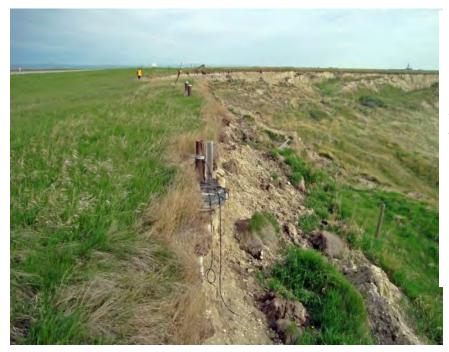
Photo S4-1 (May 2013) – Facing north across the area to the south of the soil nail repair area. The crest is now coincident with the old SI installations from ongoing retrogression.

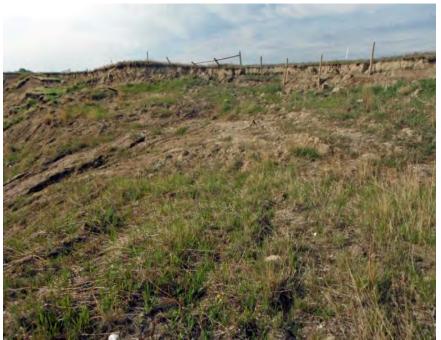
## Photo S4-2 (May 2013) – Facing southwest at the slide area within the soil nailed area. The instabilities in the upper, steeper portions of the slope are mostly unchanged from 2012. Retrogression of the slide continues to occur with blocks sliding down and adding to the slide mass although at a seemingly slower rate than observed previously.

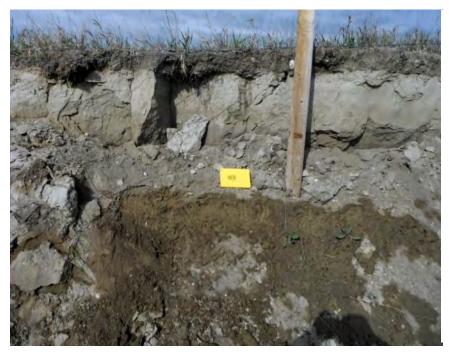
Photo S4-3 (May 2013) – Facing west at the headscarp within the soil nailed slide area. There was visible seepage noted approximately 1 m below the crest.

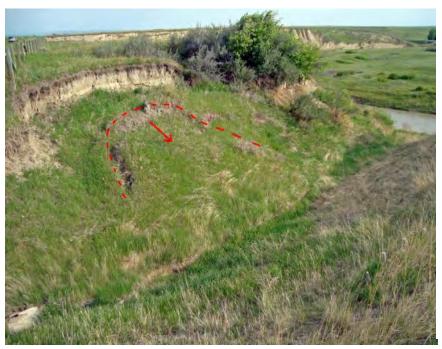
Photo S4-4 (May 2013) – Standing on the south side of the erosion gully at the south end of the site, looking towards the northeast at a recent translational slide on the north side-slope. The extents and direction of the failure are outlined in red.

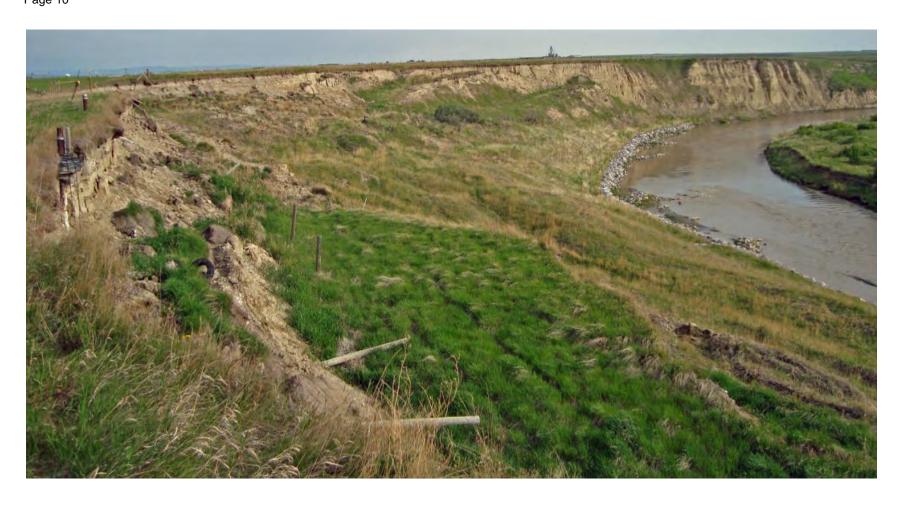
Photo S4-5 (May 2013) -

Facing north at the slide area with a view of the lower slope and river bank. Note the sedimentation within the vanes and the improved vegetation cover.
