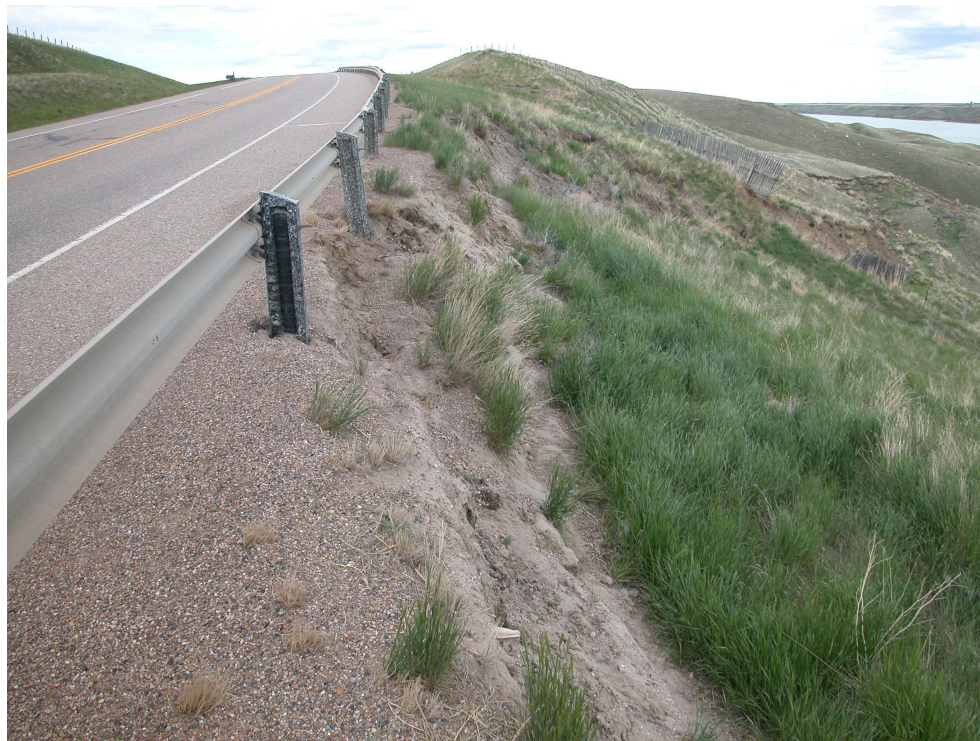
Photo S5-1 (upper left) – May 2004 – facing east across the shallow slumping area immediately downslope of the guardrail along the downslope edge of the road. The slumping has undermined some of the guardrail posts. It does not appear that significant additional movement has occurred since the July 2003 inspection, however the potential for additional movement in response to precipitation and surface runoff remains.

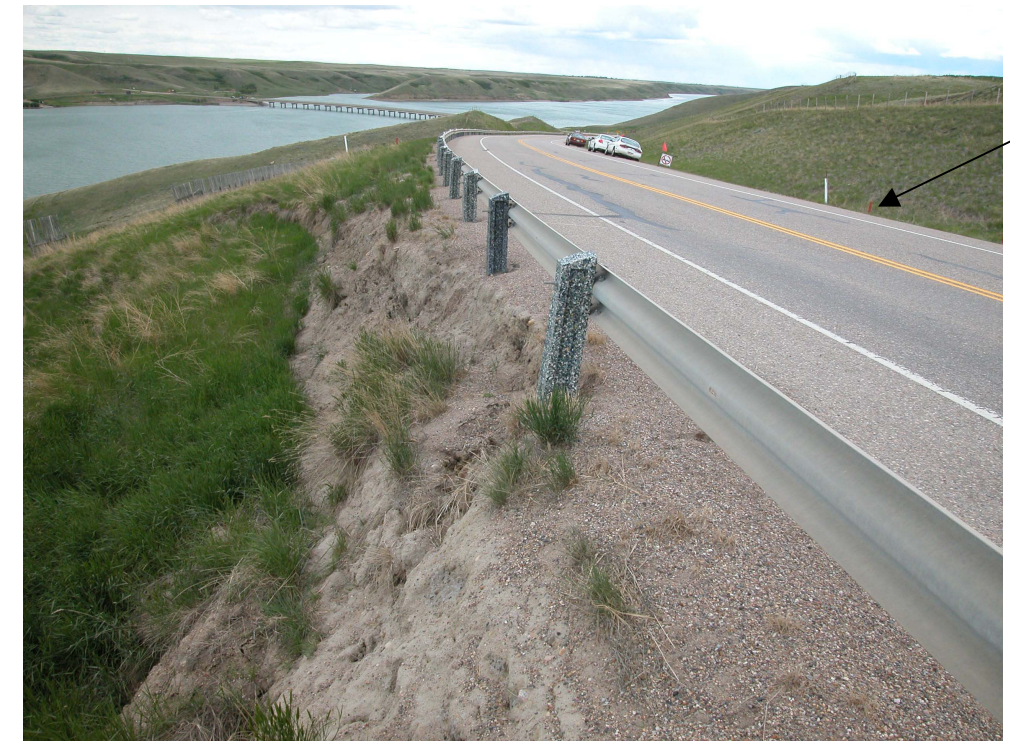
Photo S5-2 (upper right) – May 2004 – facing west across the area shown in Photo S5-1.

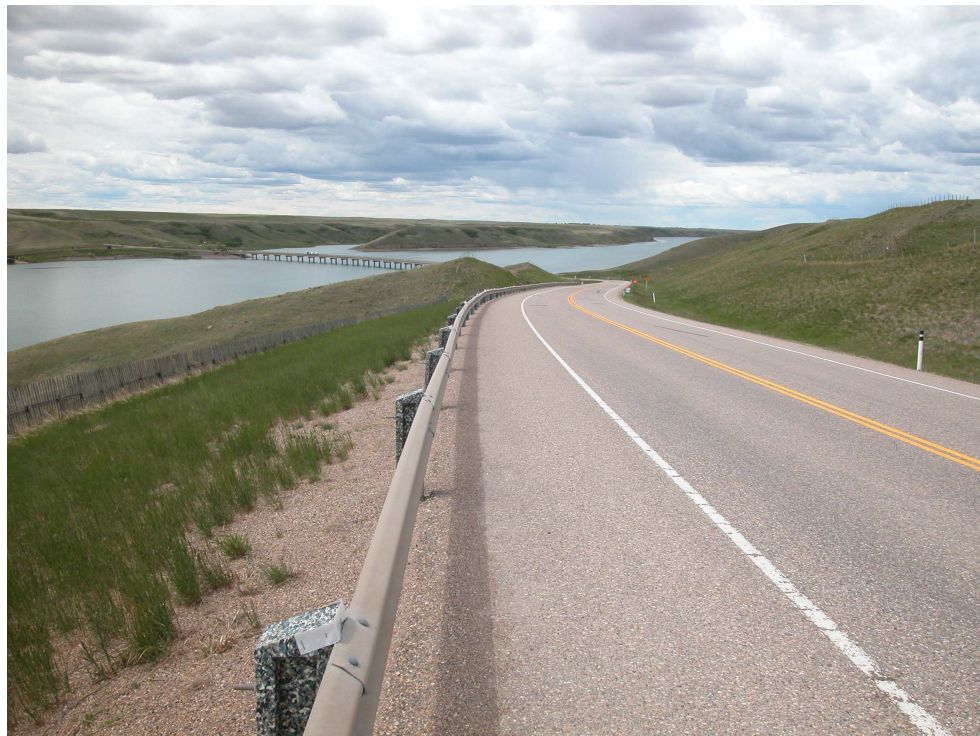
Photo S5-3 (lower left) – May 2004 – overall view facing west across the S5 – Chin Coulee site.

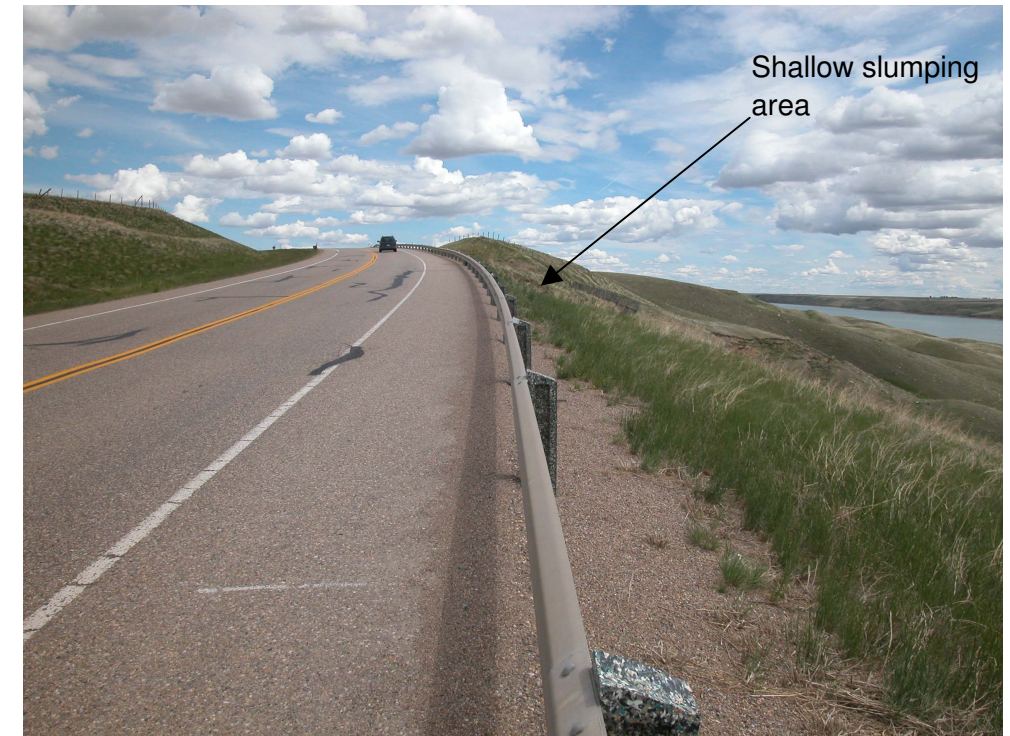
Photo S5-4 (lower right) – May 2004 – overall view facing east across the S5 – Chin Coulee site.

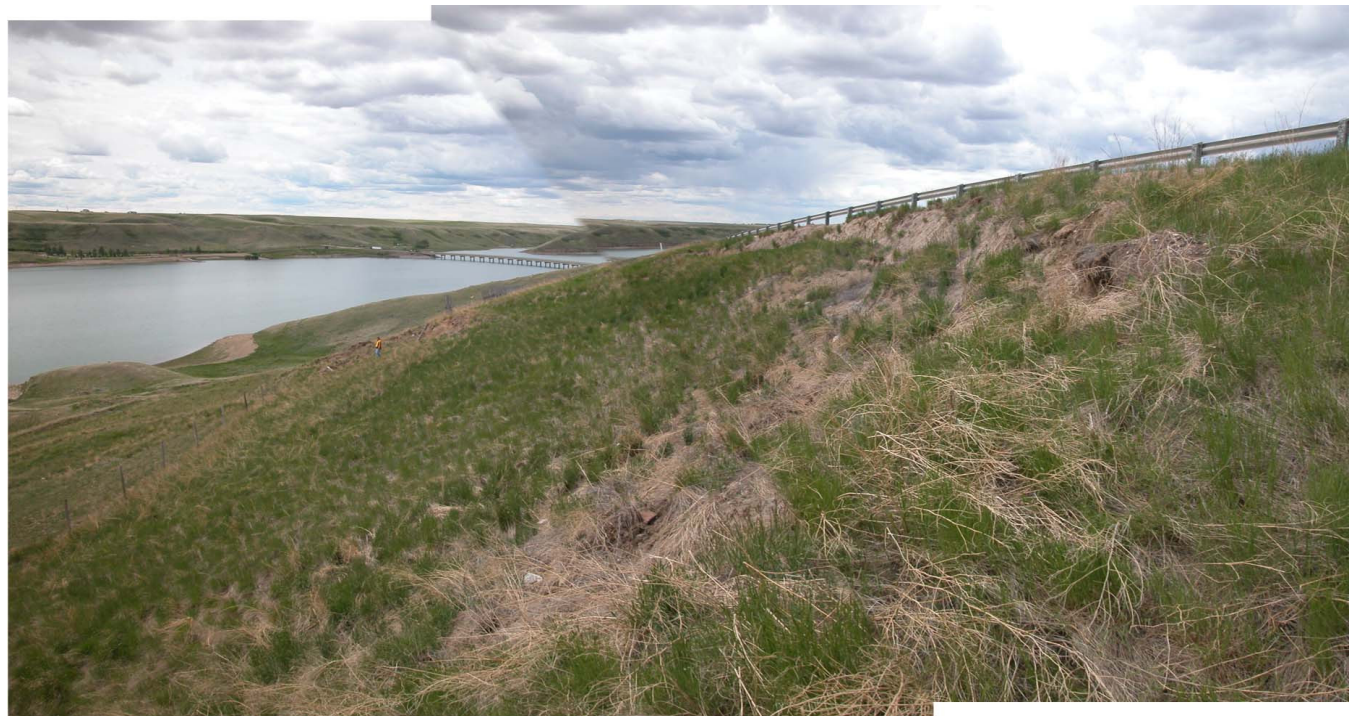
Photo S5-5 (upper left) – May 2004 – facing west across shallow slumping area downslope of the guardrail. There is the potential for future retrogression of this shallow slumping to further undermine the guardrail and possibly impact upon the highway. This area is also susceptible to surface erosion because of the incomplete revegetation.

The existing SI's at this site are not installed in the shallow slumping area therefore there is no direct subsurface monitoring of the movement rate or depth of the shallow slumping.

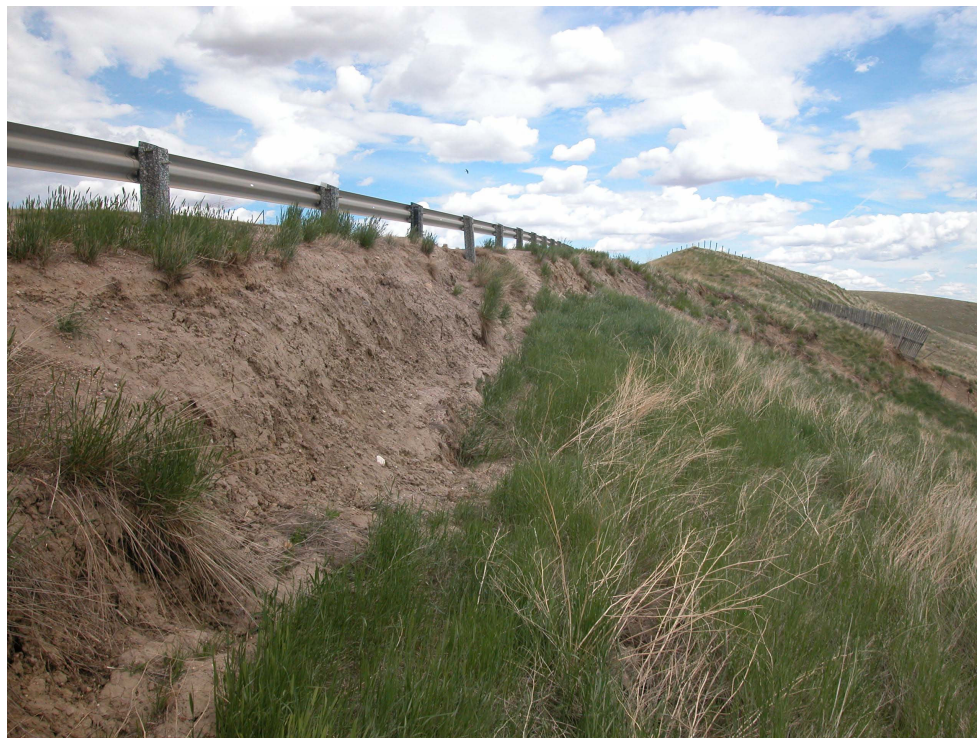
Photo S5-6 (lower left) – May 2004 – closer view of the exposed soils at the scarp of the shallow slumping, immediately downslope of the guardrail.

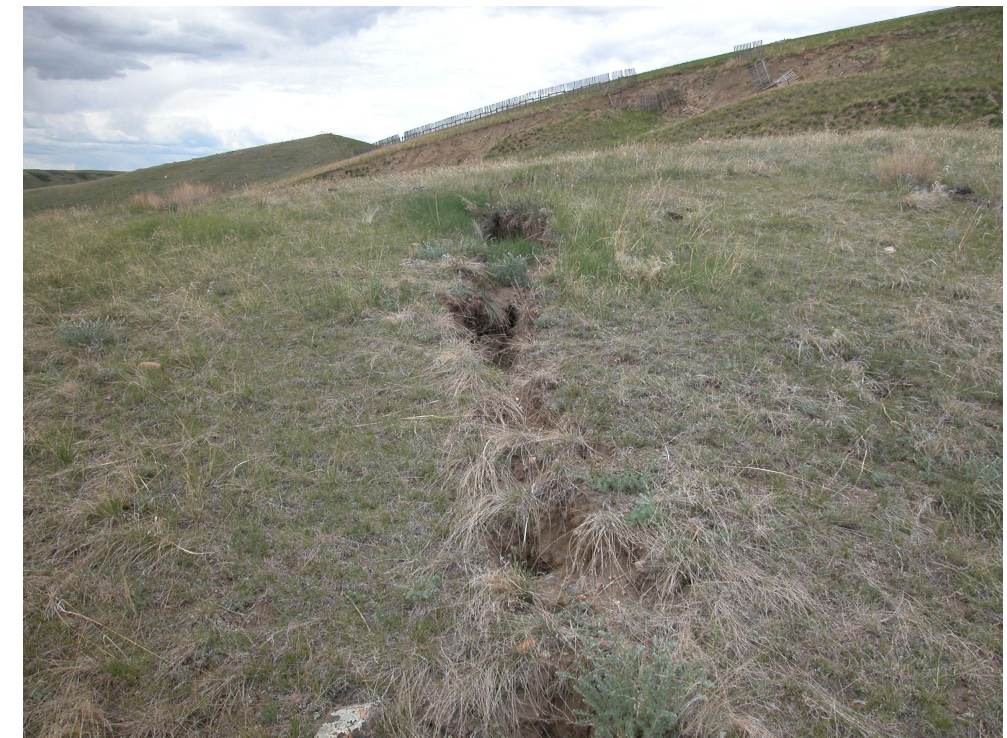
Photo S5-7 (lower right) – May 2004 – possible new tension crack and/or erosion gully on the lower portion of slope face below the highway. A number of similar features were noted in the area marked on Figure S5-1. The position and orientation of these possible tension cracks suggested that new or renewed movement in the lower portion of the slope downslope of the road may be occurring. It is judged that such movement would not impact the highway in the short term, but should be visually monitored in the near-future to confirm the situation and to assess the potential impacts with respect to the stability of the overall slope.

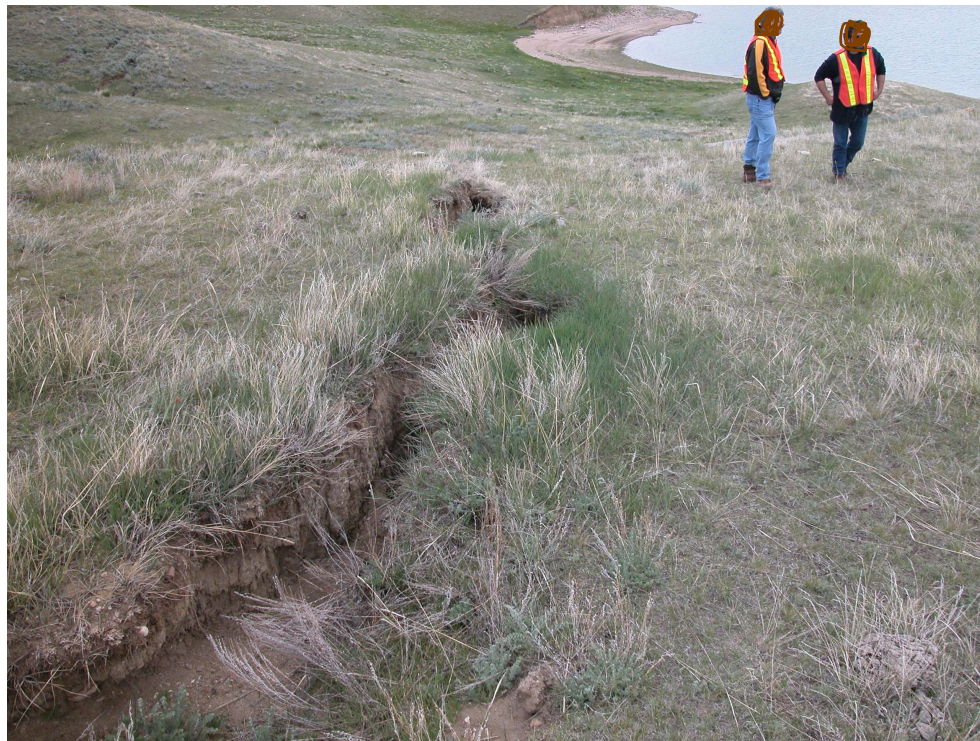
Photo S5-8 (left) – May 2004 – another view of one of the potential new tension cracks on the lower portion of the slope downslope of the highway.

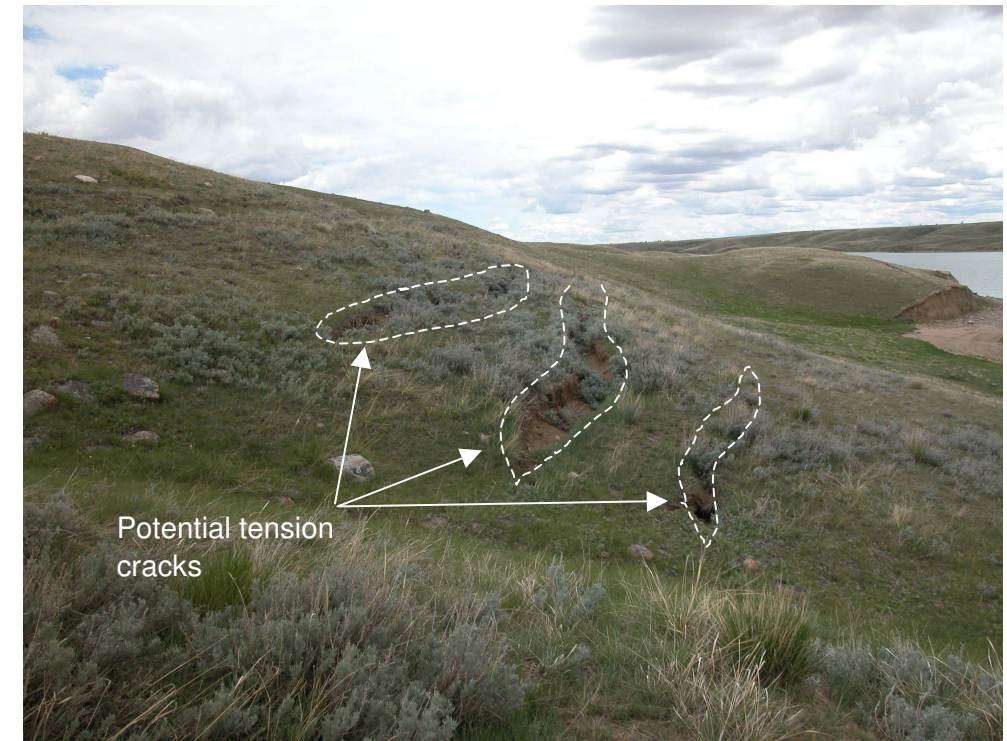
Photo S5-9 (right) – May 2004 – facing across the slope to some of the potential new tension cracks noted on the slope face downslope of the highway.
