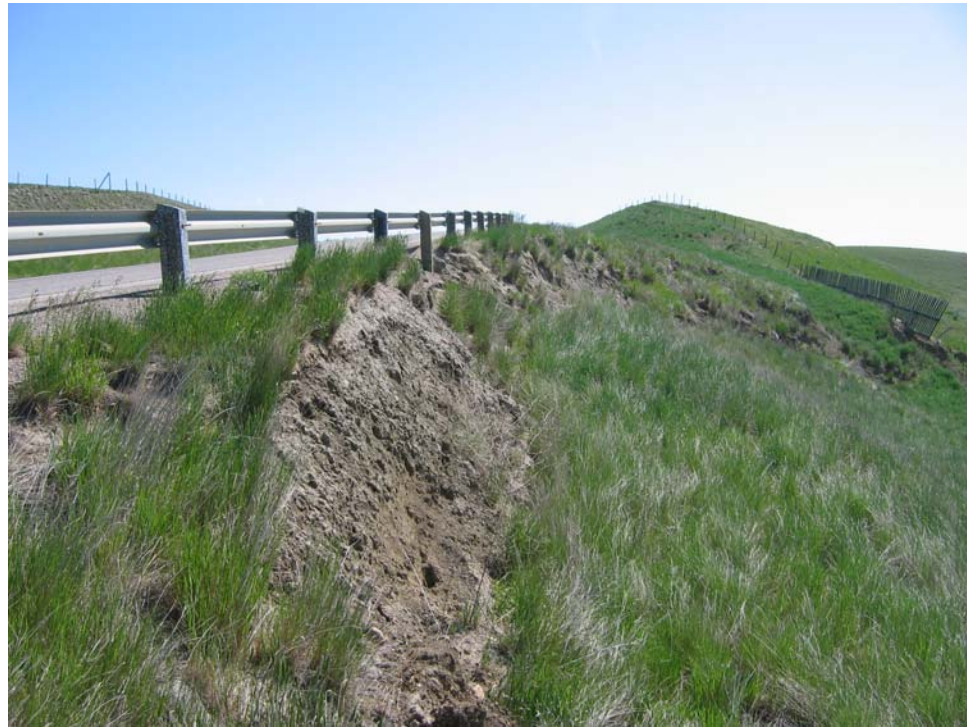
Photo S5-1 (upper left) – May 2006 – facing east across the shallow slumping area that is undermining the guardrail along the downslope edge of the road. Compare with Photo S5-2 that shows the same area as it appeared during the June 2005 inspection.

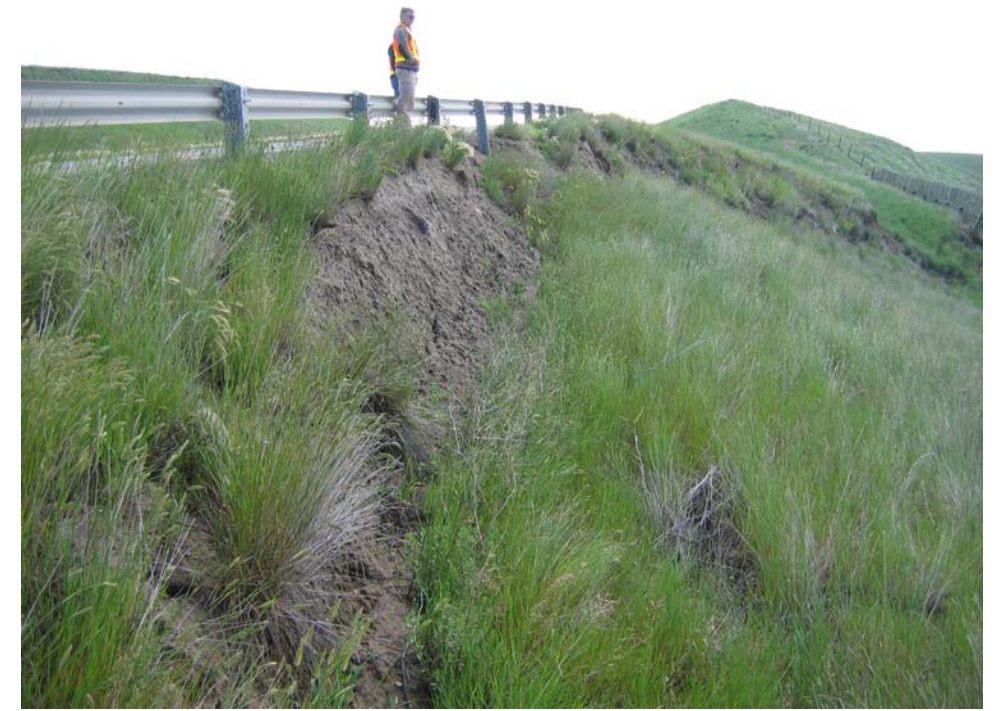
Photo S5-2 (upper right) – June 2005 – undermined segment of guardrail, as it appeared during the June 2005 inspection.

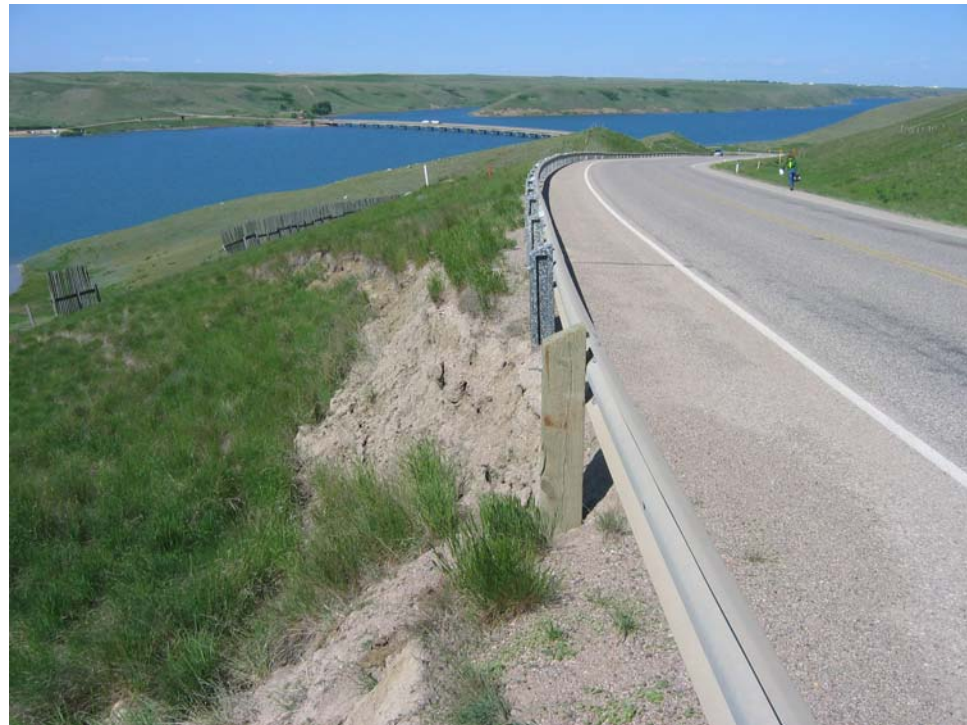
Photo S5-3 (lower left) – May 2006 – facing west across the shallow slumping area below the road. The guardrail posts are becoming undermined, but the shallow slumping has not yet retrogressed into the paved road surface.

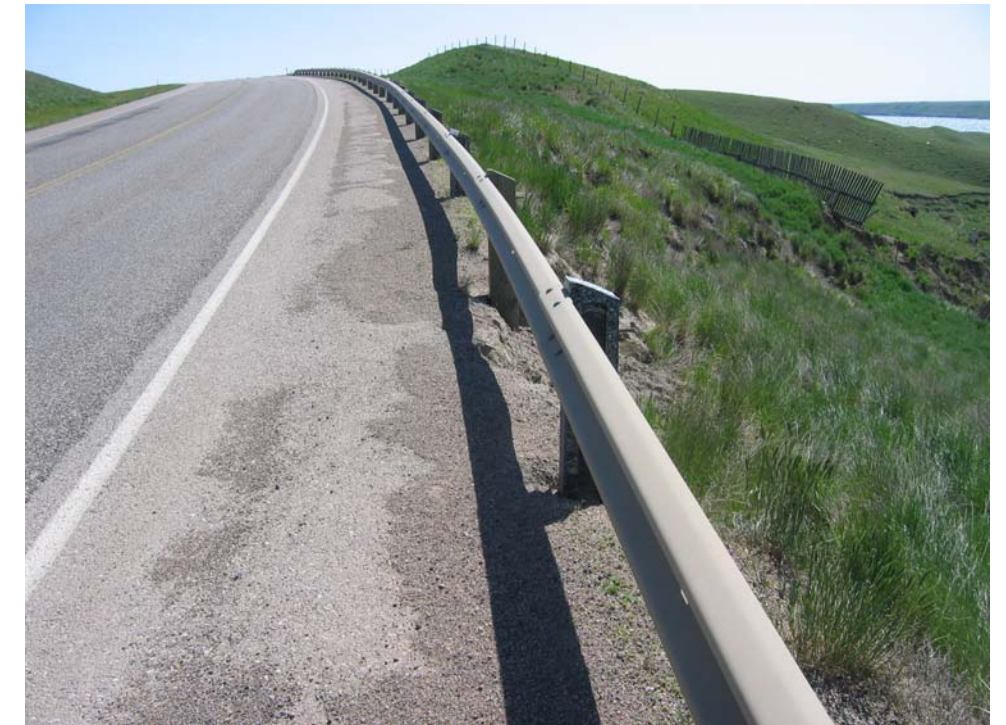
Photo S5-4 (lower right) – May 2006 – facing east along the eastbound lane of the road. Note the settlement in the shoulder along the guardrail.

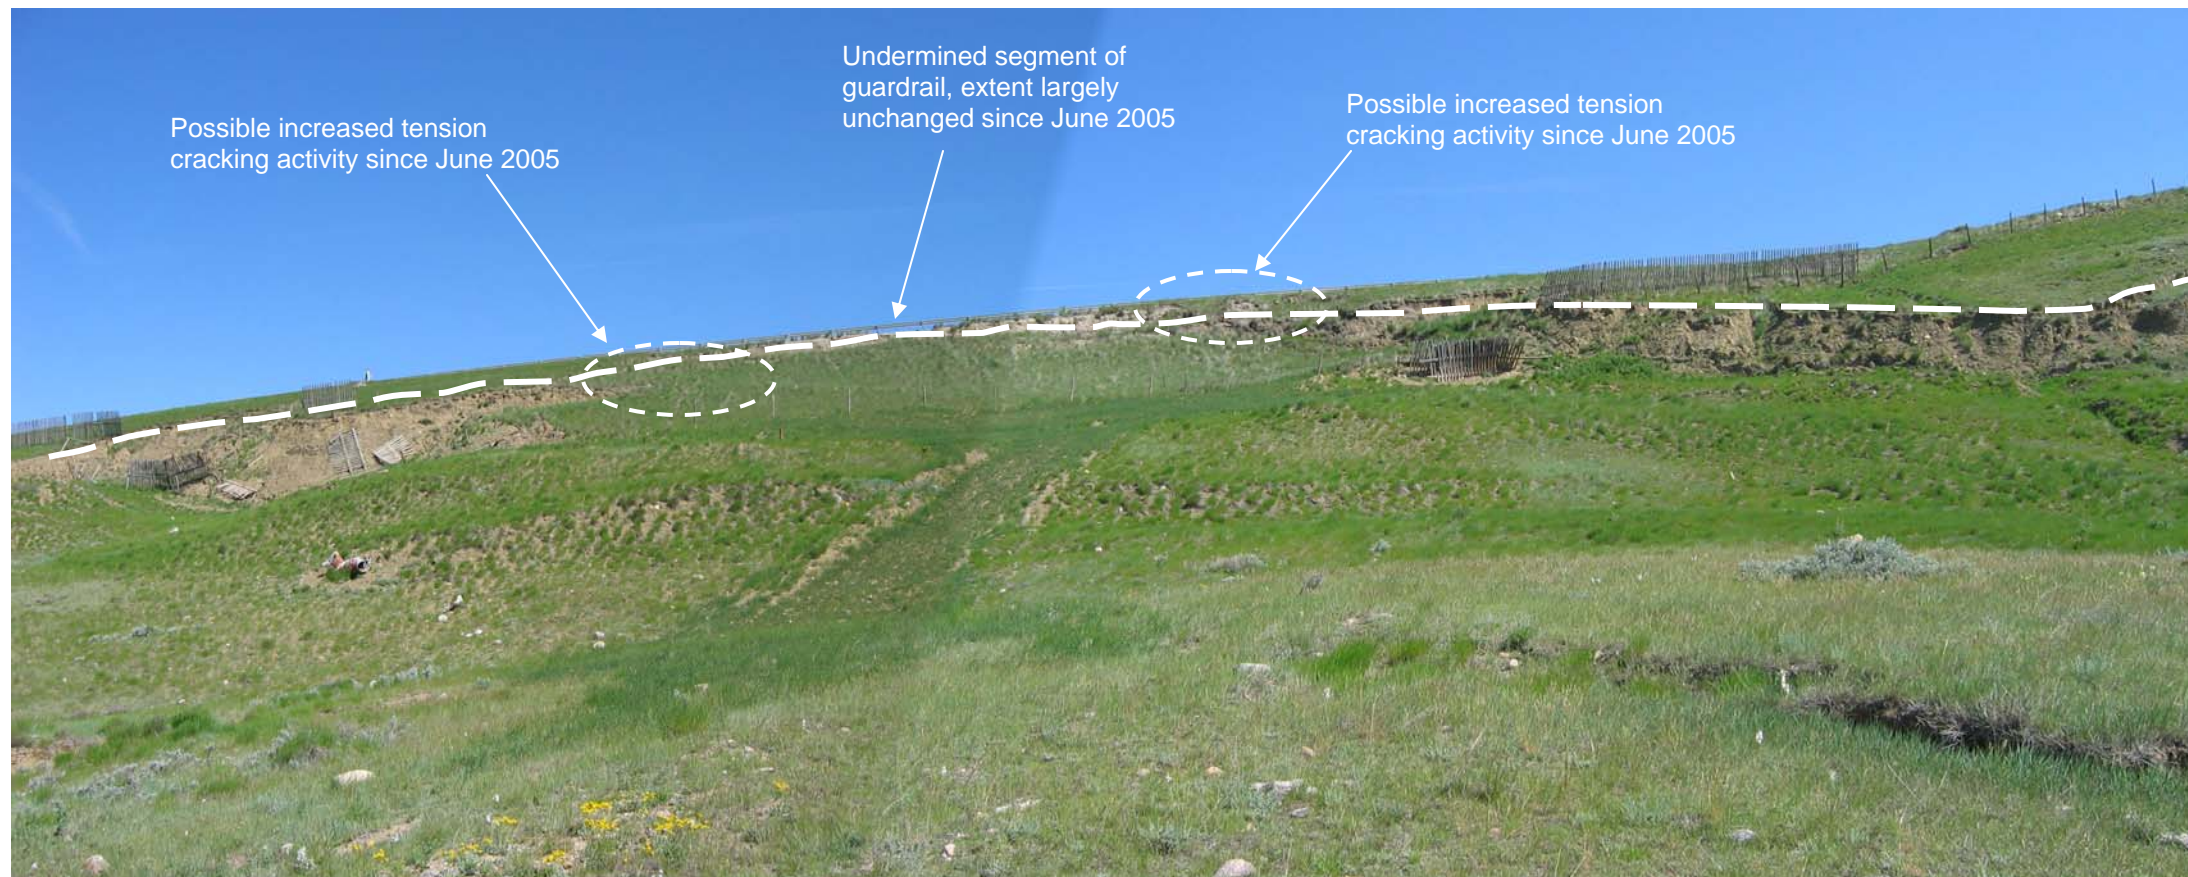
Photo S5-5 – May 2006 – facing upslope towards the road. The scarp of the slumping below the road is visible along with the undermined segment of the guardrail. Aside from some possibly increased tension cracking along the upper flanks of the slumping, the visual appearance of this slumping has not changed significantly since the previous inspection.
