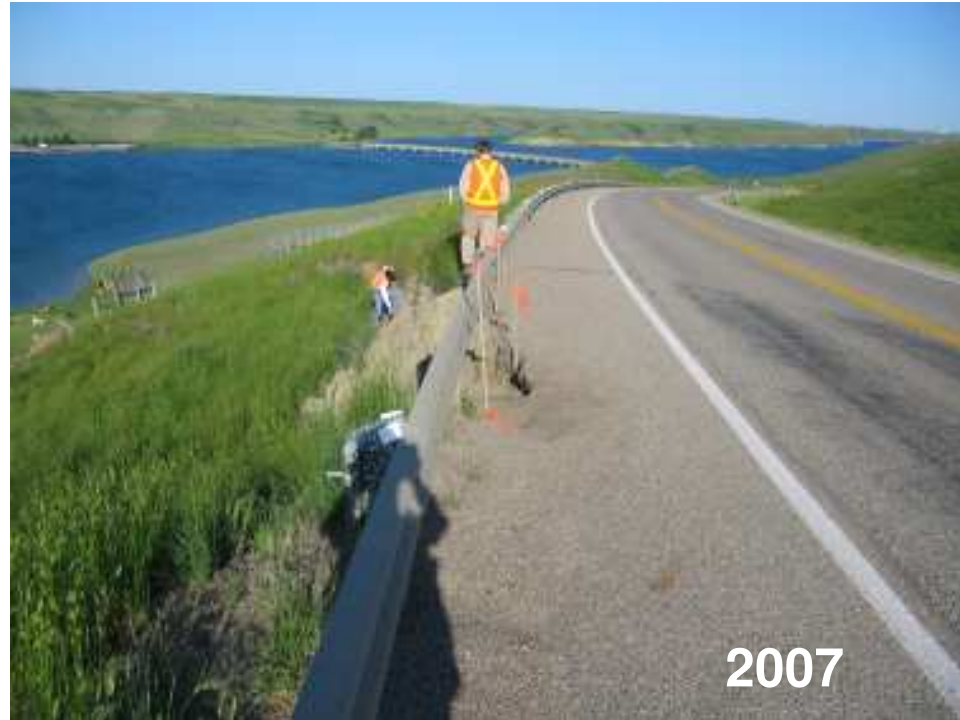
Photo S5-1 – June 2007 (upper left)
Facing west across the shallow slumping area below the road. The shallow slumping has started to retrogress into the paved road surface since the May 2006 site inspection. Compare with Photo S5-2 which shows the same area as seen during the May 2006 site inspection.

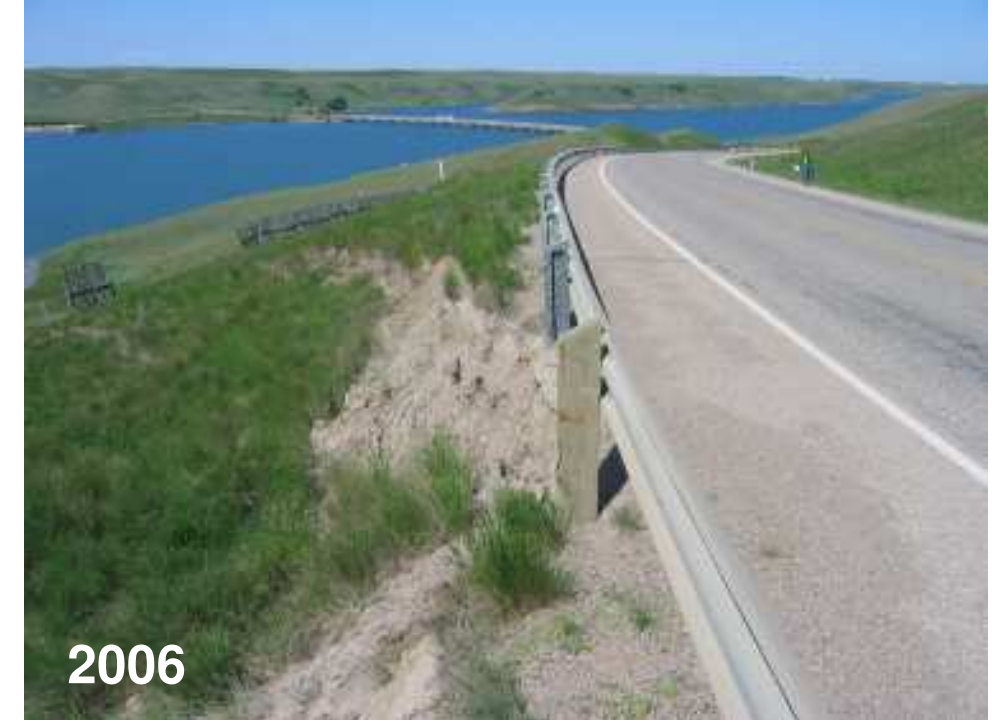
Photo S5-2 – May 2006 (upper right)
Same area as shown in Photo S5-1, as seen during the May 2006 site inspection.

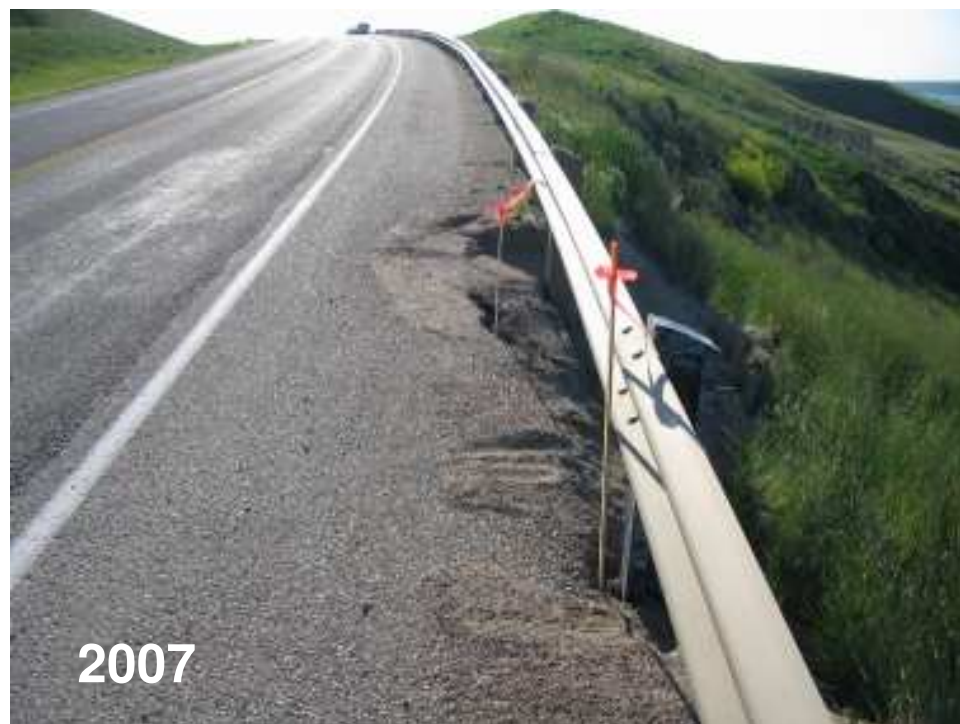
Photo S5-3 – June 2007 (lower left)
Facing east across the shallow slumping area.

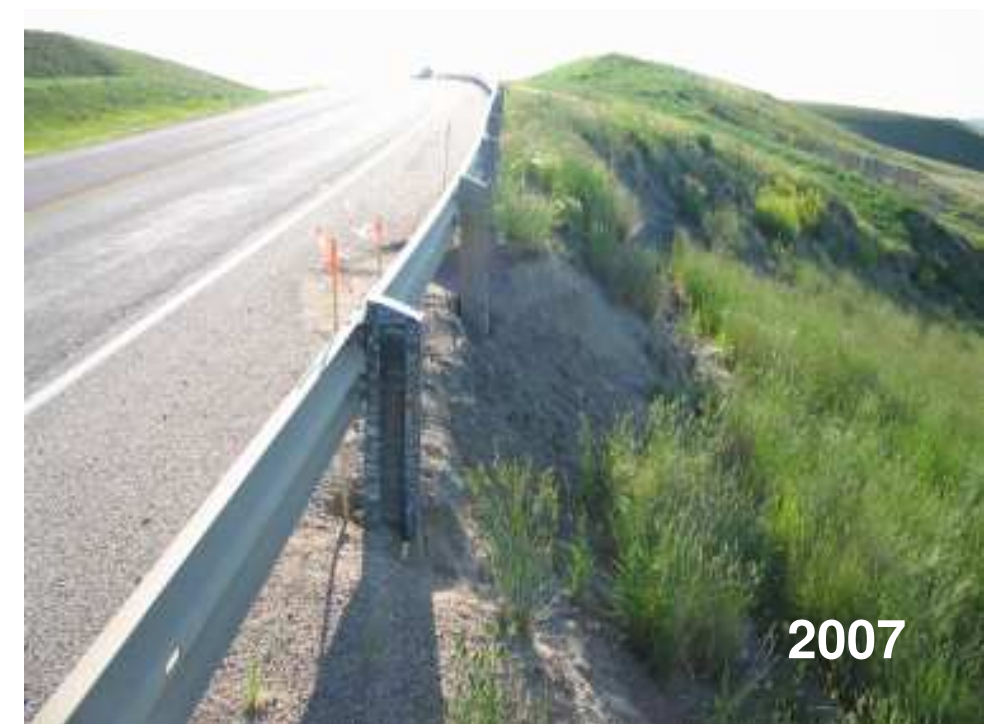
Photo S5-4 – June 2007 (lower right)
Another view of the area where the shallow slumping has retrogressed into the paved road surface, with the 2 to 3 m drop in the slope profile adjacent to the highway visible on the right hand side of the photo.

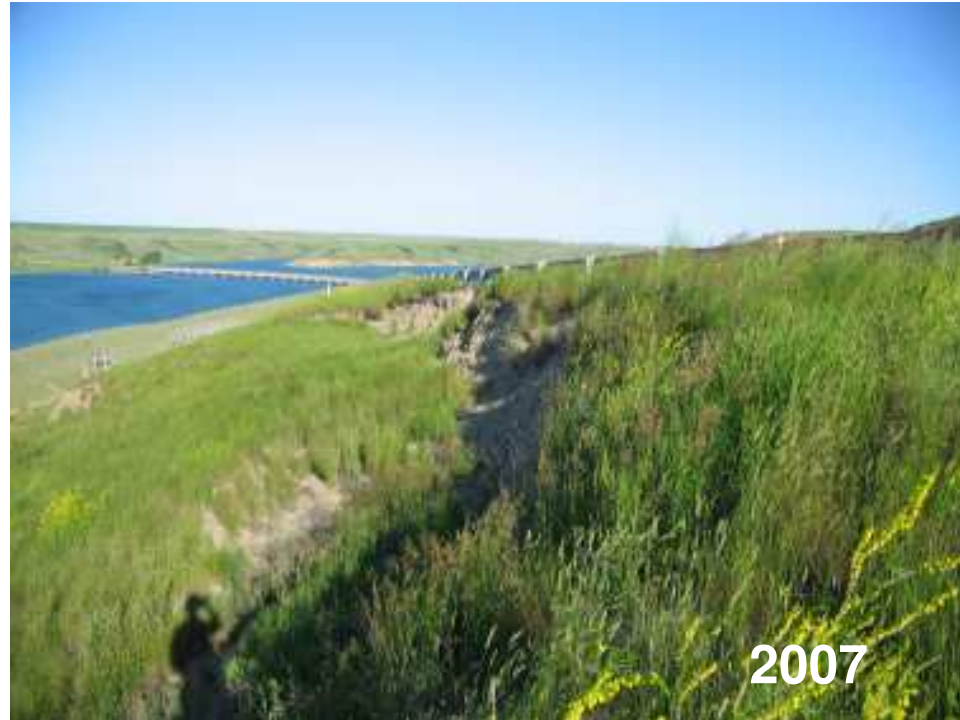
Photo S5-5 – June 2007 (upper left)
Facing west across the upper portion of the slope in the shallow slumping area. Note the 2 to 3 m drop adjacent to the guardrail.
