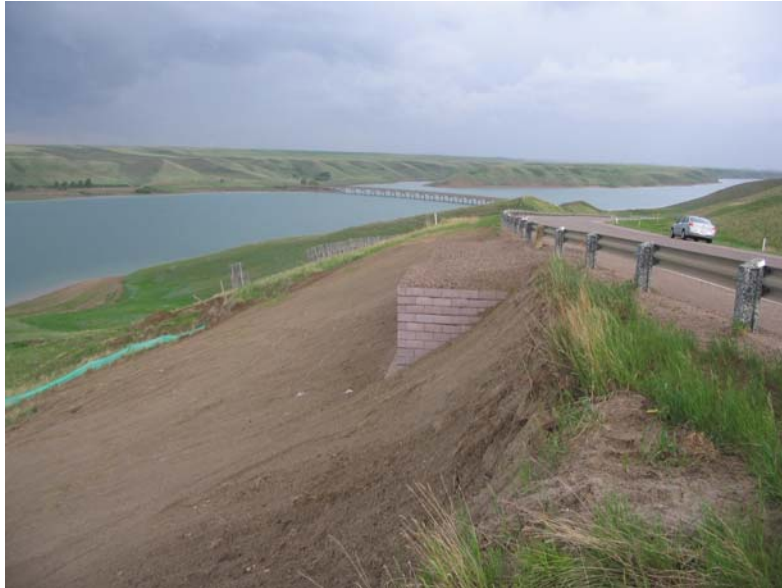
Photo S5-1 – June 2008 (top)

Facing west across the slope below the highway, with the retaining wall constructed in May 2008 visible. The uppermost portion of the slope below the guardrail was also reinforced with launched soil nails.

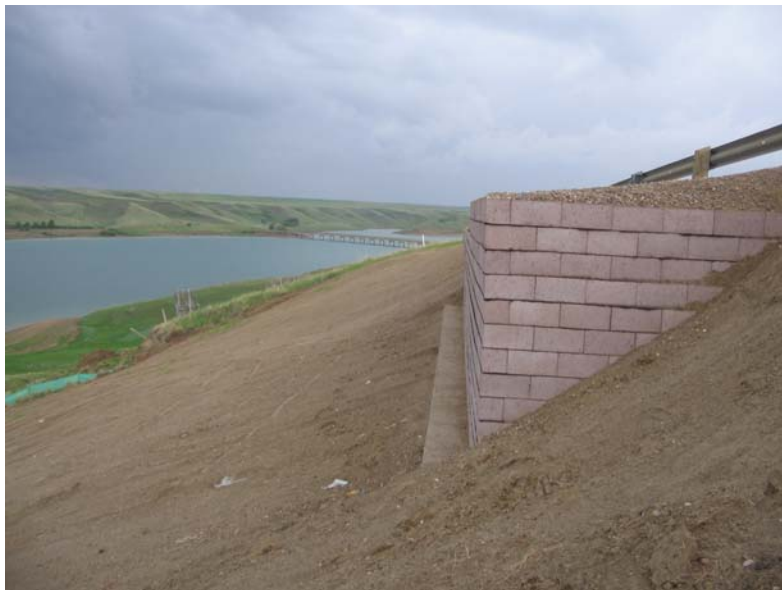
Photo S5-2 – June 2008 (bottom)

Closer view of the retaining wall and adjacent regraded slopes. Note the possible, very slight downslope tilt of the uppermost 4 rows of the wall blocks along with the overall slight back rotation of the wall. It is likely that this was how the wall was constructed, but future visual reviews of the wall will be useful to check if the wall tilts or deforms due to underlying slope movement.

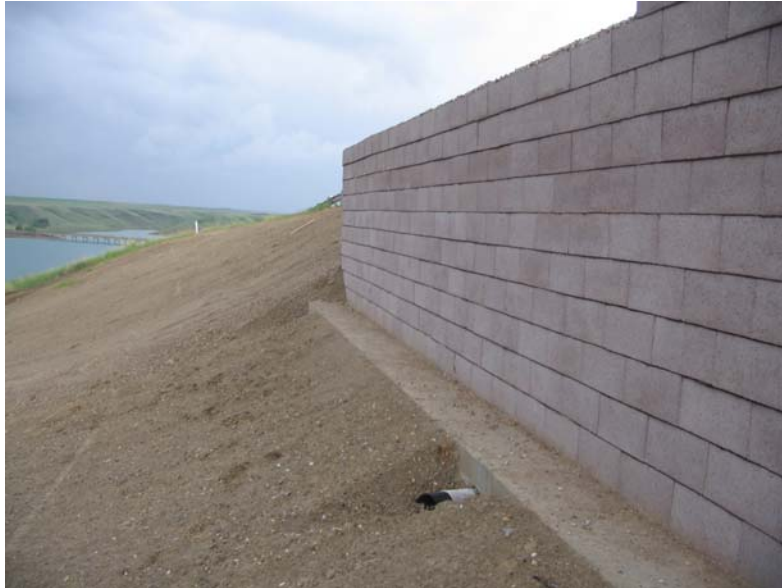
Photo S5-3 – June 2008 (top)

Closer view of the base of the wall, with one of the wall backfill drain discharge points onto the exposed soils downslope of the wall visible in the foreground.

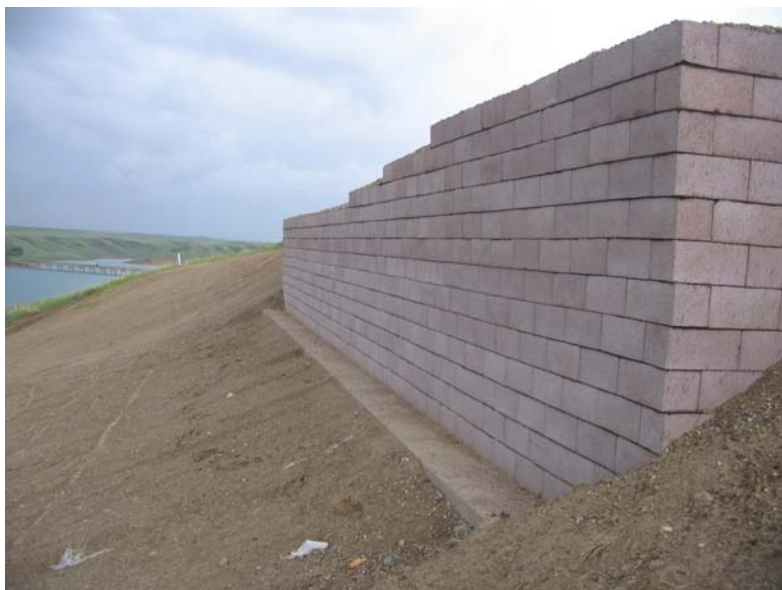
Photo S5-4 – June 2008 (bottom)

Another view of the base of the wall.

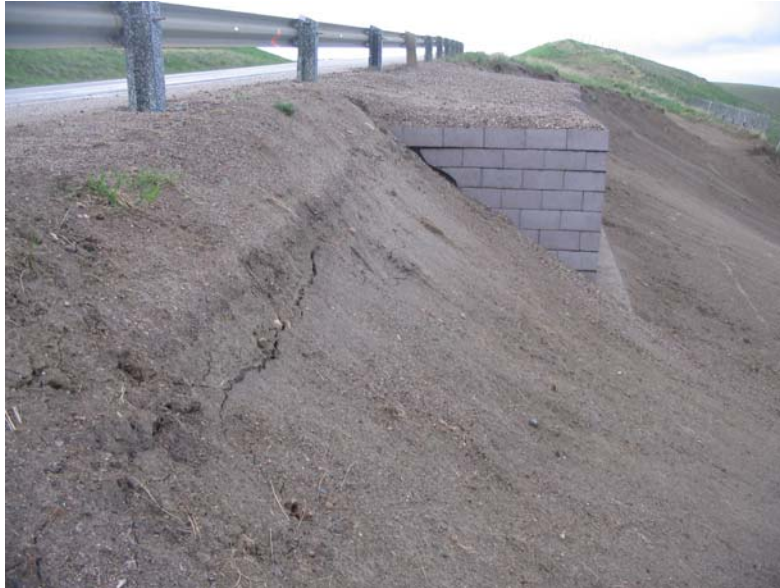
Photo S5-5 – June 2008 (top)

Facing east across the retaining wall. The slope in the foreground and the corresponding slope on the opposite side of the wall were reinforced with launched soil nails and subsequently covered with backfill to establish the overall slope angle visible in this photo. Note the shallow tension crack across the backfill on the slope, likely due to short-term, post-construction settlement of the backfill.
