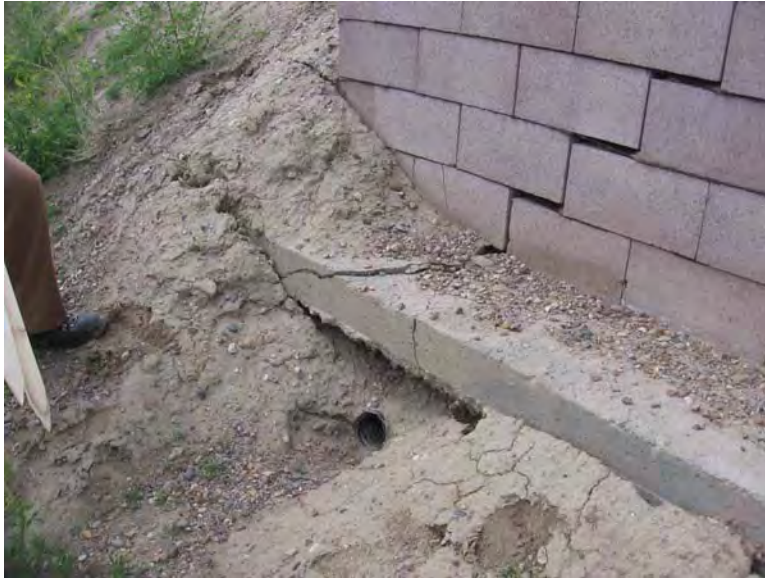
Photo S5-1 – June 2009

The footing at the west end of the May 2008 retaining wall has become undermined around the drainage pipe and cracking of the footing has occurred. This damage has occurred since the June 2008 site inspection. See Photo S5-2 for another view of this same area, after a stake and spray paint markings were added for future reference.

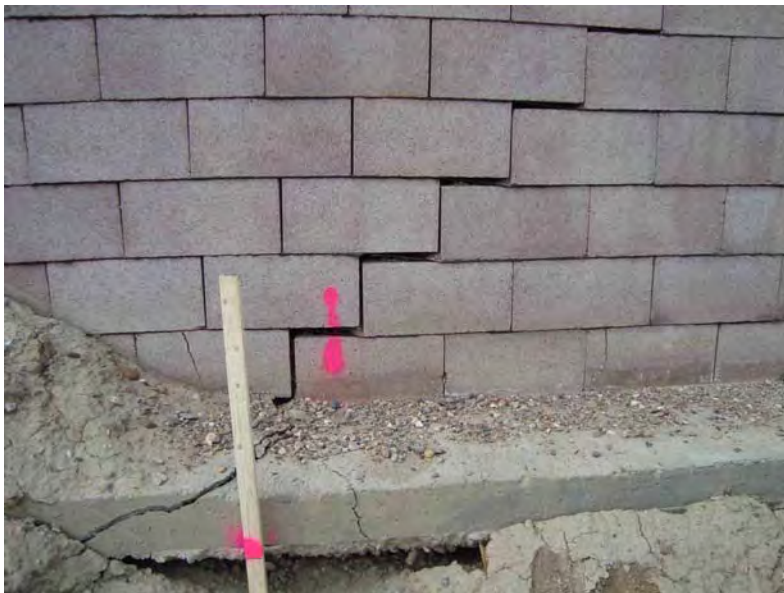
Photo S5-2 – June 2009

Separation of the wall blocks due to footing undermining and wall settlement. This damage has occurred since the June 2008 site inspection. The central portion of the wall foundation has at least 15 cm of differential settlement as observed from the deflection of the rows of blocks. The crack at the painted mark is separated by 32 mm. A survey stake was installed at the undermined area to reference for future settlement (mark on the footing and stake at the same elevation).

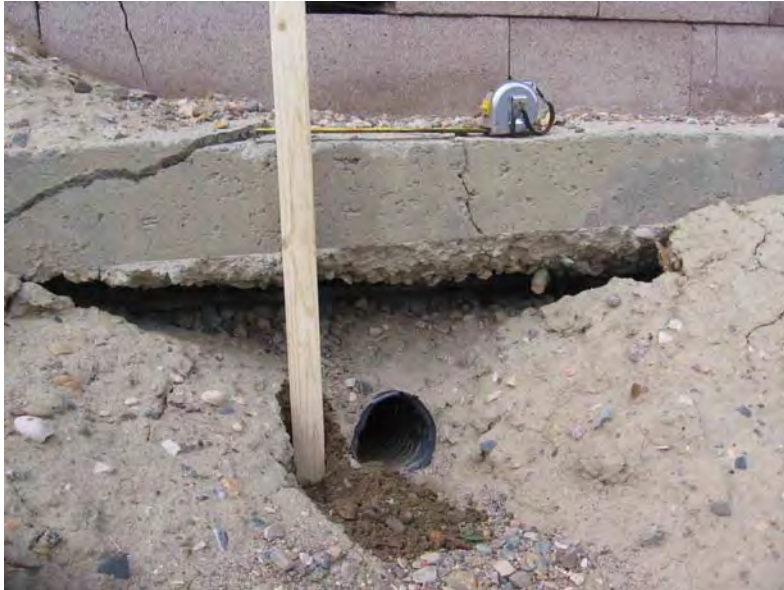
Photo S5-3 – June 2009

Closer view of the undermined footing at the west side of the wall.

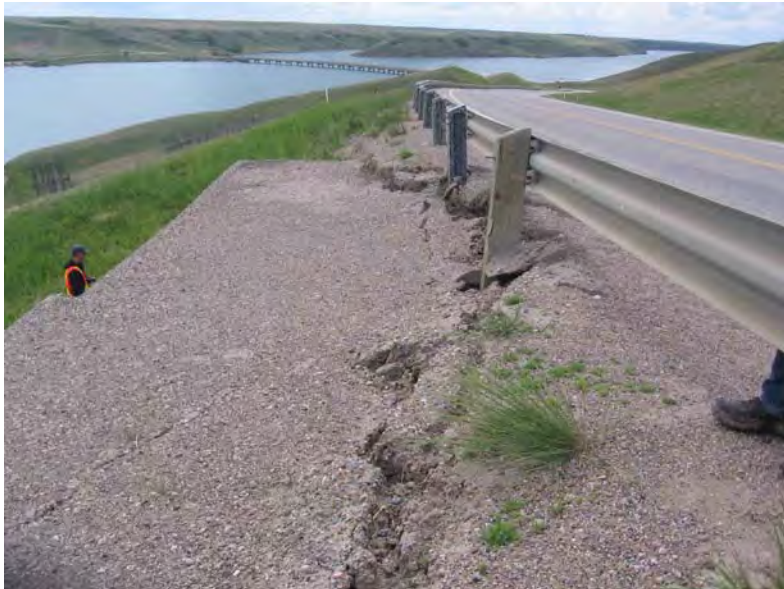
Photo S5-4 – June 2009

Facing west from the east end of the retaining wall. Cracking and settlement of the fill behind the wall is causing two guardrail posts to become unsupported.

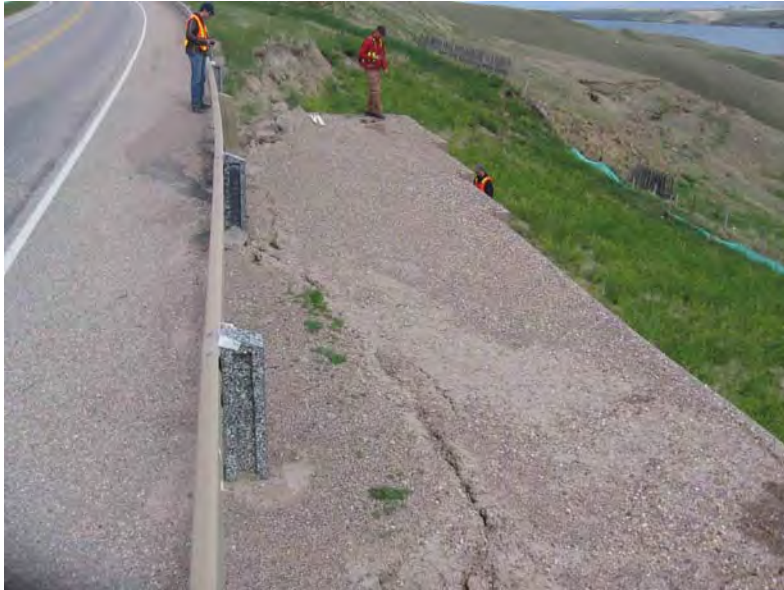
Photo S5-5 – June 2009

Facing east from the west end of the retaining wall. Settlement of the wall backfill and undermining of the guardrail posts is visible. Note that no new cracking has appeared on the road surface since the 2008 annual inspection.

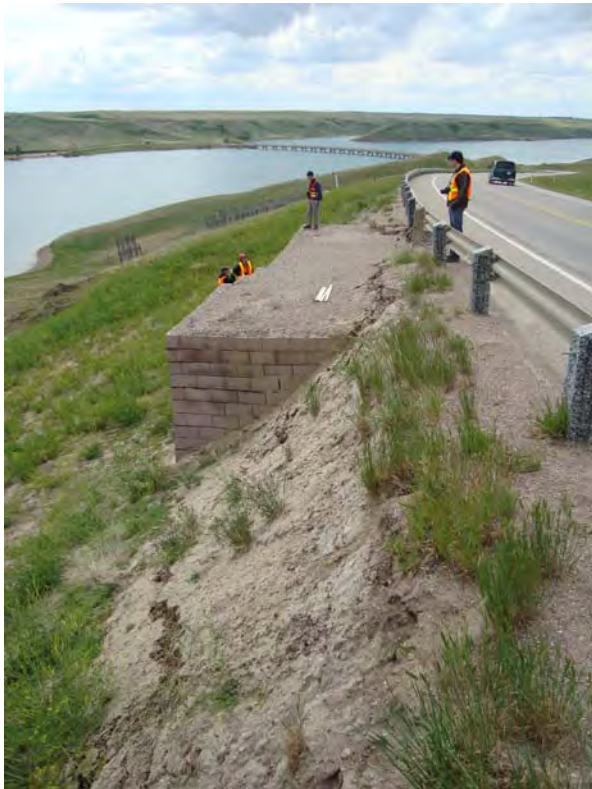
Photo S5-6 – June 2009

Facing east from the west end of the soil nailed area. Note that vegetation is becoming established, however the steeper scarp remains mostly bare since regrading in May 2008.
