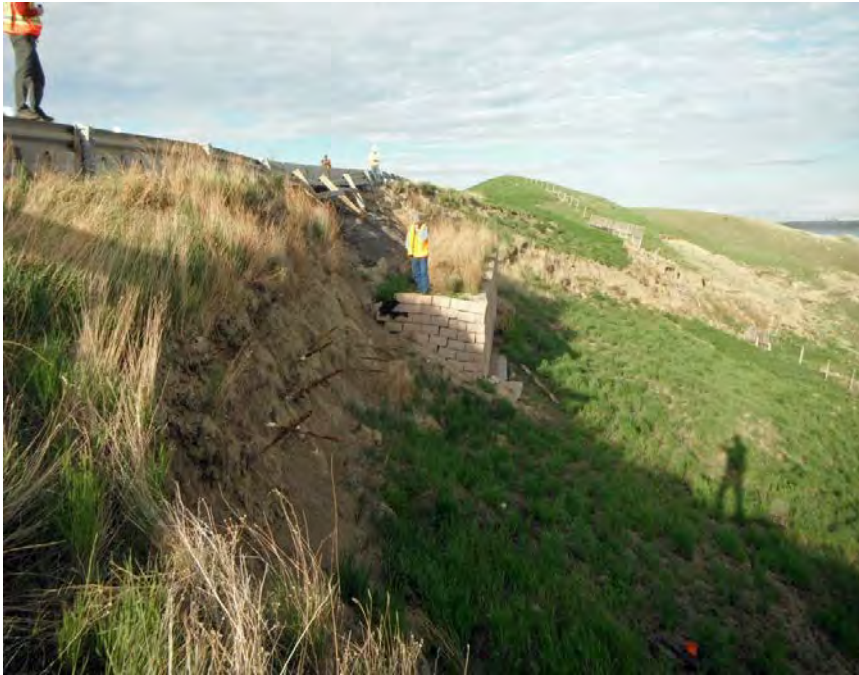
Photo S5-1 (May 2013) –
A general view of the site area facing towards the east, illustrating the extent of the wall settlement, undermined guardrail and the exposed soil nails.

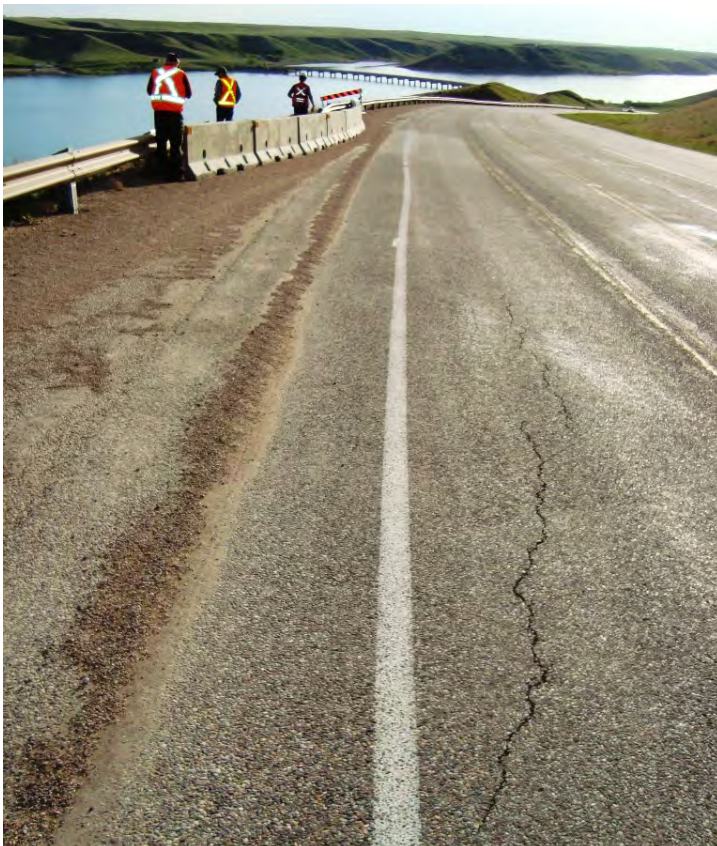
Photo S5-2 (May 2013) –
Standing in the eastbound lane facing southwest at the subtle pavement cracking observed northeast of the diversion barriers and retaining wall.

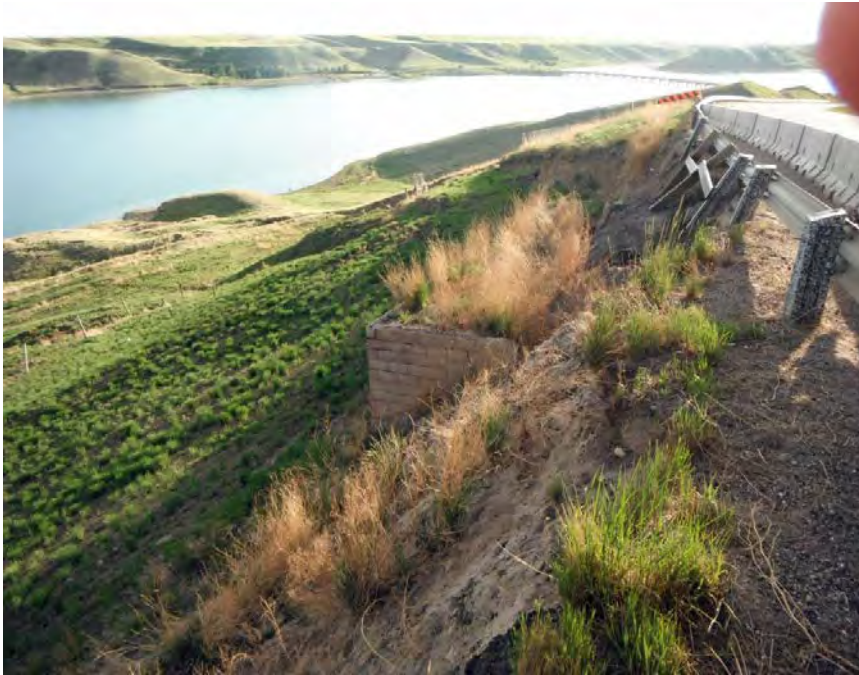
Photo S5-3 (May 2013) – Standing on the south road shoulder looking towards the southwest at the headscarp retrogression into the road surface and retaining wall.

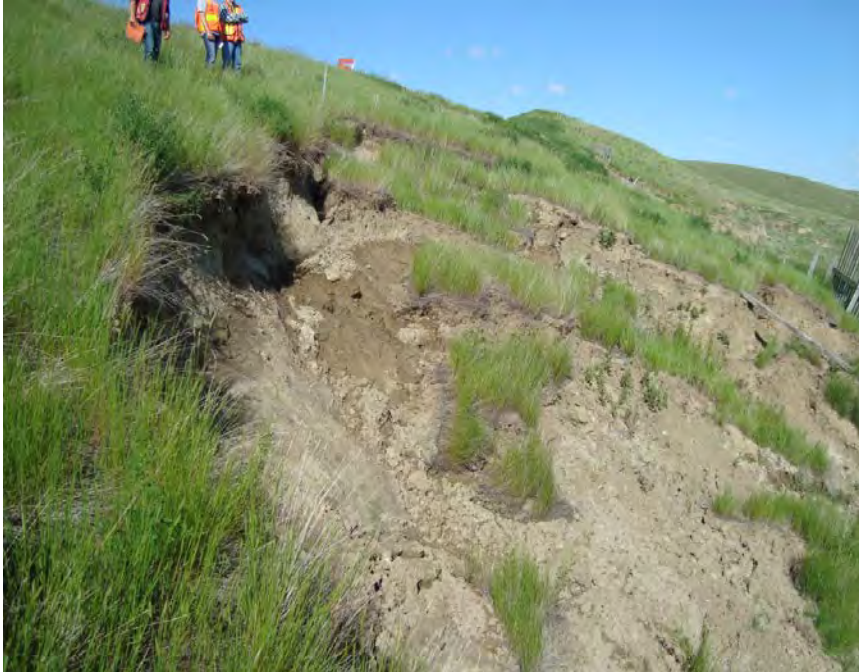
Photo S5-4 (June 2011) –
An active scarp at the west slide flank noted during the 2011 inspection. Refer to Photo S5-5 for comparison from the 2013 inspection.

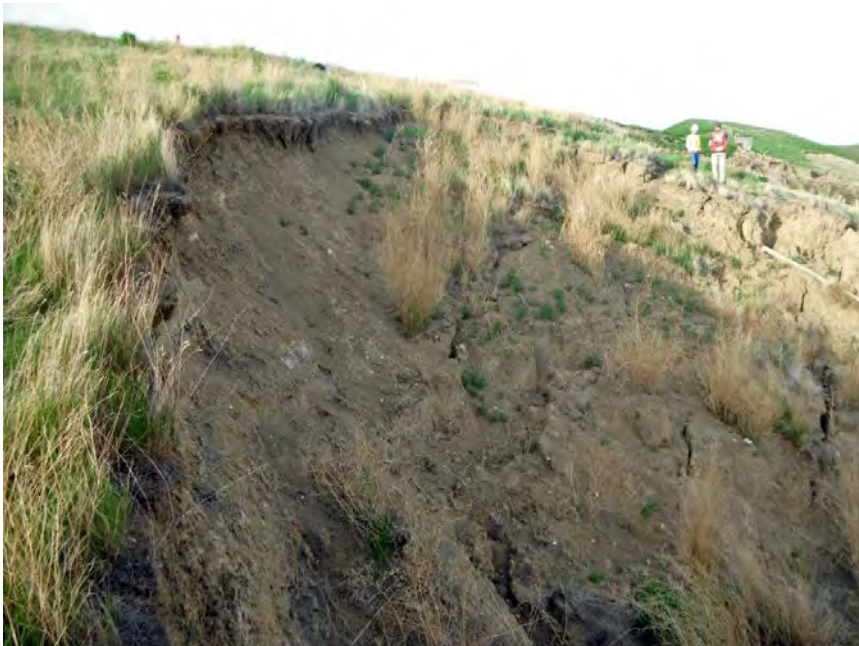
Photo S5-5 (May 2013) –
Looking towards the same slide area as Photo S5-4. The exposed soil has eroded but the condition is generally unchanged.
