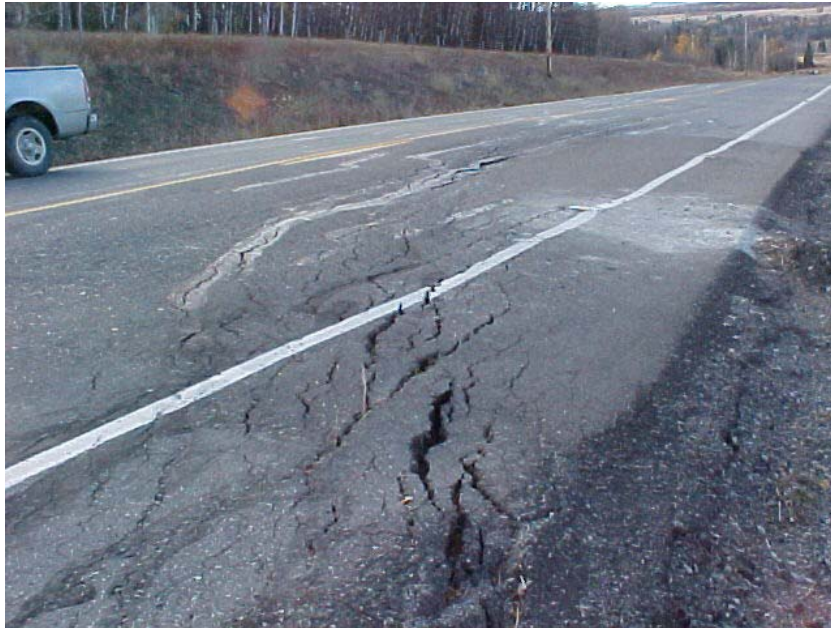
Photo 1 – October 2001 photo of tension cracks in the settlement/cracking area that was previously identified and investigated in the summer of 2001. The rate of movement and cracking in this area appeared to accelerate in the late summer/fall of 2001. This area was repaved in October 2001 after this photo was taken.

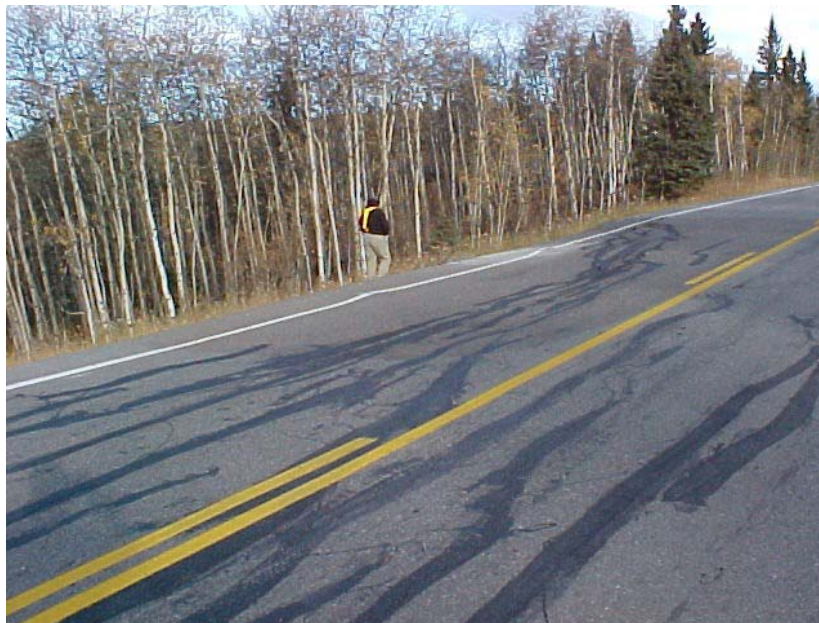
Photo 2 – Another view of the settlement/cracking area before repaving in October 2001.

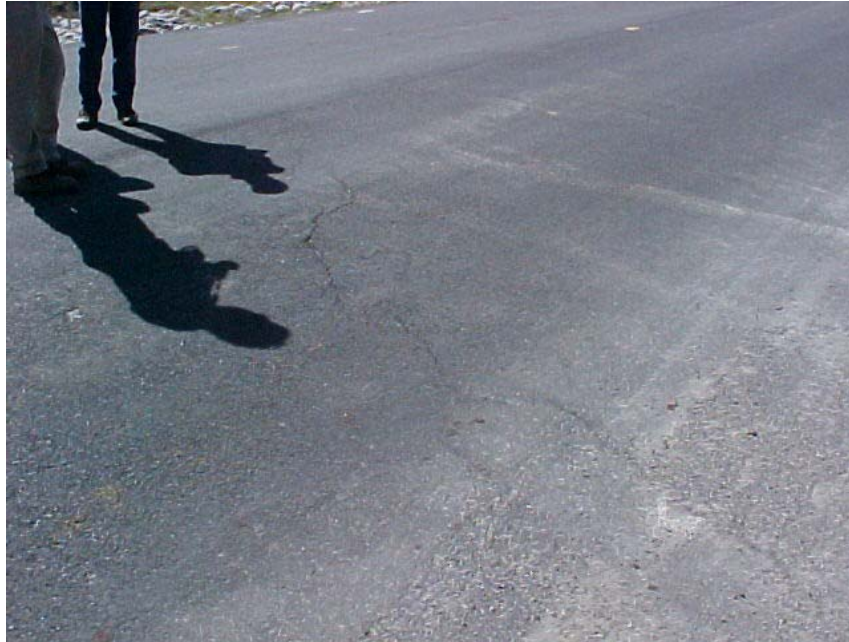
Photo 3 – Fresh cracks in the repaved settlement/cracking area, as seen in May 2002.

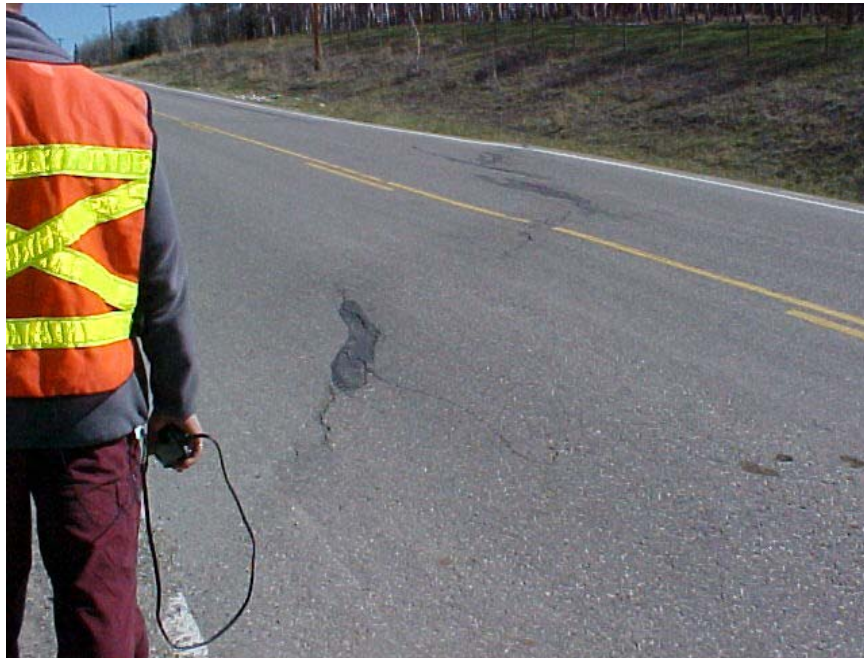
Photo 4 – New crack extending northeast/southwest across the road, approximately 80 m south of the settlement/cracking area shown in Photos 1 to 3. May 2002 photo.

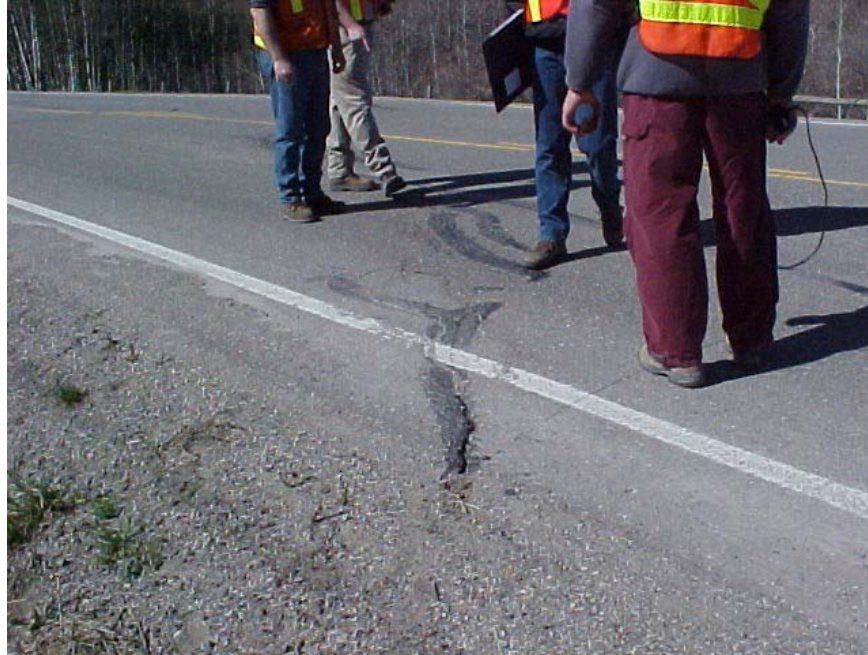
Photo 5 – Another view of the new crack. May 2002 photo.
