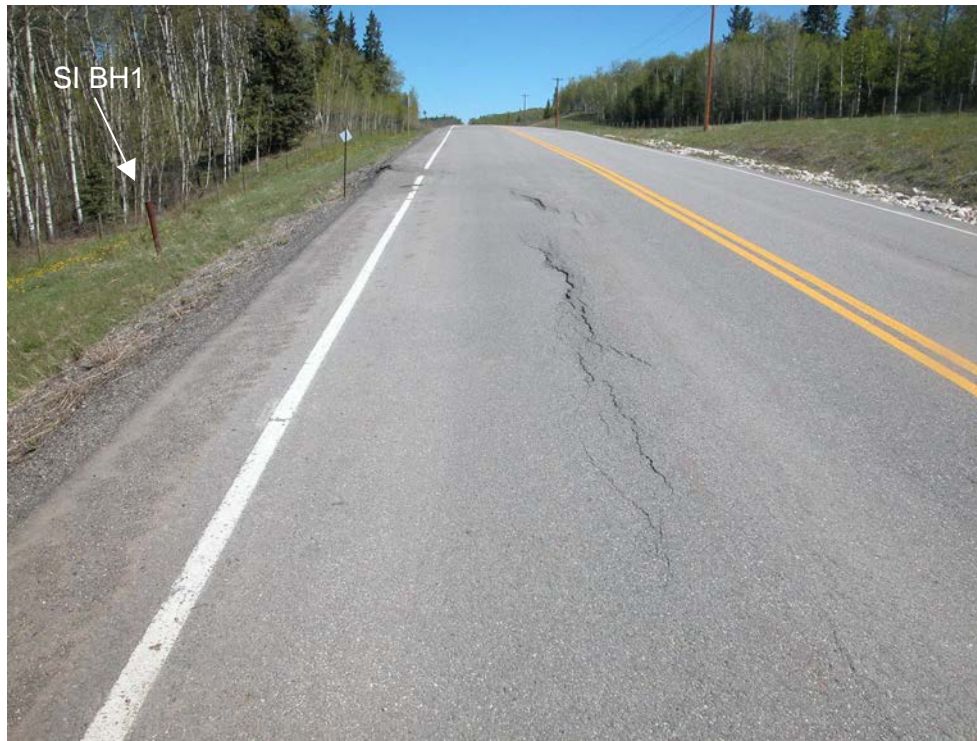
**Photo S8-1** (upper left) – May 2004 – cracking and settlement at the north end of the S8 – Fisher Creek site. Similar damage to the road surface has been noted during previous inspections. The SI in BH1 on the west slope below the road is visible (left side of photo). This SI sheared off at approximately 5 m depth between the spring and fall of 2002 and has not been read since. Based on the continued cracking and settlement in this area, slope movement is continuing.

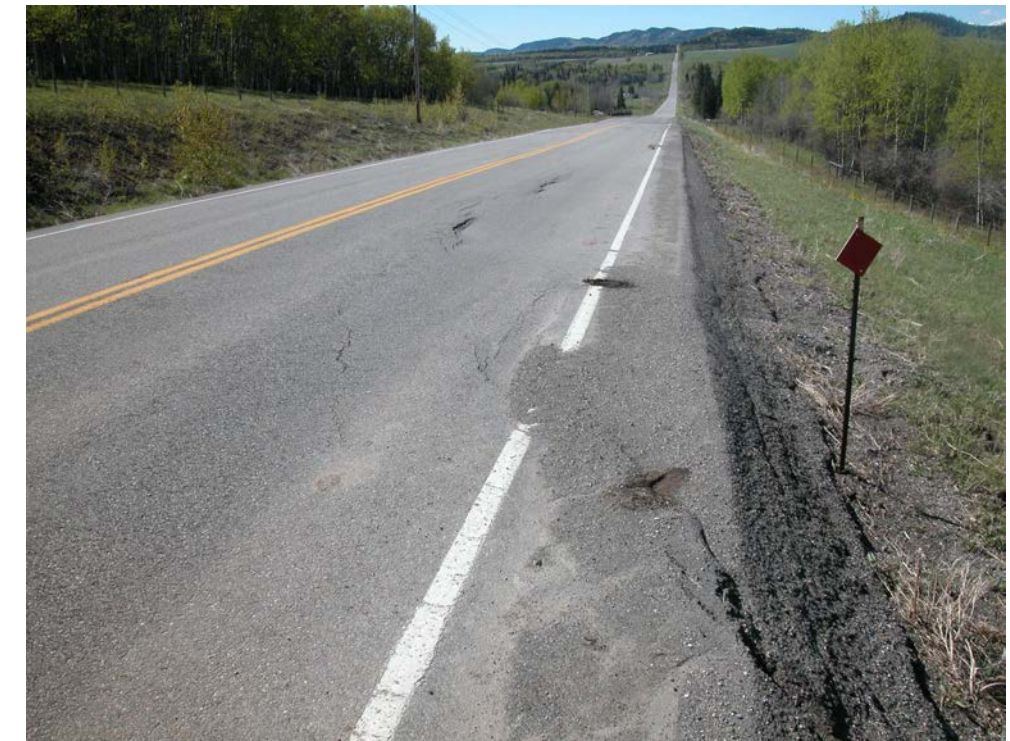
**Photo S8-2** (upper right) – May 2004 – Facing south across the damaged portion of the southbound lane at the north end of the S8 – Fisher Creek site.

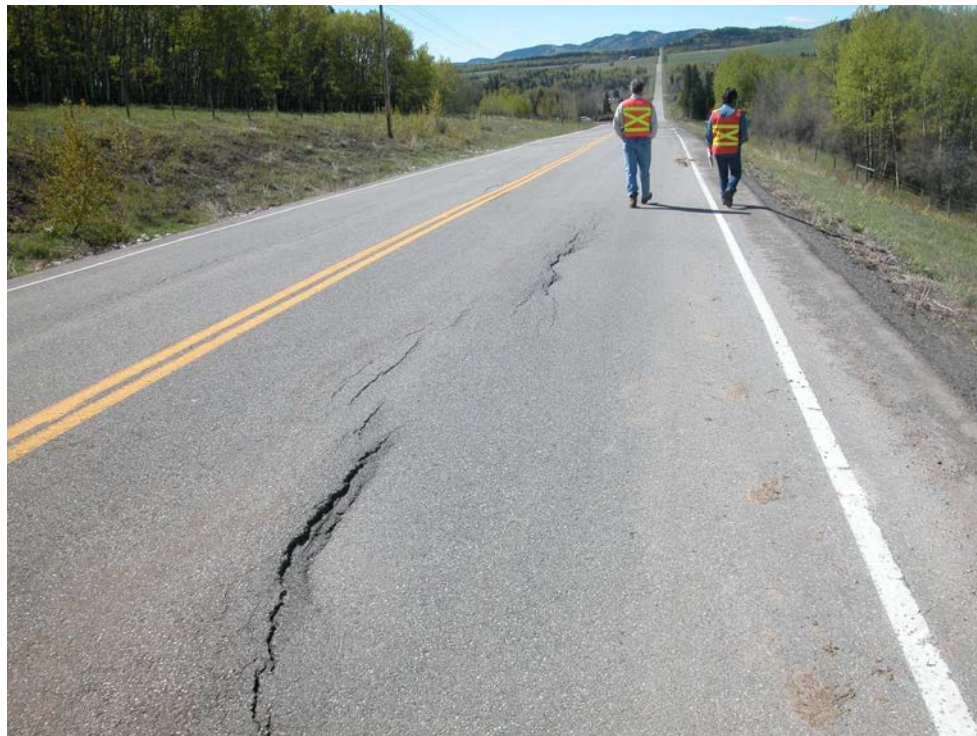
**Photo S8-3** (lower left) – May 2004 – a closer view showing the magnitude of the cracking and settlement in the southbound lane at the north end of the Fisher Creek site.

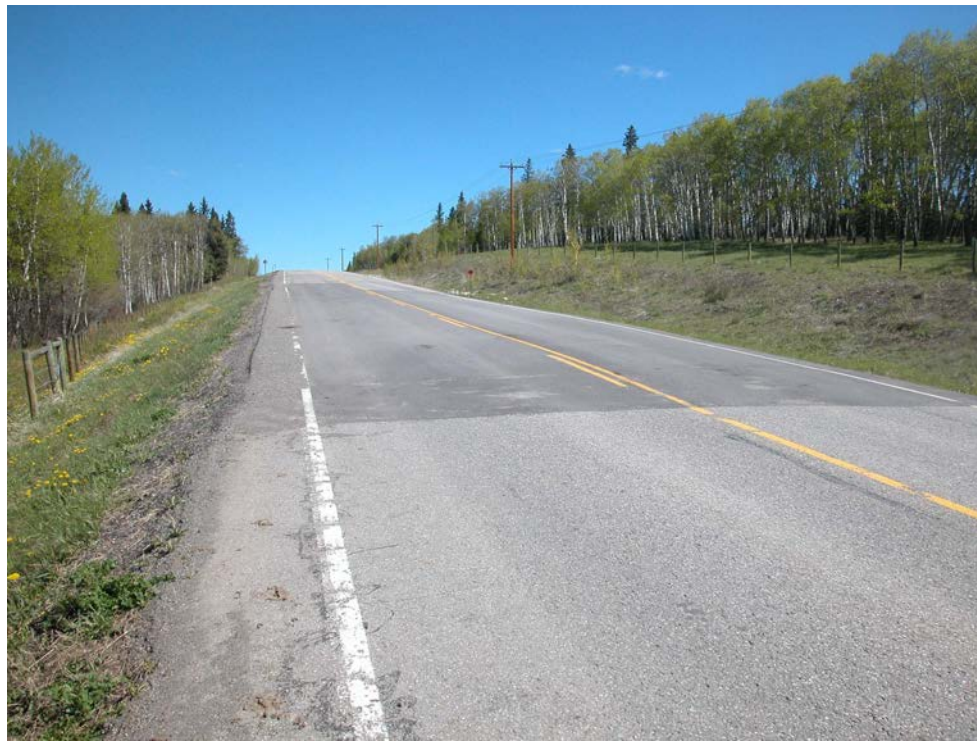
**Photo S8-4** (left) – May 2004 – facing north across the south end of the S8 – Fisher Creek site. An arc-shaped crack was first noted in the road surface in this area during the May 2002 inspection and 3 SI's were installed in the fall of 2002 in order to monitor for underlying slope movement that may have caused the cracking. Each of the SI's measured ongoing slope movement towards the west (left side of the photo) at 4 to 6 m depth in the native clay soil underlying the road fill.

This area was repaved in July 2003. This overlay is visible in the photo as the relatively darker shade of grey pavement. No cracking has been observed in the road surface since that time despite continued movement measured in the SI's.

An additional overlay was placed in this area in early June 2004 (after this photo was taken).

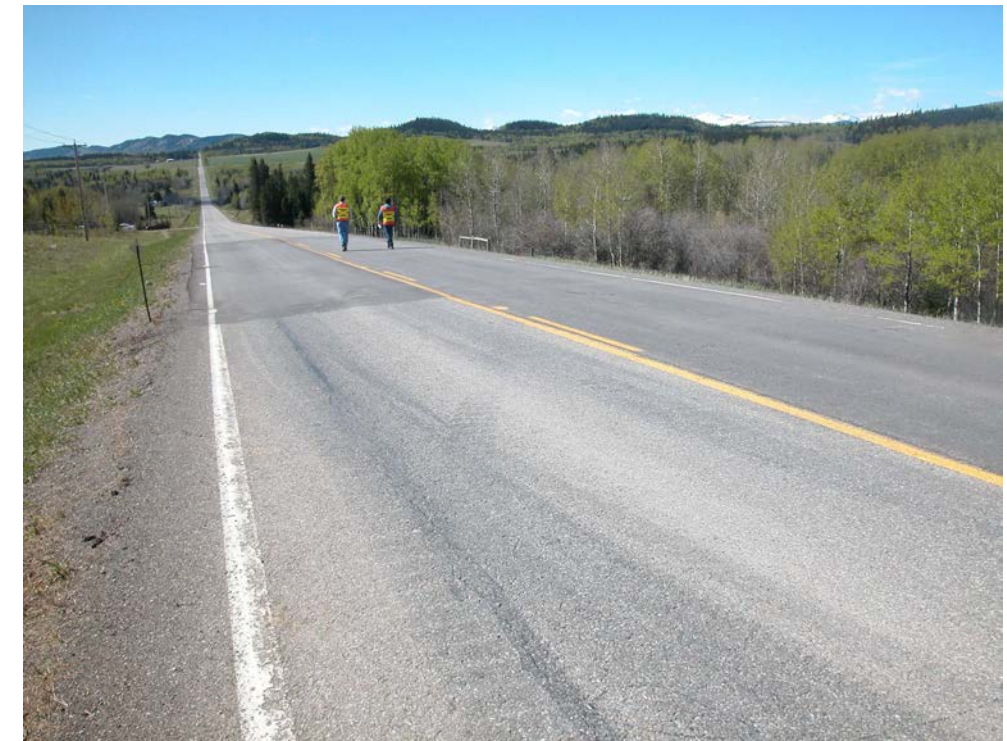
**Photo S8-5** (right) – May 2004 – facing south across the area shown in Photo S8-5.
