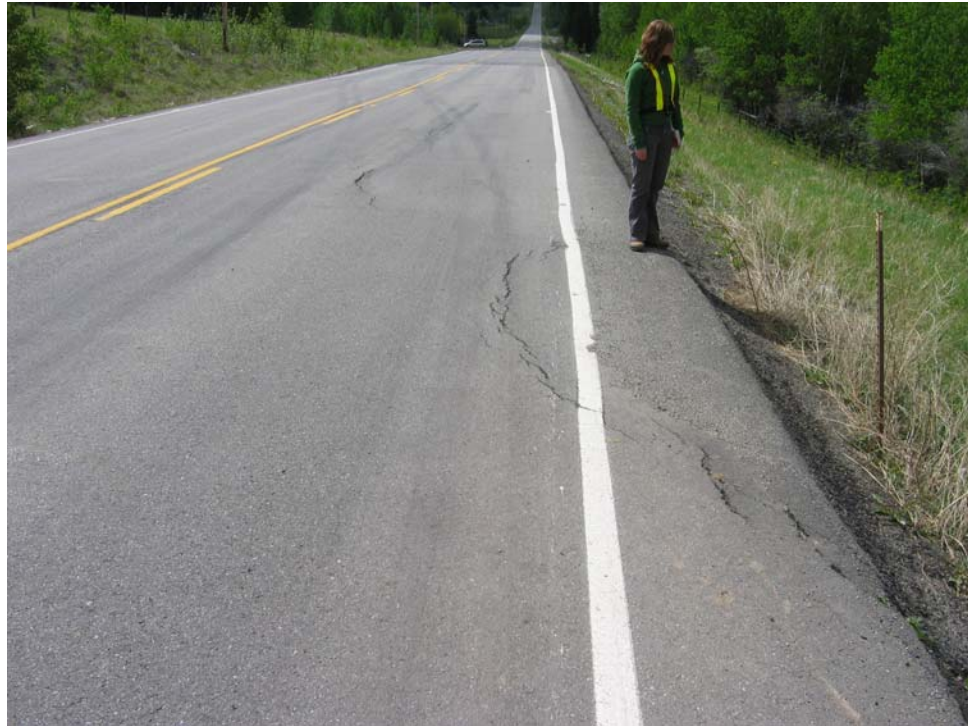
Photo S8-1 (upper left) – May 2006 – facing south along the northern area of the site. New cracking observed in the previously-noted cracking and settlement area. The visible cracking has developed since the area was repaved after the 2005 inspection.

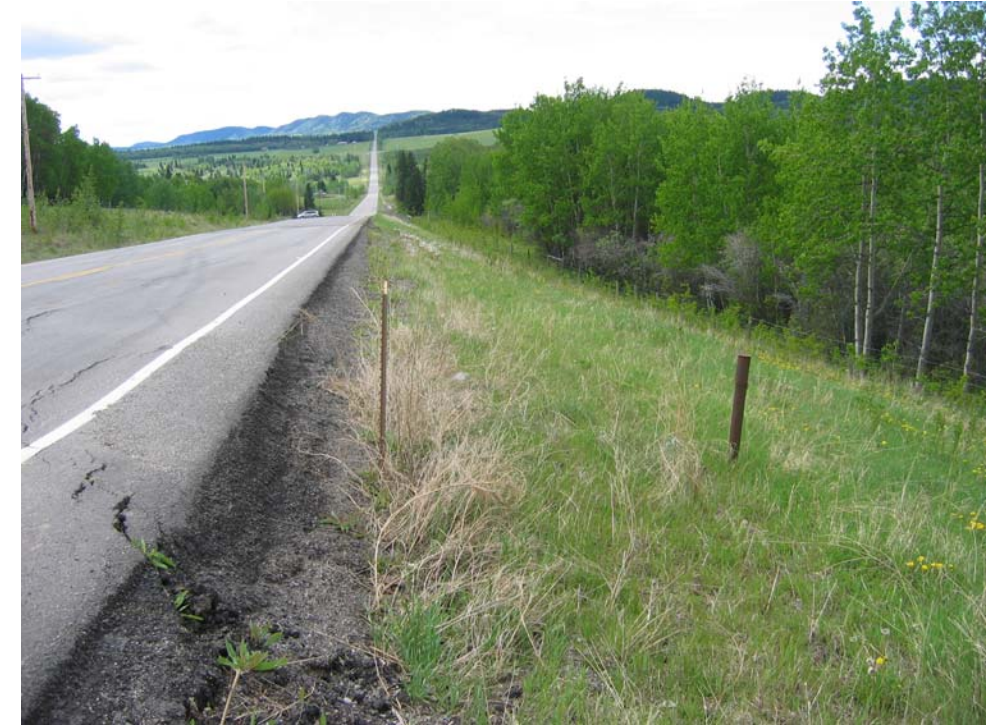
Photo S8-2 (upper right) – May 2006 – facing south along the northern area of the site. Another view of the new cracking noted in previous cracking and settlement area.

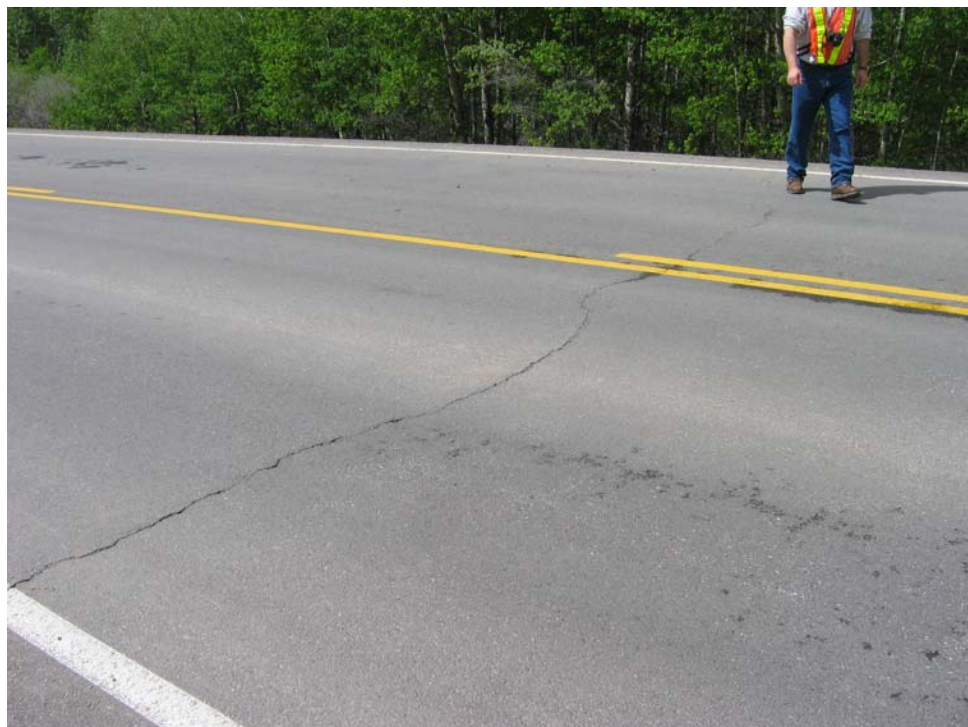
Photo S8-3 (lower left) – May 2006 – new crack in the road surface approximately 12 m south of the estimated north edge of the area that was repaved since the June 2005 inspection.

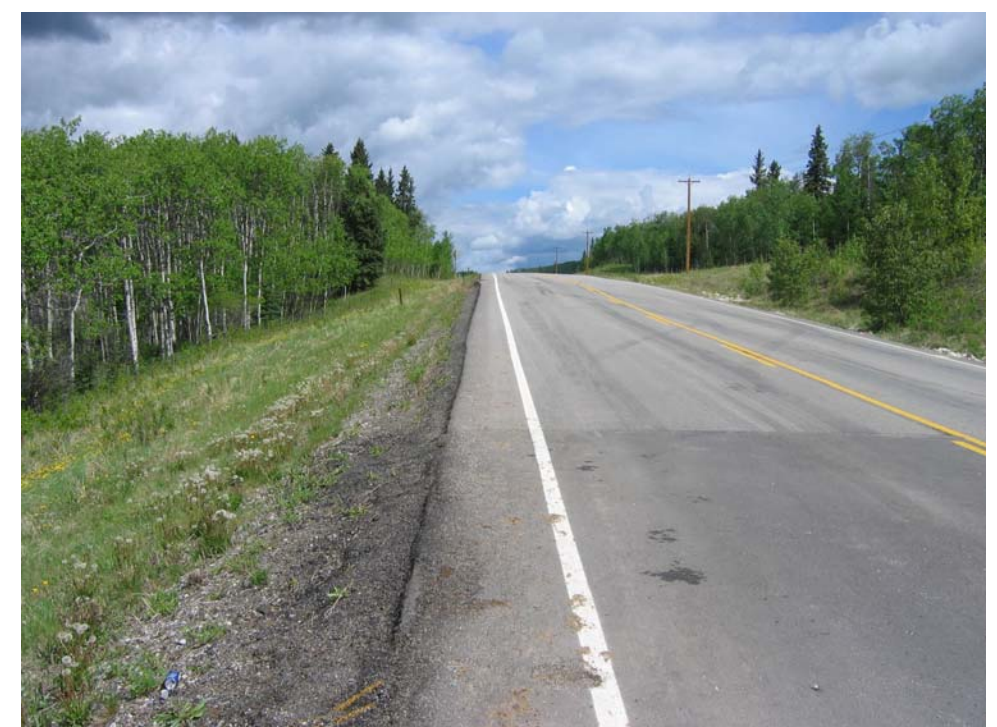
Photo S8-4 (lower right) – May 2006 – facing north along the southern area of the site. No new cracking or settlement was noted in this area.
