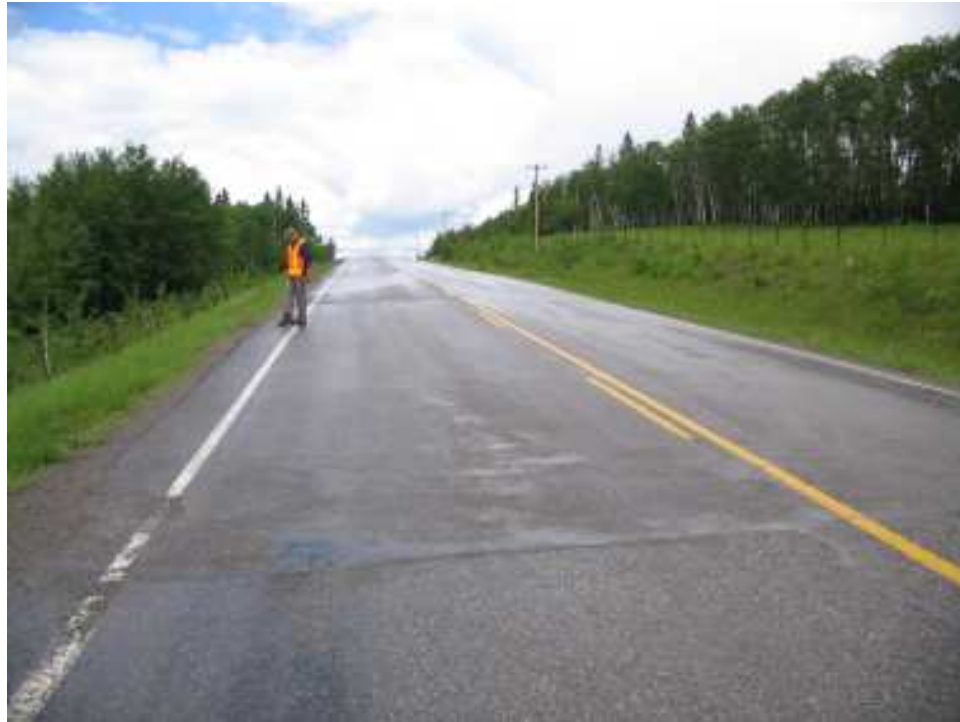
Photo S8-1 – June 2007 (upper left)
Facing north from the central portion of the site with the recent overlays on the road surface visible.

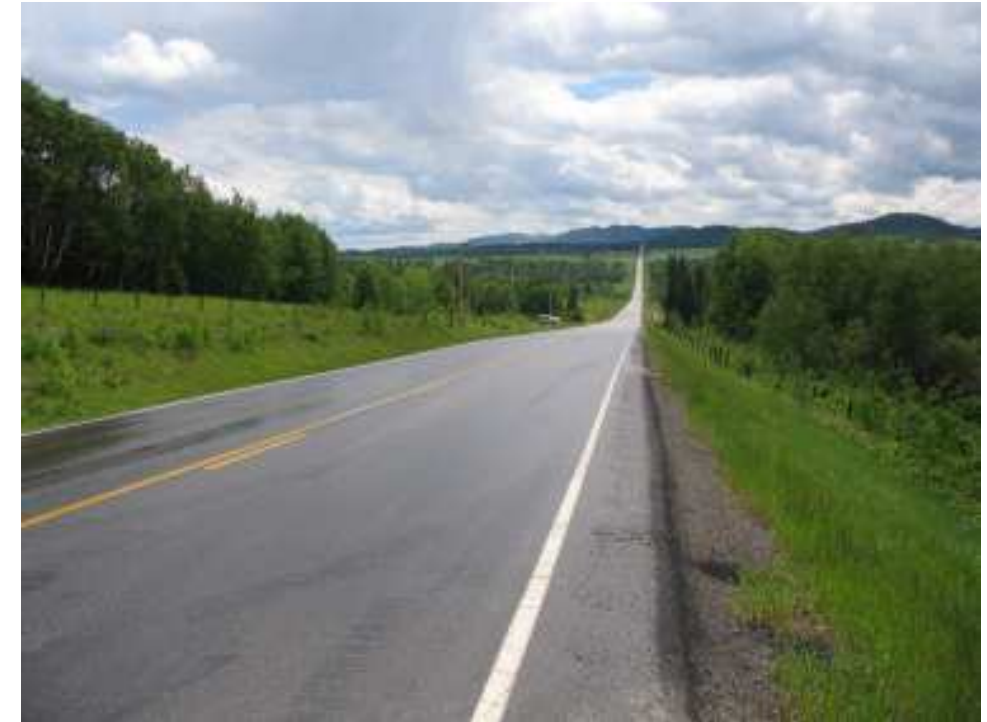
Photo S8-2 – June 2007 (upper right)
Facing south from the central portion of the site. No significant cracking or damage to the road surface since the previous overlays in 2005 and 2006.

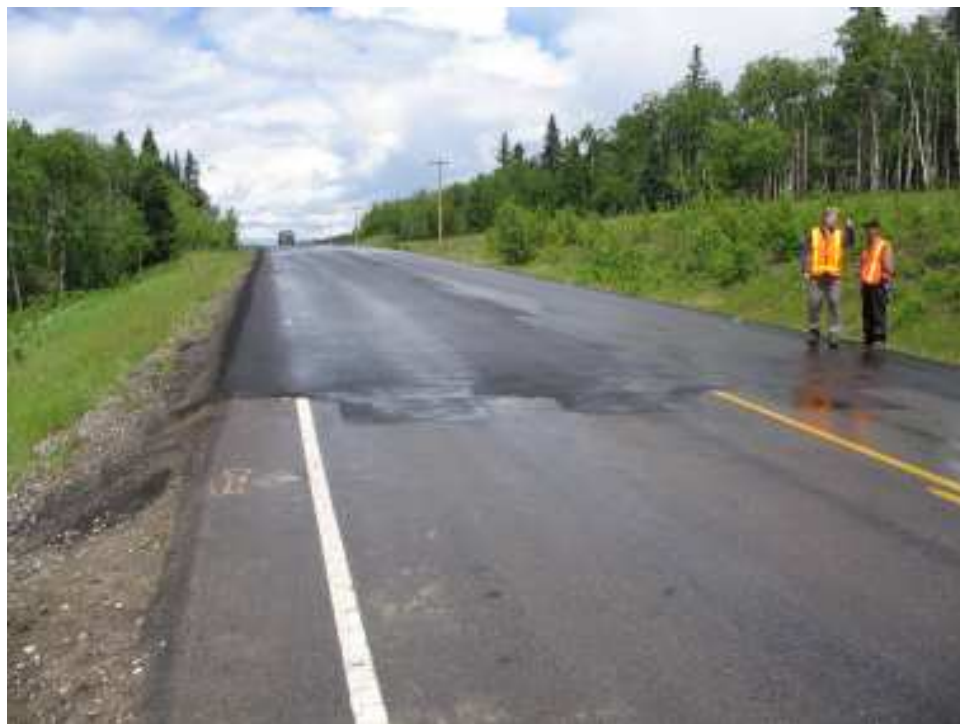
Photo S8-3 – June 2007 (lower left)
Facing north across the southern limit of recent overlay around SI 2007-3. The SI at Borehole 2007-3 is marked on the west shoulder of the road, on the left side of the photo.

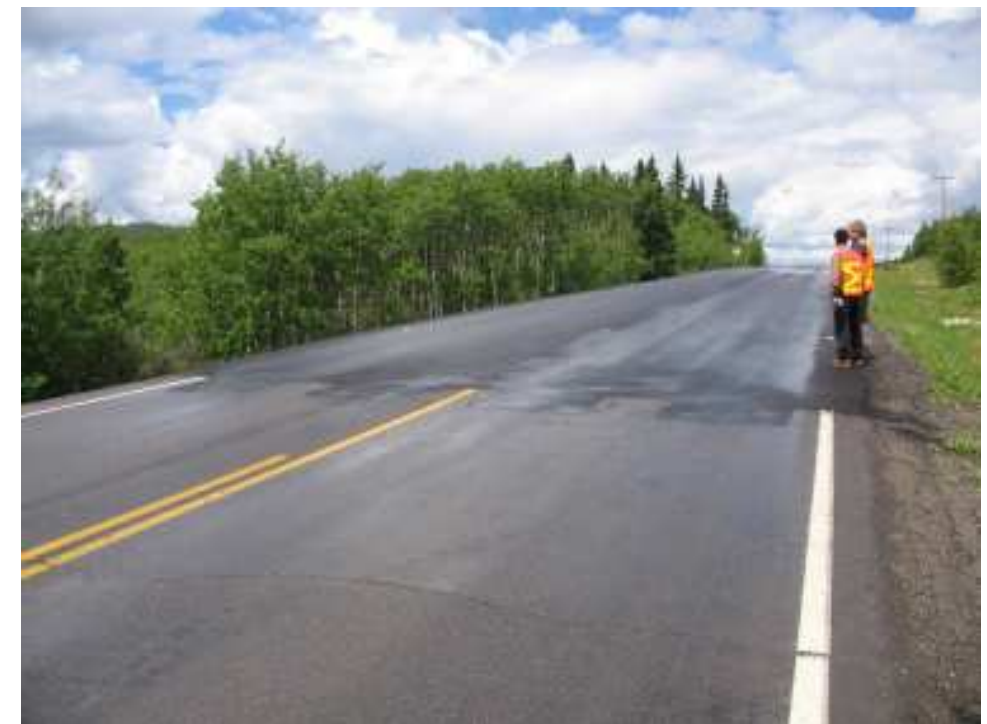
Photo S8-4 – June 2007 (lower right)
Facing northwest across the same area as shown in Photo S8-3.

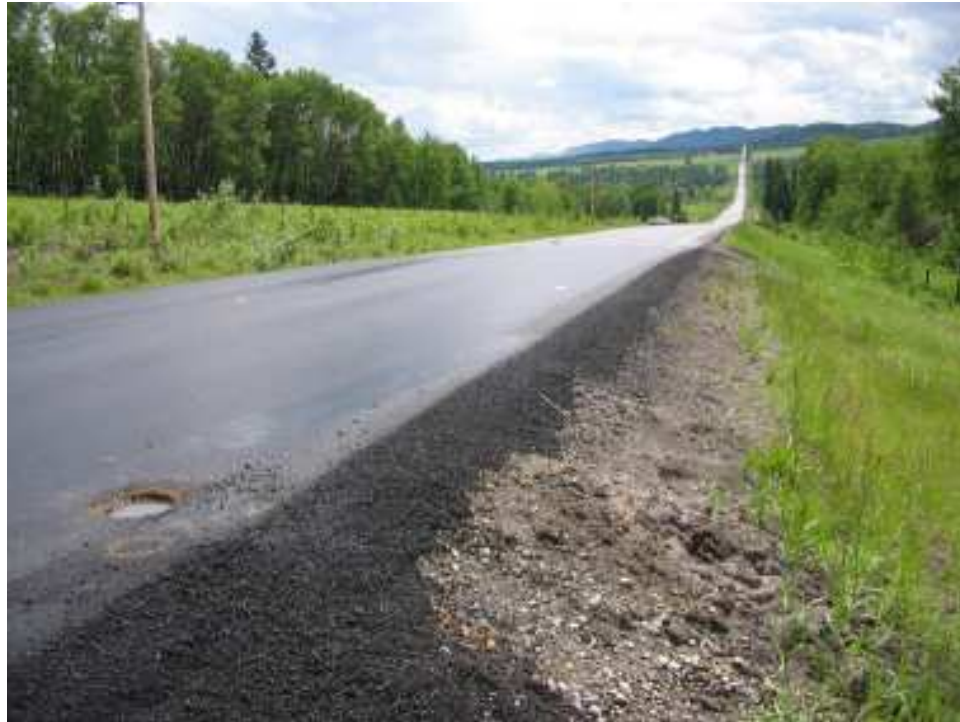
Photo S8-5 – June 2007 (upper left)
Facing south across the recent overlay with the SI at Borehole 2007-2 visible in the left foreground of the photo. The thickness of the recent overlay in this area was approximately 50 mm.

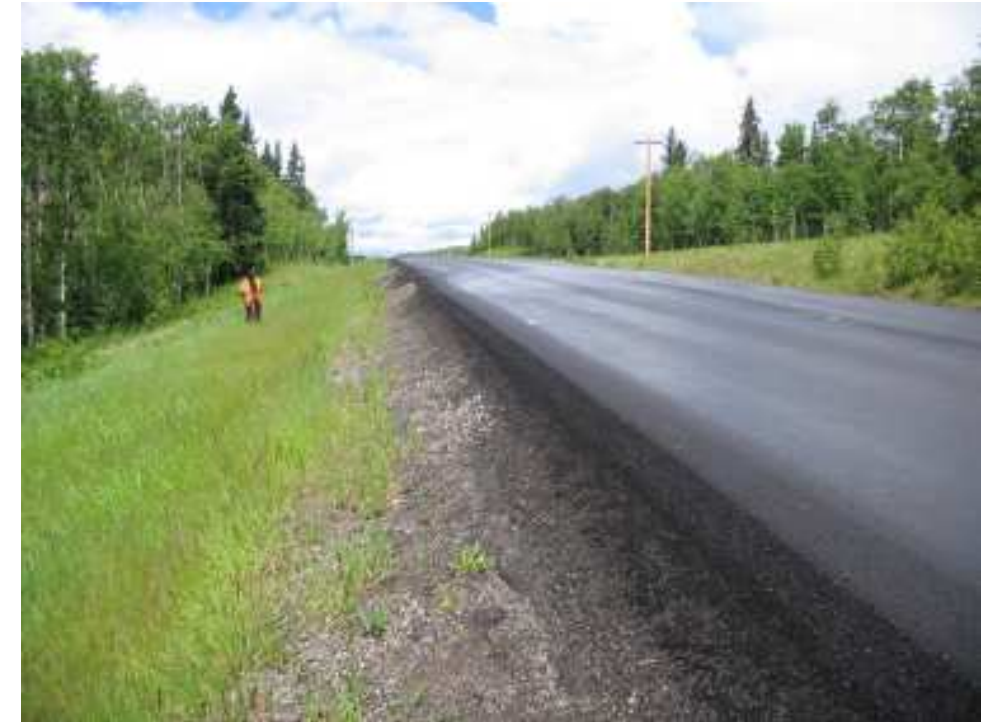
Photo S8-6 – June 2007 (upper right)
Another view of the recent overlay area around the north end of the site. Based on the cross-section exposed at the edge of the road, the thickness of the overlay seemed to range between 25 and 50 mm. Note the steep drop-off on the west side of the road (left hand side of the photo).

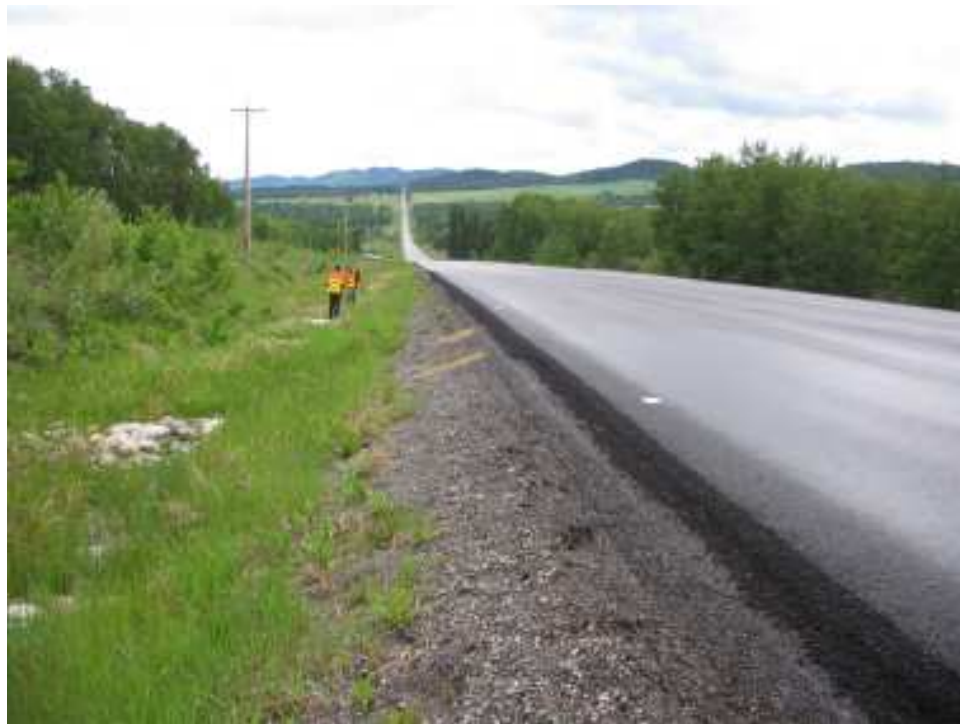
Photo S8-7 – June 2007 (lower left)
Facing south along the east shoulder of the road with the thickness of the recent overlay visible along the edge of the road.
