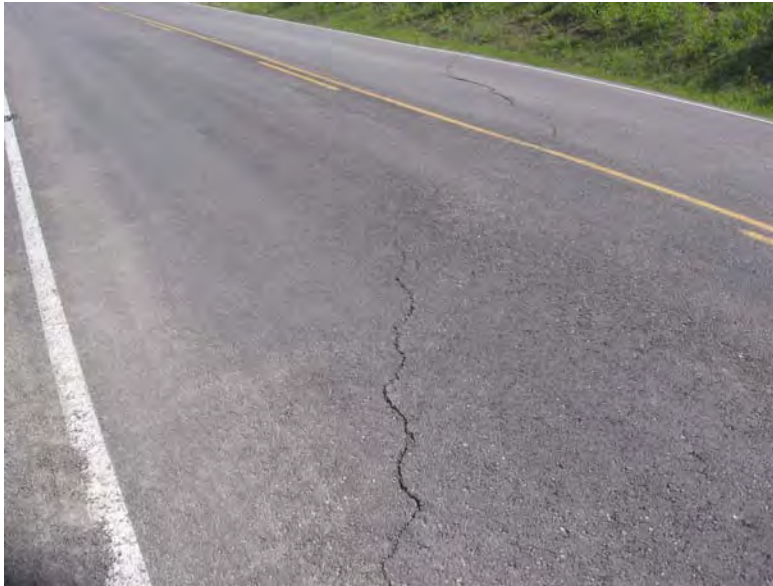
Photo S8-1 (top) – June 2009
Road surface cracking at the south end of the site around SI 2002-1.

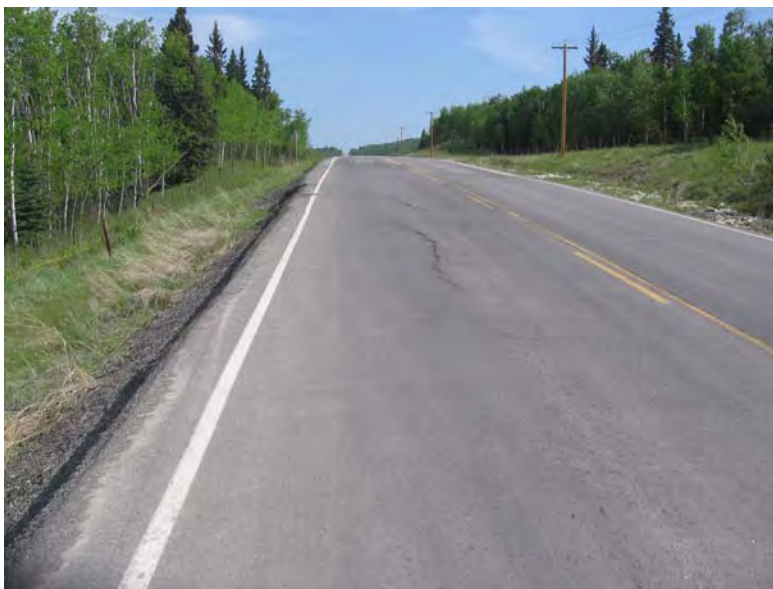
Photo S8-2 (bottom) – June 2009
Facing northbound across the north end of the site, with cracking noted in the September 2008 asphalt overlay. See the site plan on Figure S8-1 for further illustration.

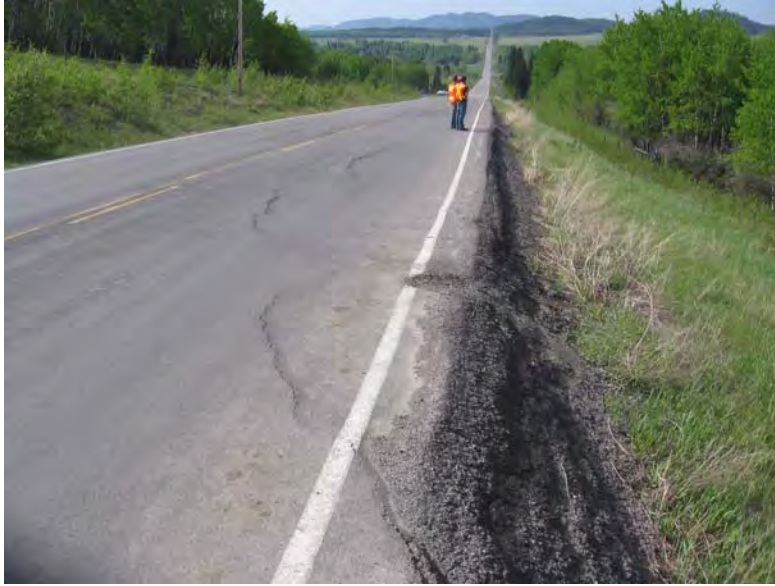
Photo S8-3 – June 2009

Facing southbound across the north end of the site, with cracking noted in the September 2008 asphalt overlay. See the site plan on Figure S8-1 for further illustration.
