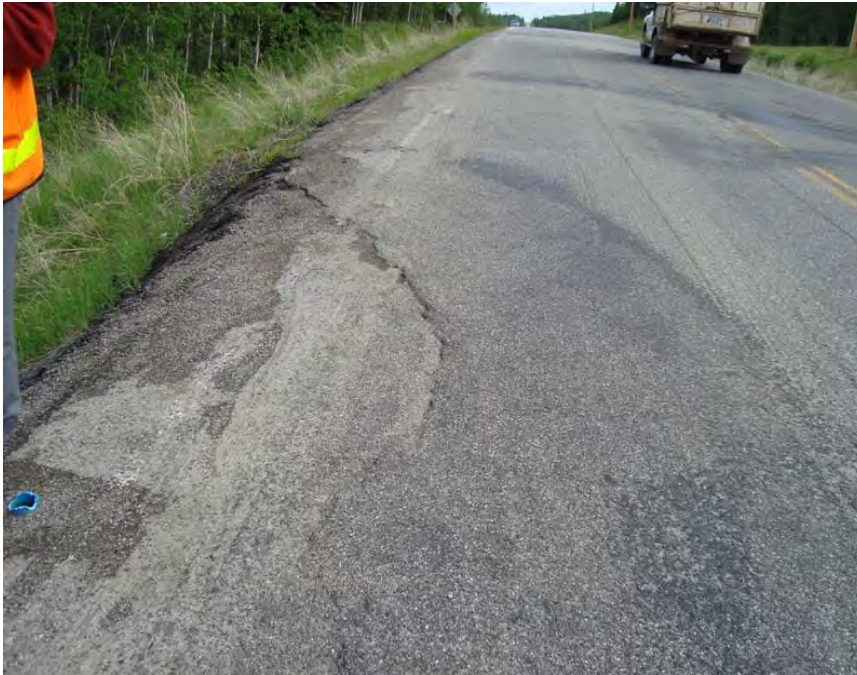
Photo S8-1 (June 2012) - Facing north along the west edge of the road surface at the north end of the site. This area had the most significant cracking following a similar pattern as has been observed during previous inspections. The road surface has been smoothed over from recent milling work.

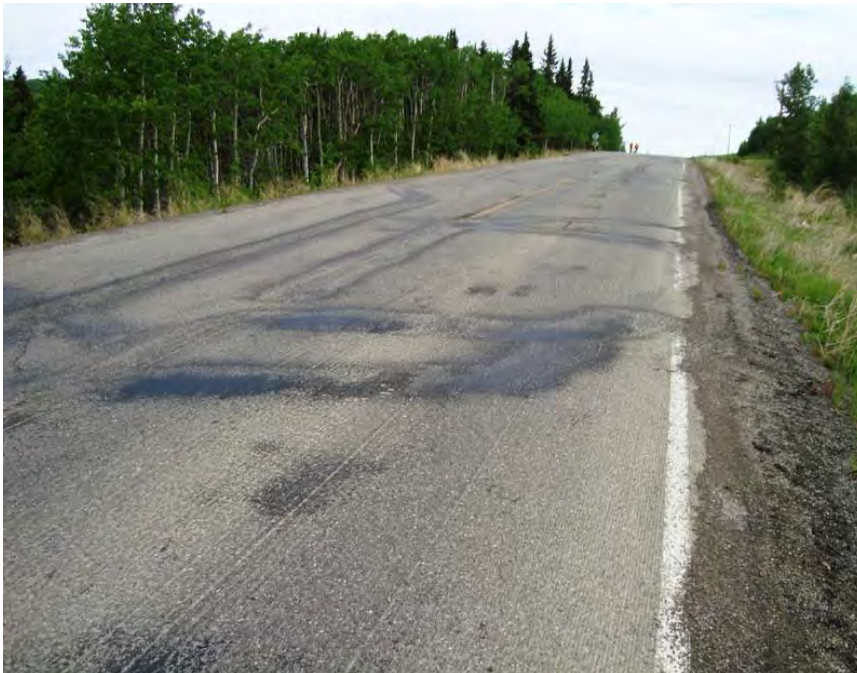
Photo S8-2 (June 2012) - Facing north from the middle of the site. The amount of additional cracking in the road surface is relatively minor, and follows a similar pattern as has been observed during past inspections.

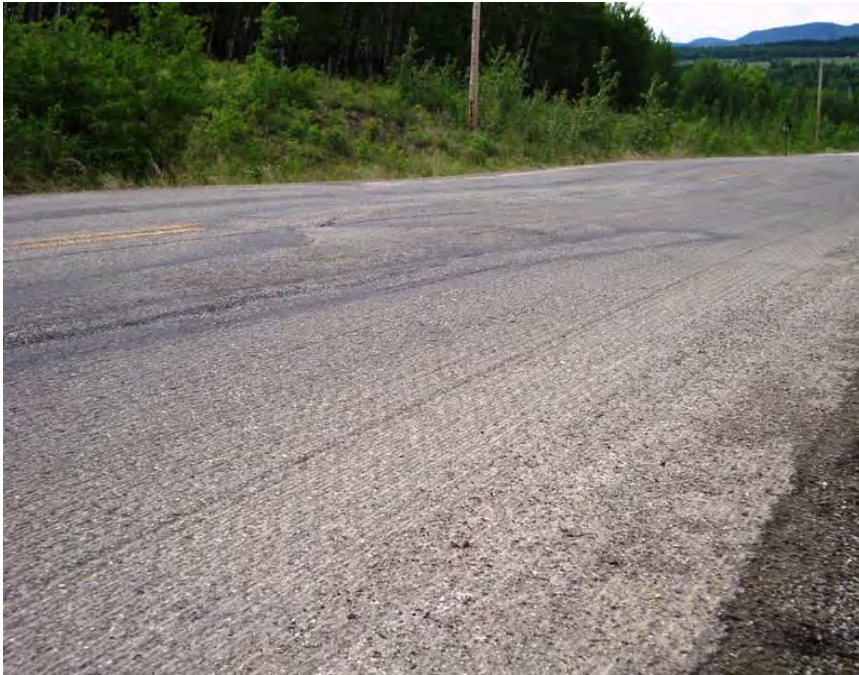
Photo S8-3 (June 2012) -
Facing southeast at the
visible settlement in the
upslope lane at the north
end of the site.
