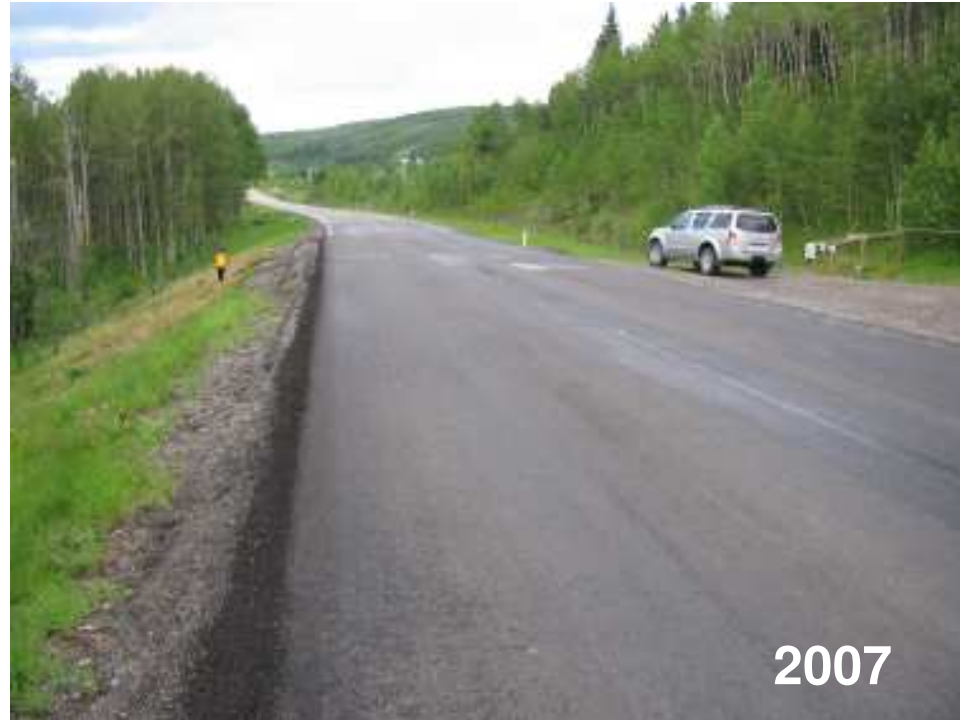
Photo S10(A)-1 – June 2007 (upper left)
Facing north across the site. The recent overlay has obscured any recent cracking and settlement in the road surface. See Photo S10(A)-2 for a view of the site as it appeared during the 2005 inspection.

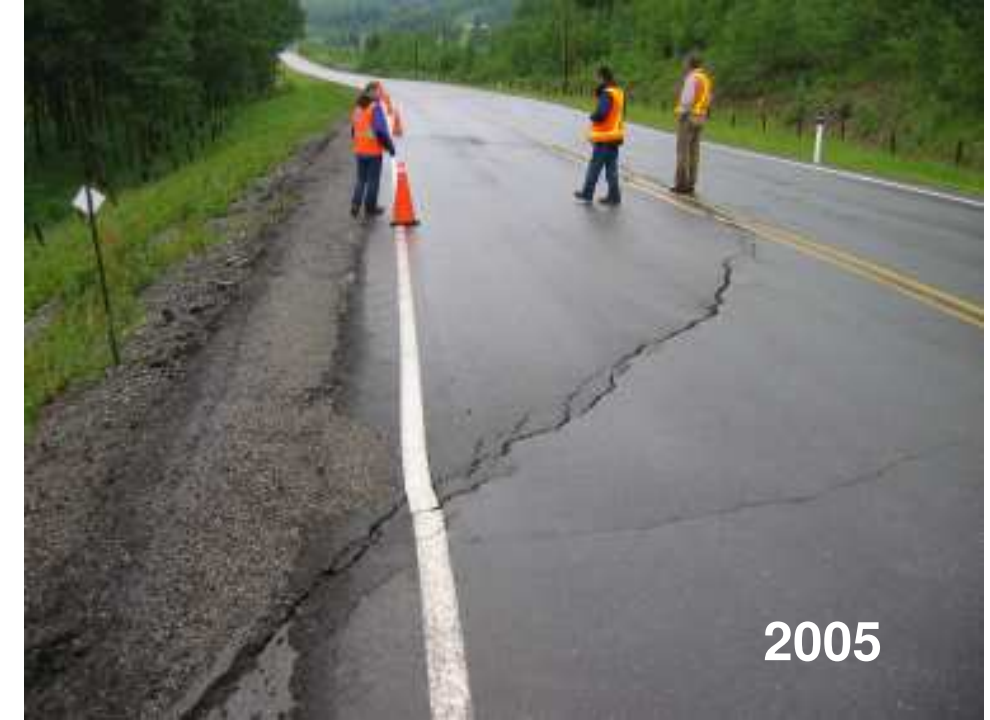
Photo S10(A)-2 – June 2005 (upper right)
Settlement and cracking of the road surface as seen during the 2005 annual inspection. This pattern of damage to the road surface has been ongoing for the last several years, and was most recently noted during the borehole drilling and instrument installations in the spring of 2007 prior to the June 2007 inspection and photos.

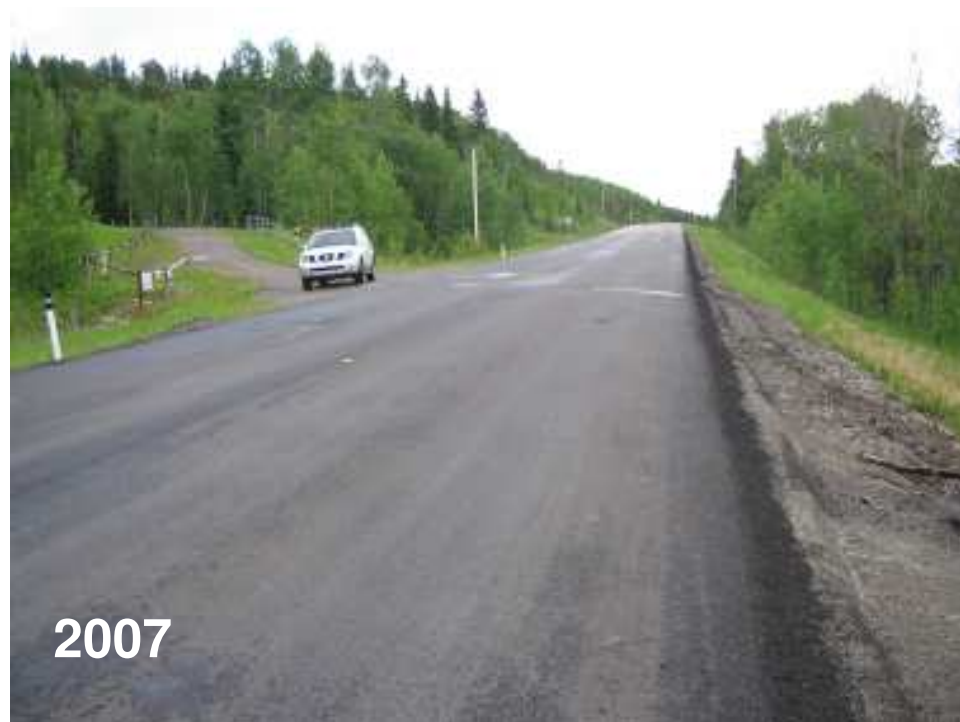
Photo S10(A)-3 – June 2007 (lower left)
Facing south across the site.

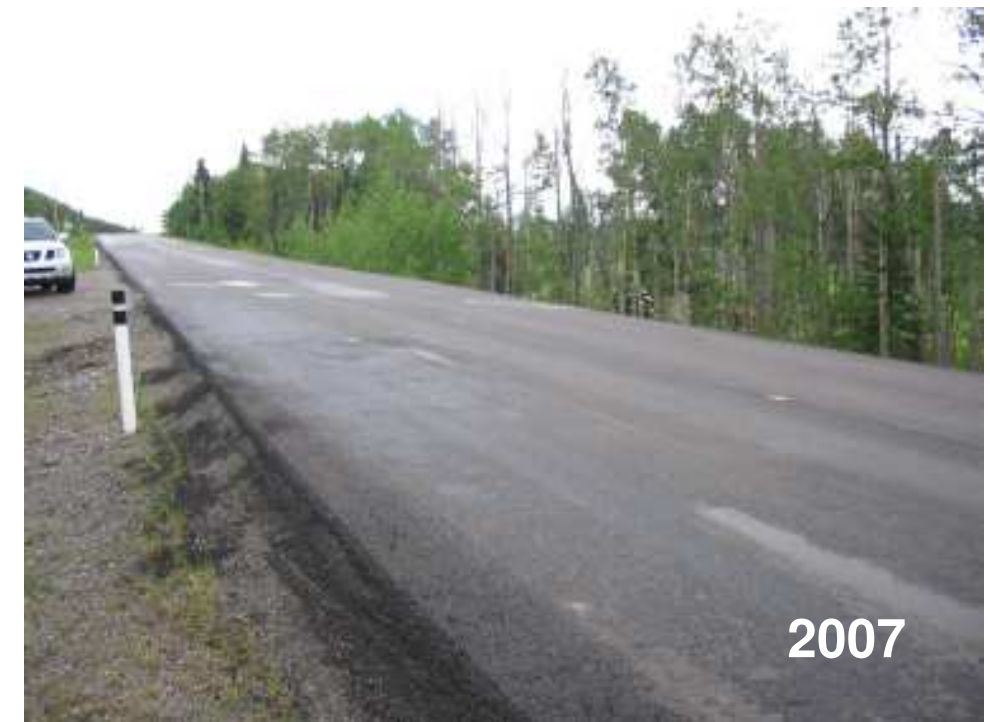
Photo S10(A)-4 – June 2007 (lower right)
Another view facing south across the site.
