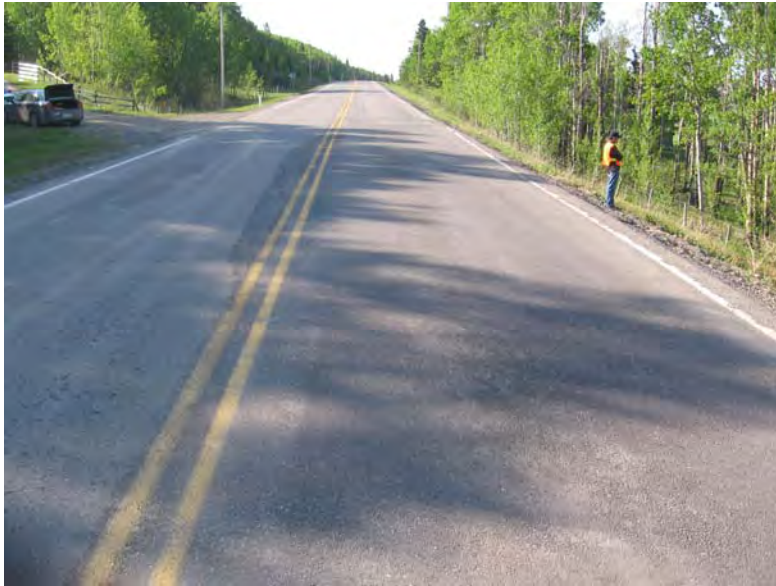
Photo S10(A)-1 (top) – June 2009
Facing southbound across the site. At the time of the June 2009 site inspection there was only minor cracking and settlement in the current asphalt overlay. The pattern and extent of the damage was similar to previous years.

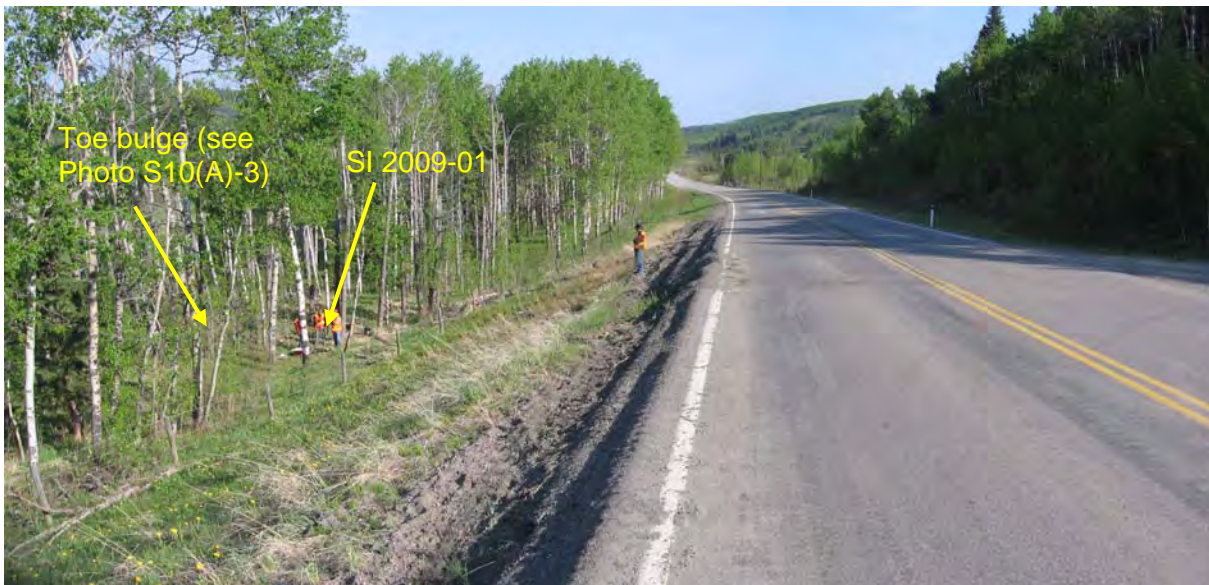
Photo S10(A)-2 (bottom) – June 2009

Facing northbound across the site. The personnel at the toe of the road embankment slope on the left side of the photo are reading SI 2009-01, which has shown movement at the depth shown on the cross-section on Figure S10-2. The toe bulge in the treed area (see Photo S10(A)-3) is a short distance further into the trees.

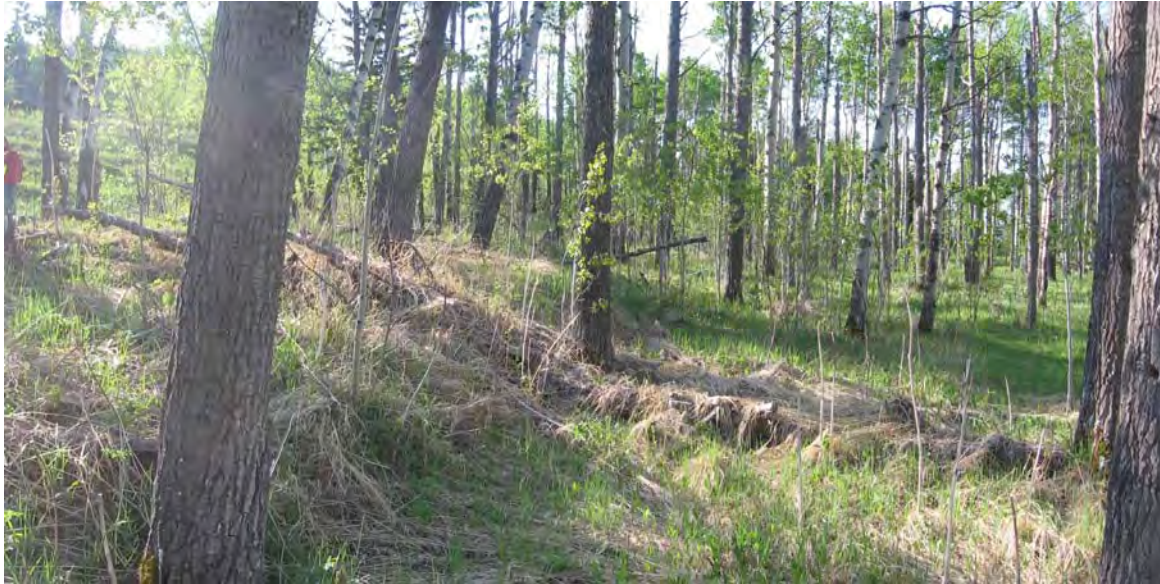
Photo S10(A)-3 – June 2009

Toe bulge in the treed area, a short distance further downslope from SI 2009-01. The depths of active ground movement in the SI's along with this toe bulge and the position of the repeated cracking on the road surface seem to align along a rotational or possible rotational/translational failure surface as shown on the cross-section on Figure S10-2.
