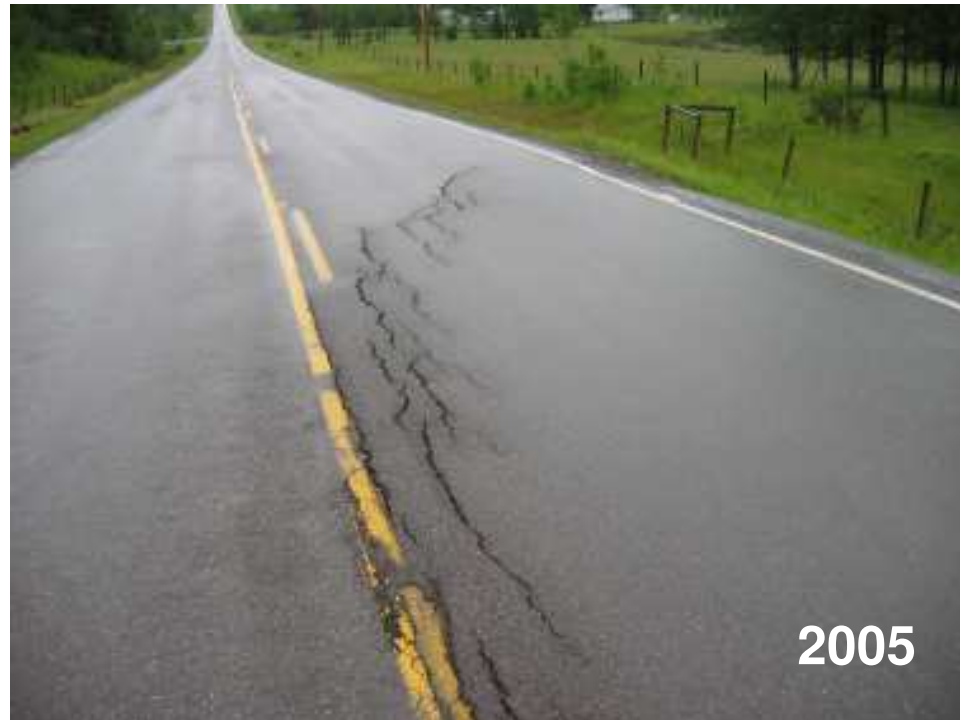
Photo S10(C)-1 – June 2005 (upper left)
Cracking and settlement of the road surface as observed during the 2005 site inspection.

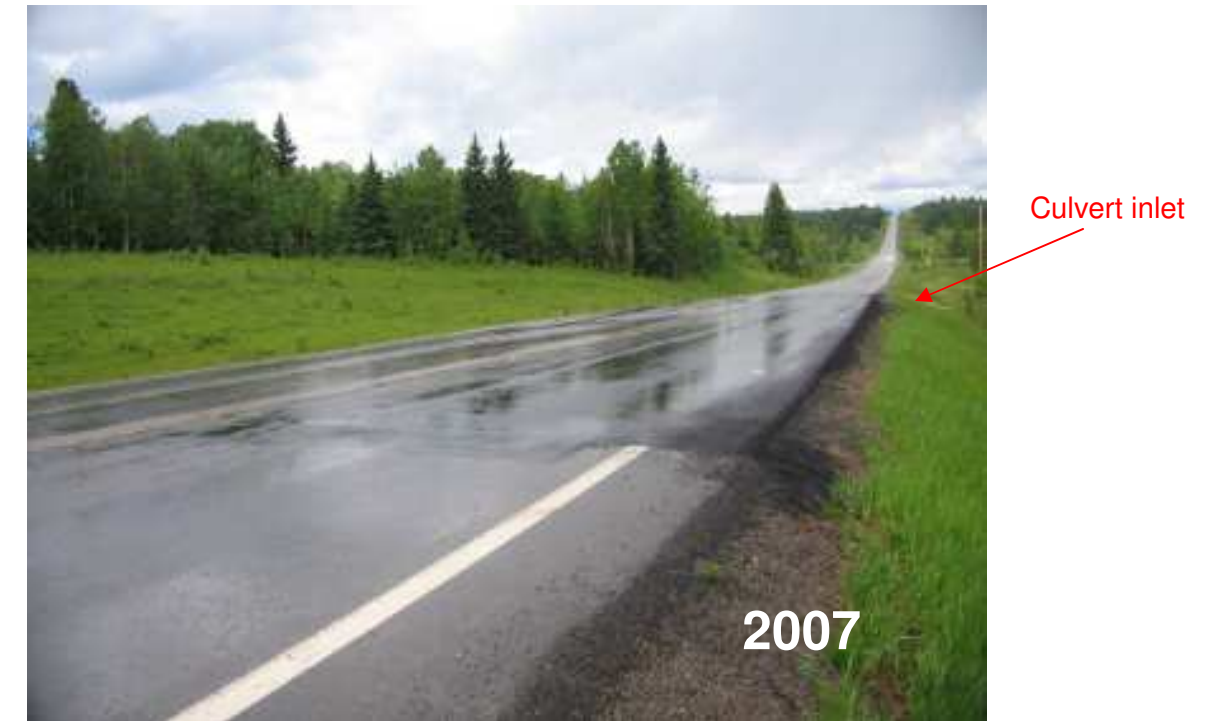
Photo S10(C)-2 – June 2007 (upper right)
Typical view facing north across the recent overlay at the site, as seen during the June 2007 site inspection. The approximate location of the culvert to the south of the overlay is shown.

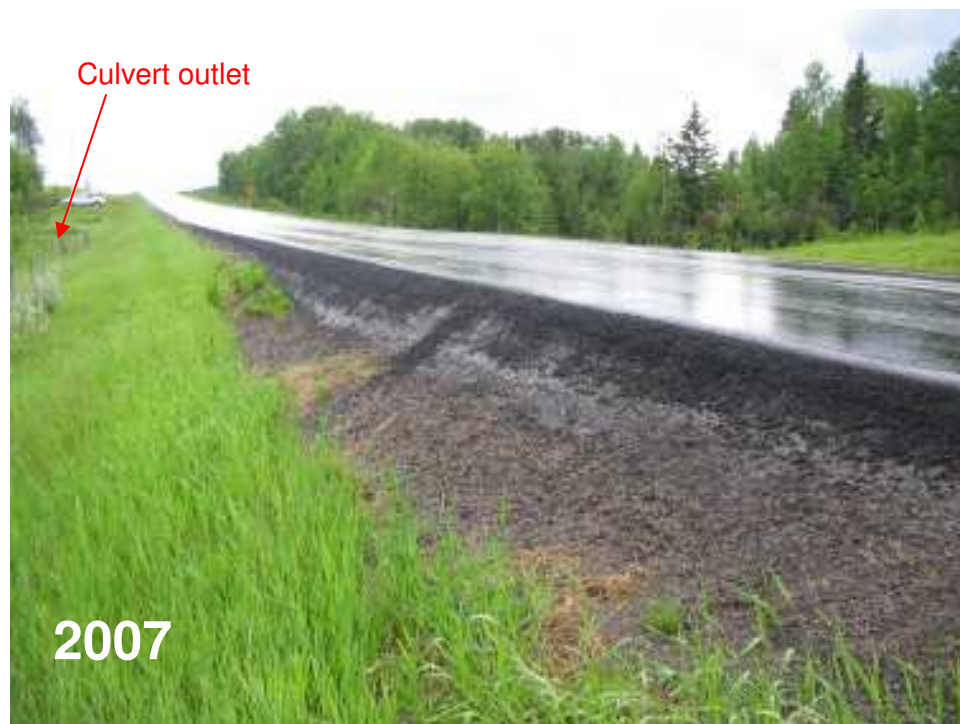
Photo S10(C)-3 – June 2007 (lower left)
Closer view of the edge of the recent overlay, along the east shoulder of the road. The approximate location of the culvert to the south of the overlay is shown.

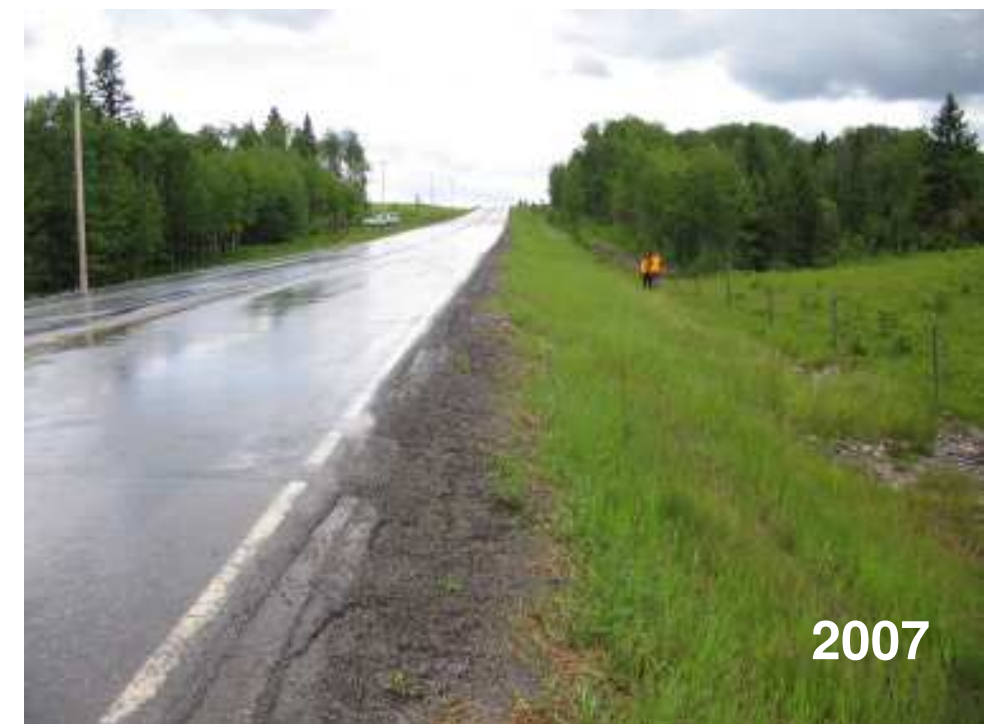
Photo S10(C)-4 – June 2007 (lower right)
Facing south along the west shoulder of the road. The culvert shown in Photos S10(C)-5 and 6 is just behind the two people standing in the ditch to the right of the road.

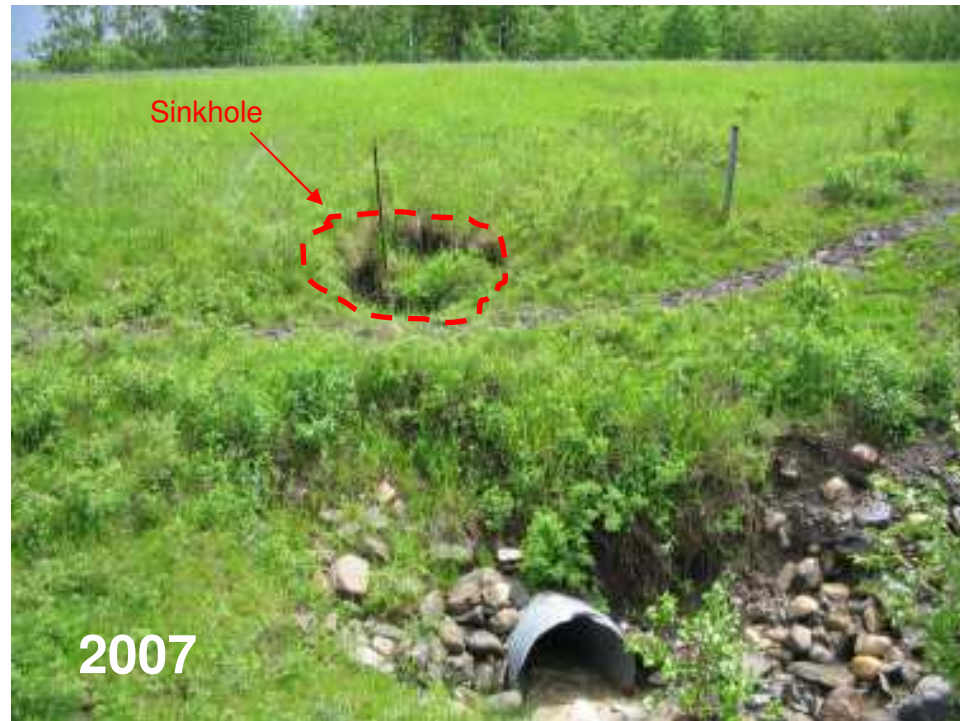
Photo S10(C)-5 – June 2007 (left)

The inlet (west) end of the creek culvert. Note the sinkhole in the slope face above the culvert and just upslope of the fenceline. This sinkhole has developed since the previous inspection in 2005.

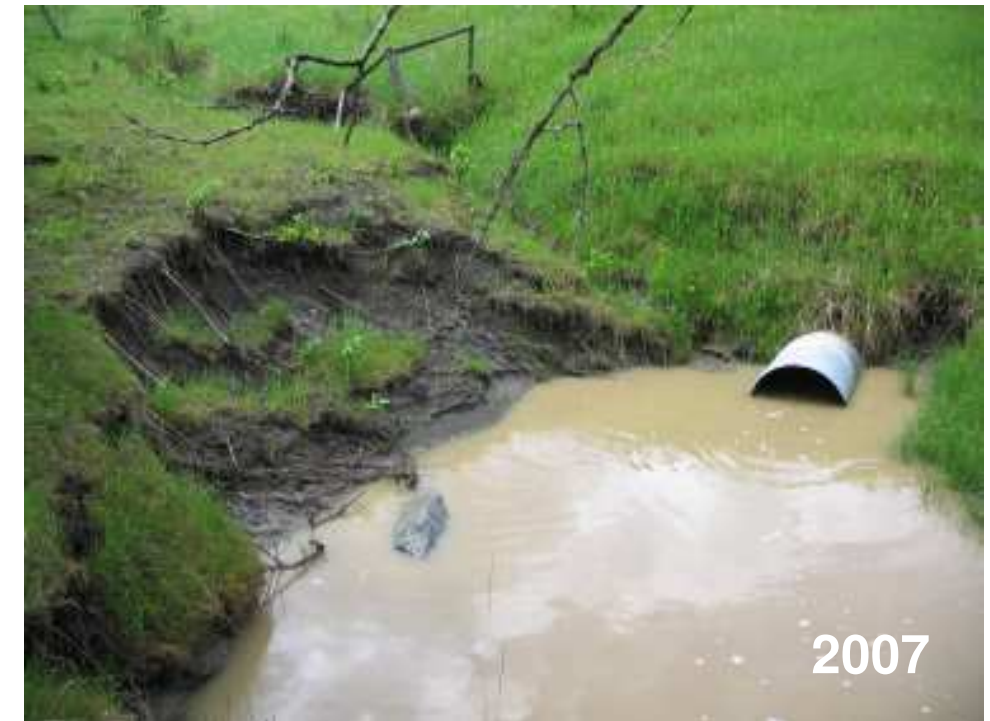
Photo S10(C)-6 – June 2007 (right)

The outlet (east) end of the creek culvert. Note the level of the water at the outlet in comparison to the level at the inlet as shown in Photo S10(C)-5. It is not known if the higher level at the outlet is due to the gradient of the culvert or settlement around the culvert outlet. Bank erosion is visible to the left of the culvert outlet, but it does not appear to be of any consequence to the road fill embankment.
