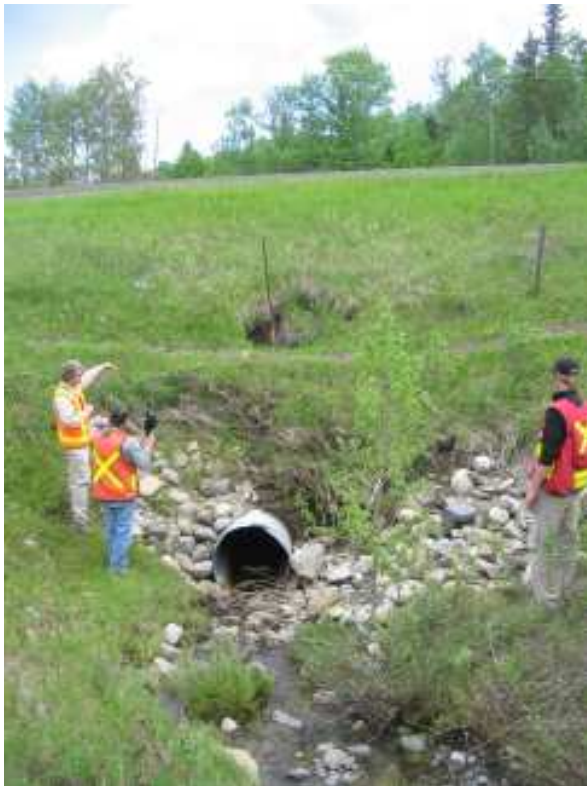
Photo S10(C)-1 – June 2008 (top)

Facing downstream towards the culvert inlet at the base of the west slope of the road embankment. The sinkhole in the slope above the culvert inlet is visible at the fenceline. This sinkhole developed sometime after the 2005 inspection and has increased in size between the 2007 and 2008 inspections.

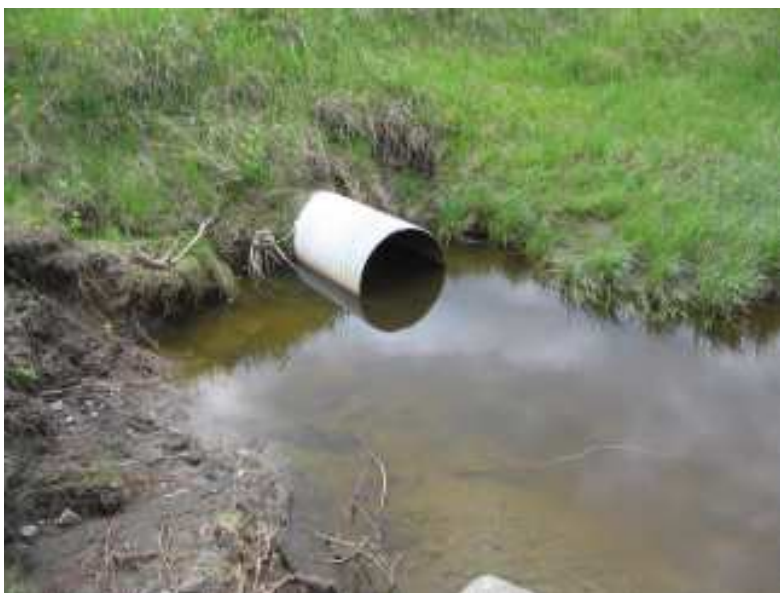
Photo S10(C)-2 – June 2008 (bottom)

Culvert outlet at the toe of the east road embankment slope. The culvert outlet is notably lower than the inlet, with slow flowing water in the creek channel backing up part way into the culvert.

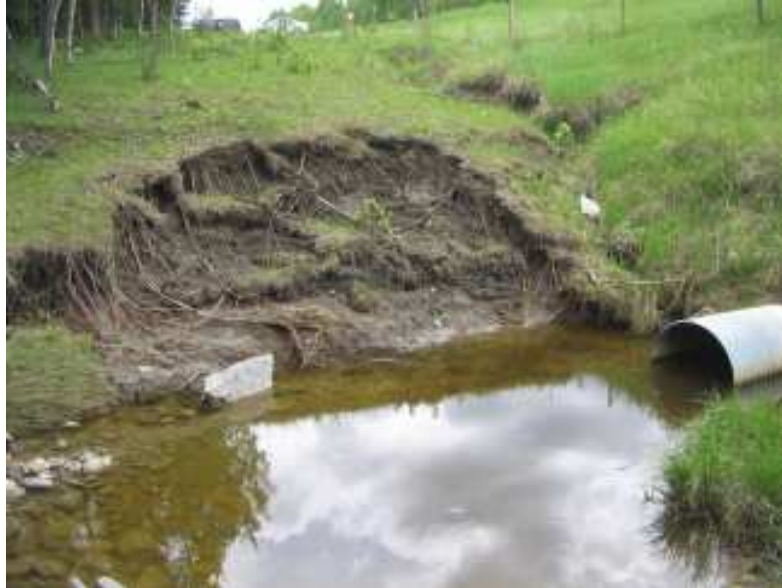
Photo S10(C)-3 – June 2008 (top)

Slumping on the right bank of the creek channel immediately downstream of the culvert outlet. This slumping is likely triggered by creek erosion at the toe of the slope, from flow concentrated towards this location by the culvert orientation.

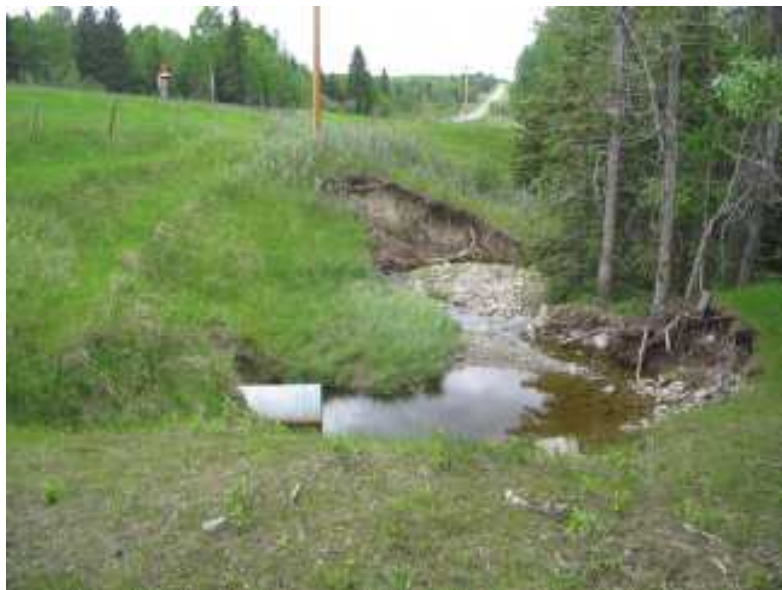
Photo S10(C)-4 – June 2008 (bottom)

Slumping on the left bank of the creek channel roughly 20 m downstream of the culvert outlet. This slumping has been noted in previous annual inspections and does not currently appear to be a threat to the road embankment, however it bears watching.

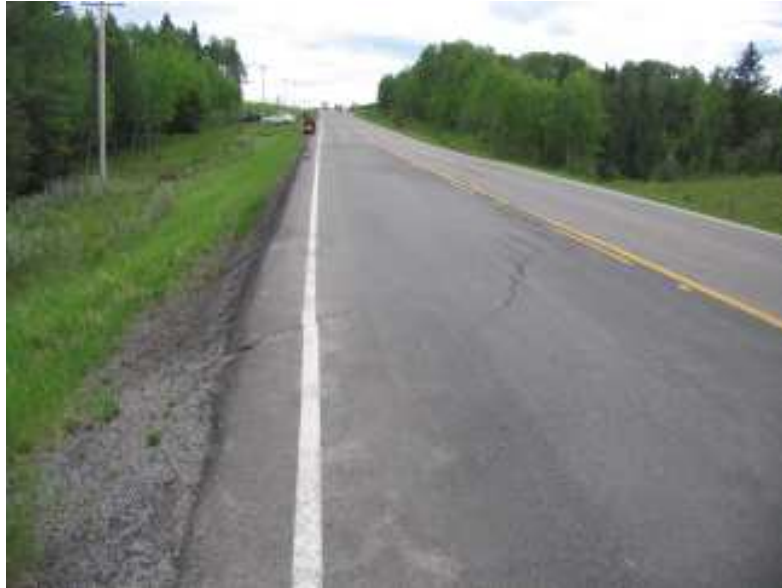
Photo S10(C)-5 – June 2008 (top)

Facing southbound along the highway, with cracking visible across the northbound lane and extending across the centerline and into a portion of the southbound lane (right hand side of photo). This cracking has formed through multiple asphalt overlays in recent years. The shape of the cracking suggests that it represents the northern flank of an eastwards moving (towards the left in this photo) slump in the road fill embankment. Note also the lateral displacement indicated in the white shoulder line. The cracking may also be due to ongoing settlement of the road fill embankment.
