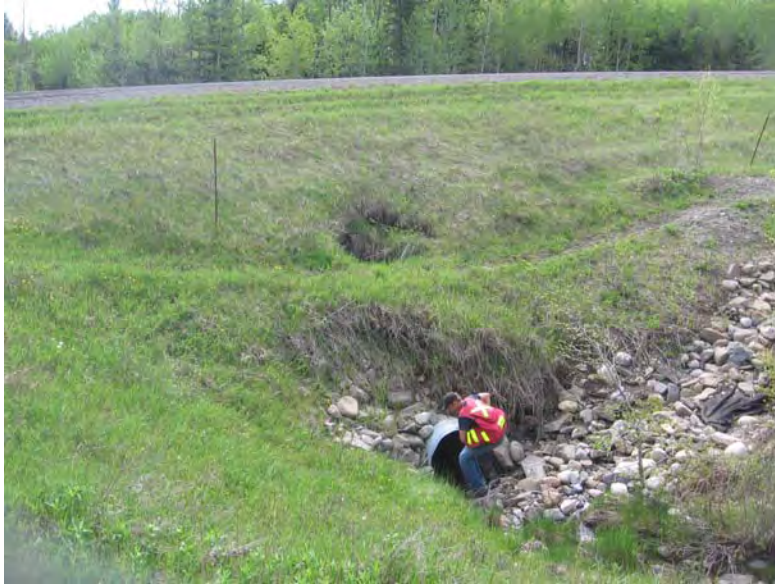
**Photo S10(C)-1 (top) – June 2009**  
Facing downstream towards the culvert inlet, with the sinkhole in the west road embankment slope above the culvert inlet visible. This sinkhole was first noted during the 2007 inspection, and has increased in size since that time.

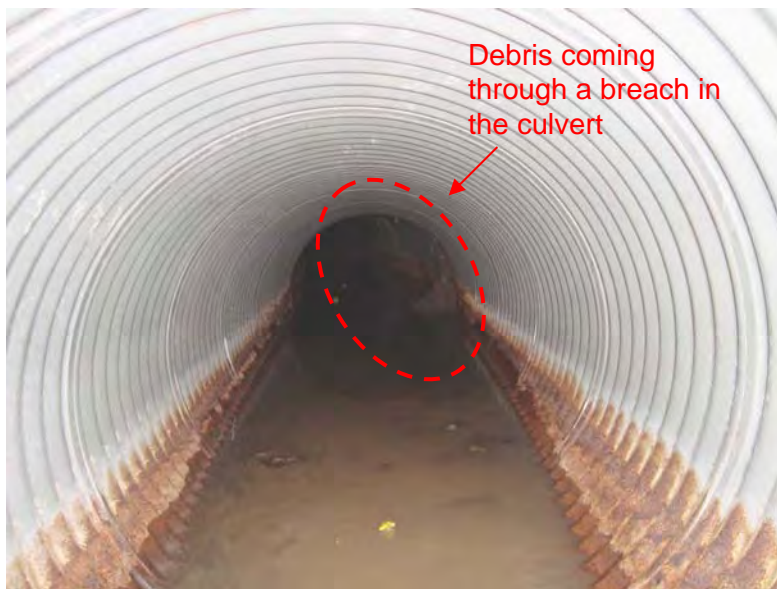
**Photo S10(C)-2 (bottom) – June 2009**  
Facing downstream from the culvert inlet, with soil debris coming through a breach in the top of the culvert faintly visible in the right background.

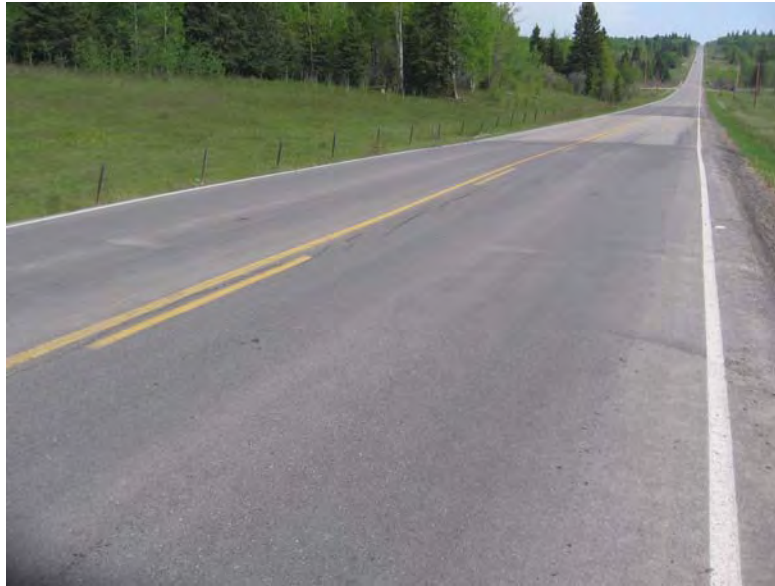
**Photo S10(C)-3 (top) – June 2009**  
Facing northbound across the asphalt overlay to the north of the culvert. Cracking and settlement of the northbound lane has formed through repeated overlays since 2003.

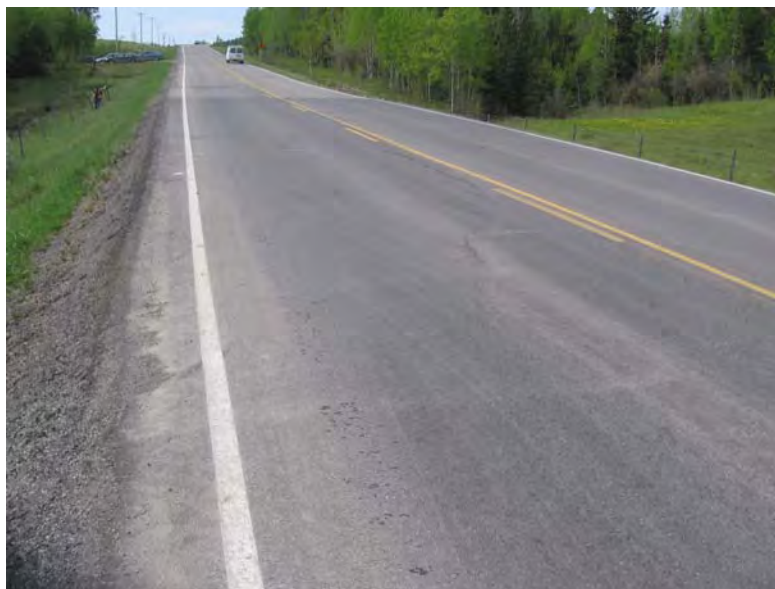
**Photo S10(C)-4 (bottom) – June 2009**  
Facing southbound across the area shown in Photo S10(C) – 3. The minor cracking and settlement of the northbound lane that is visible in this photo has formed since the most recent overlay in 2008.
