| Client | Alberta Transportation | | Figure S10(C)-1 | |
| Project | Southern Region Geohazard Assessment | | Date: | Revision |
| | S10(C) - HIGHWAY 762:02 | | Job No. | CG25309.B |

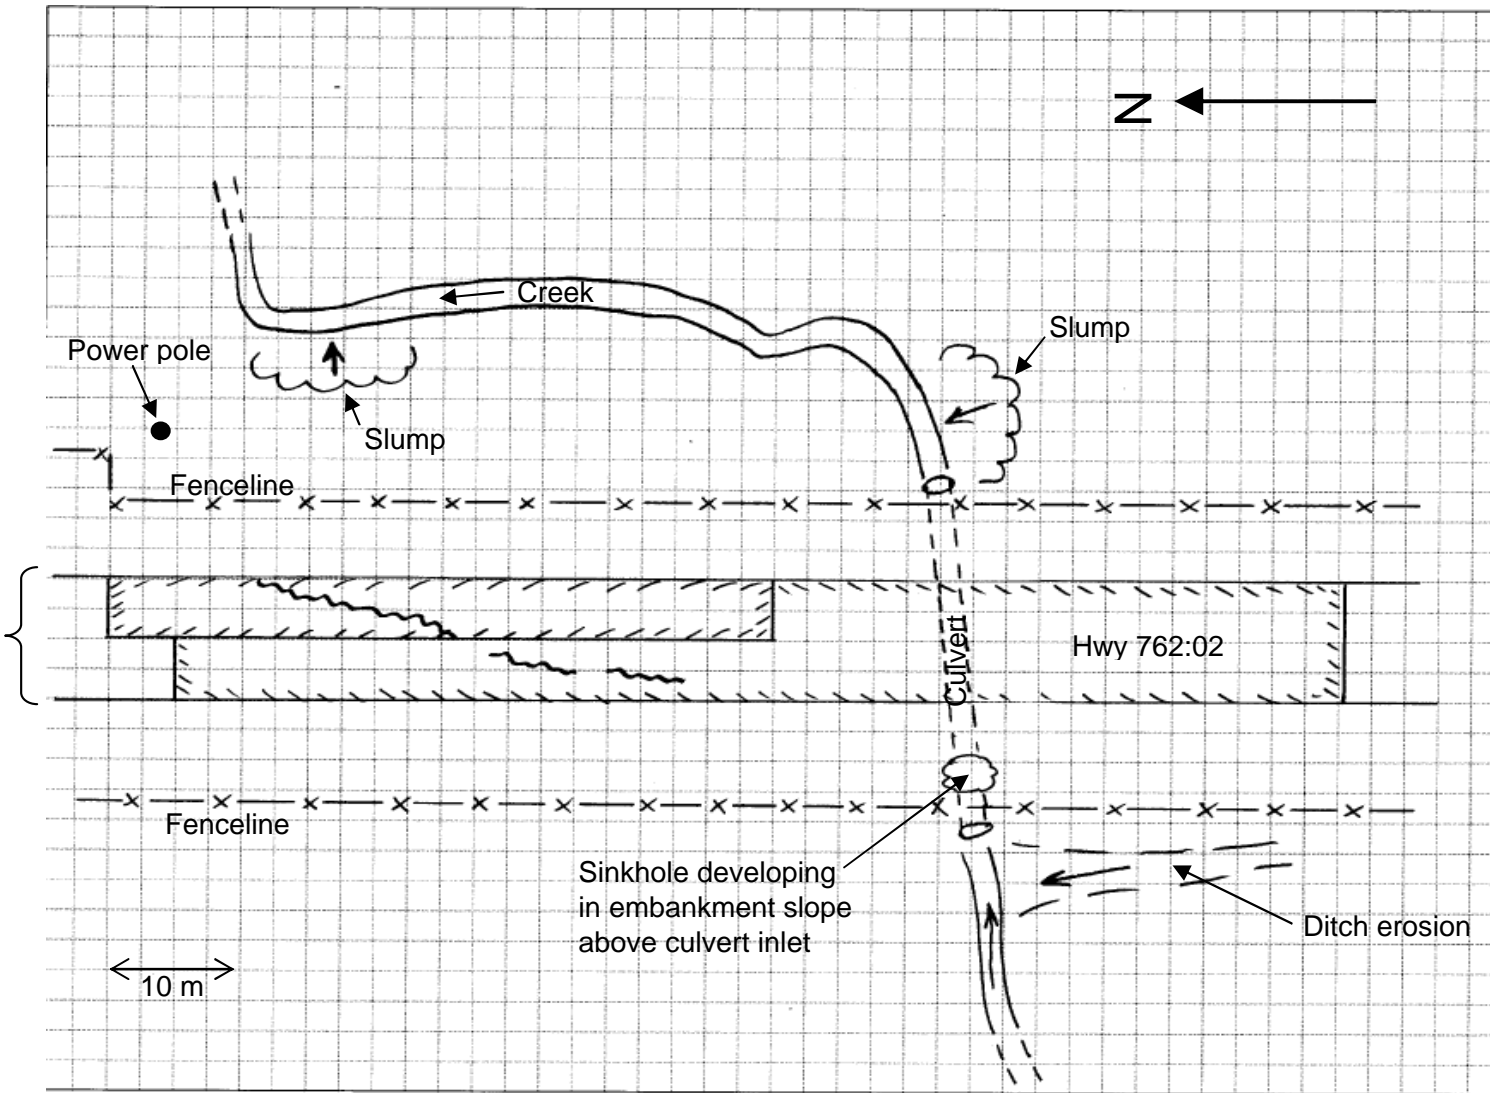
Overlays of various ages.
Typical pattern and extent of
cracking shown.
