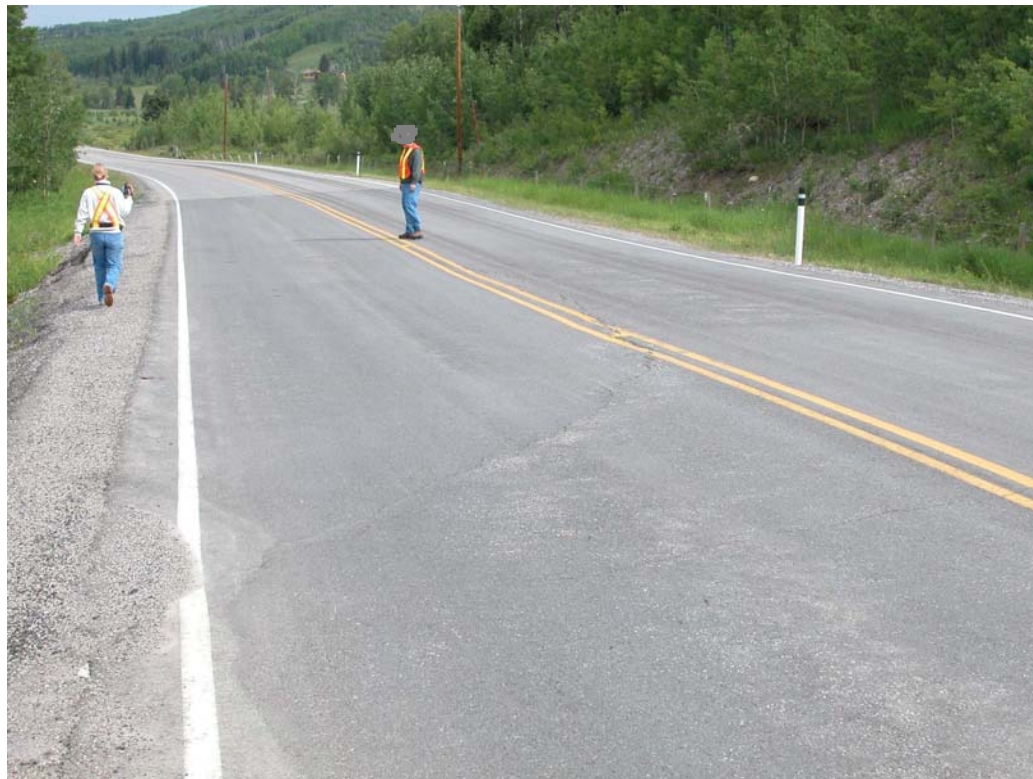
Photo 1 (upper left) Site A
Facing north across the area that has been patched since the May 2002 site inspection. Compare the cracking pattern with Photo 2 – the same movement is ongoing.

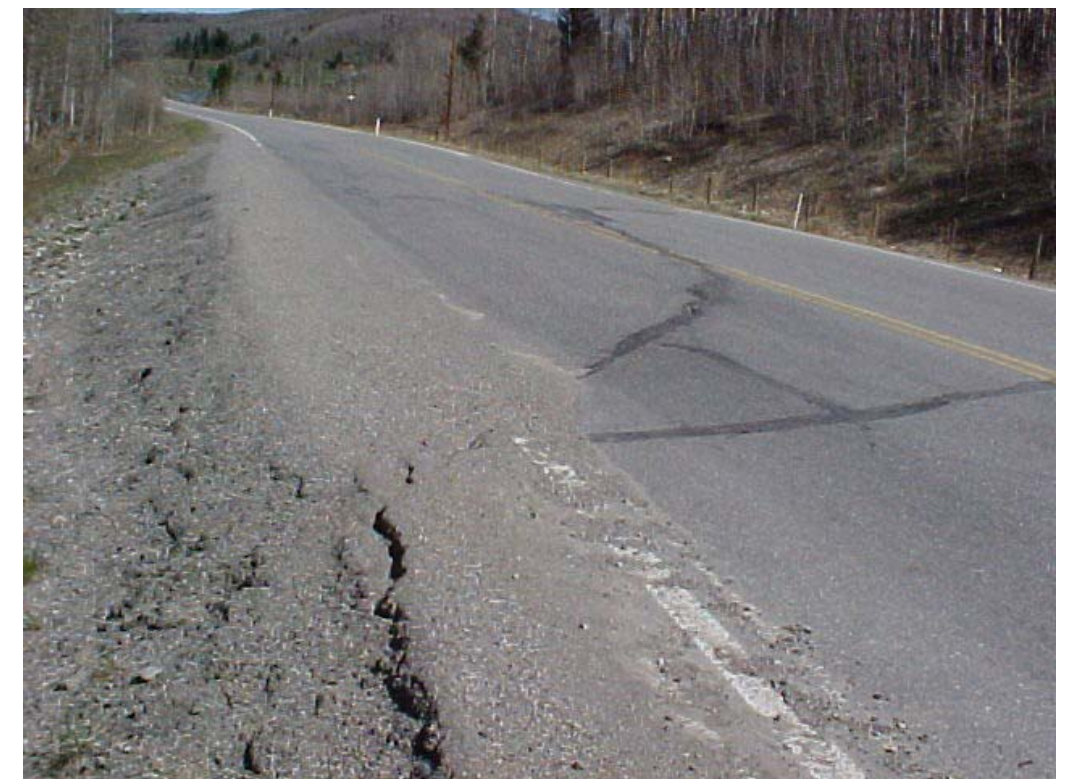
Photo 2 (upper right) Site A
Same area as Photo 1 – as seen during the May 2002 site inspection.

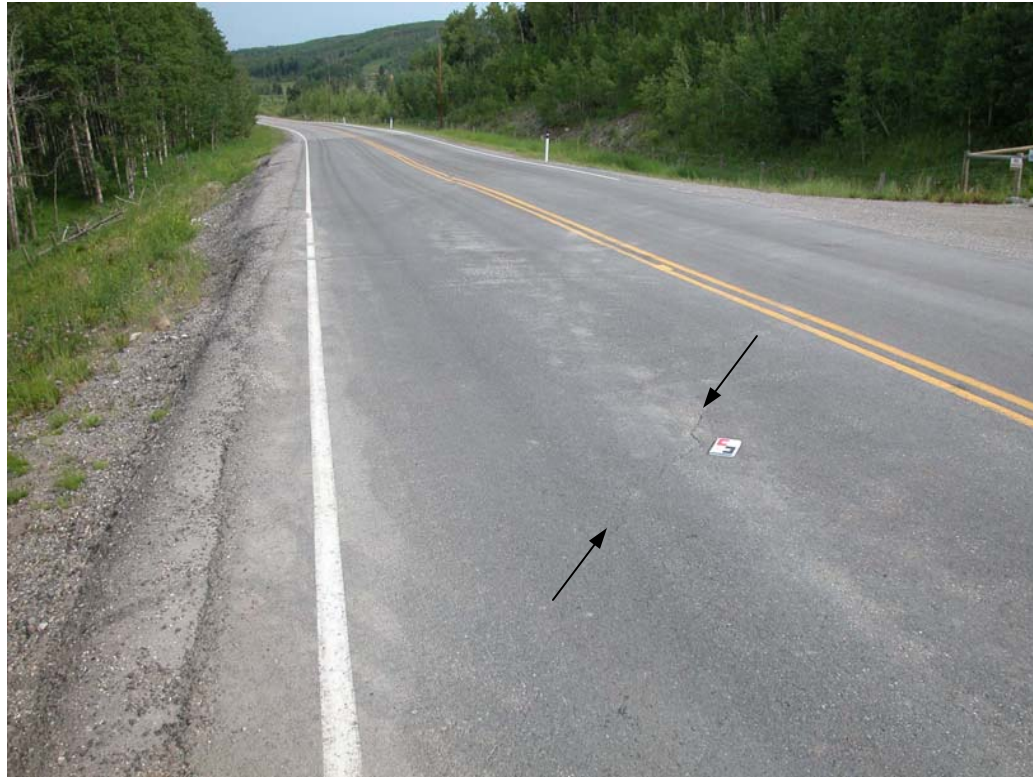
Photo 3 (lower left) Site A
Another new crack forming at Site A (notebook on road surface for scale). The area shown by Photos 1 and 2 is visible in the background.

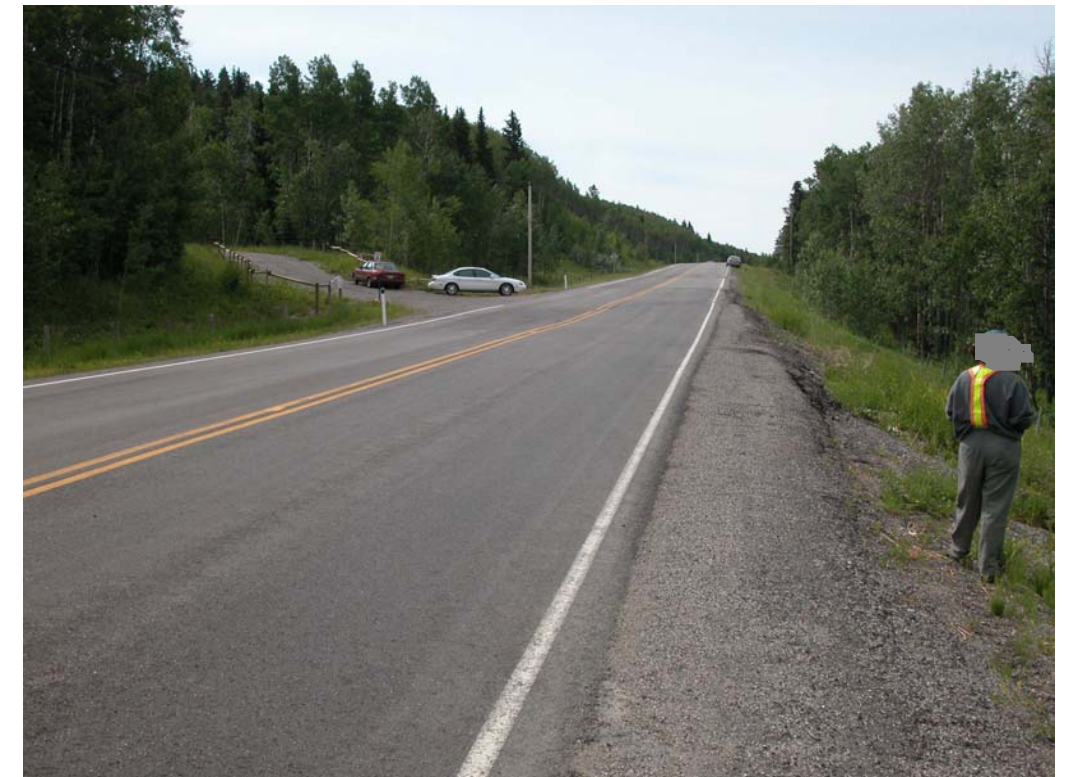
Photo 4 (lower right) Site A
Facing south across Site A. The patched area with new cracking shown in Photo 1 is marked.

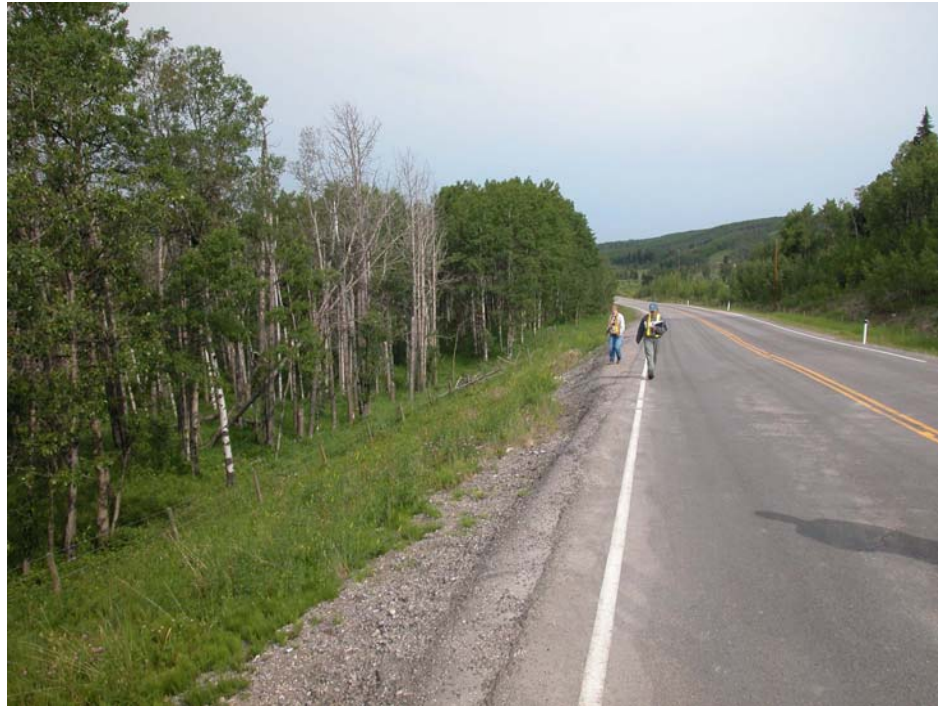
Photo 5 (upper left) Site A
 Wider view of Site A. The patch of dead trees on the slope face below the road coincides with the area where the slope profile suggests previous slope movement encompassing the road (please refer to Photo 7 caption and text of report for further discussion).

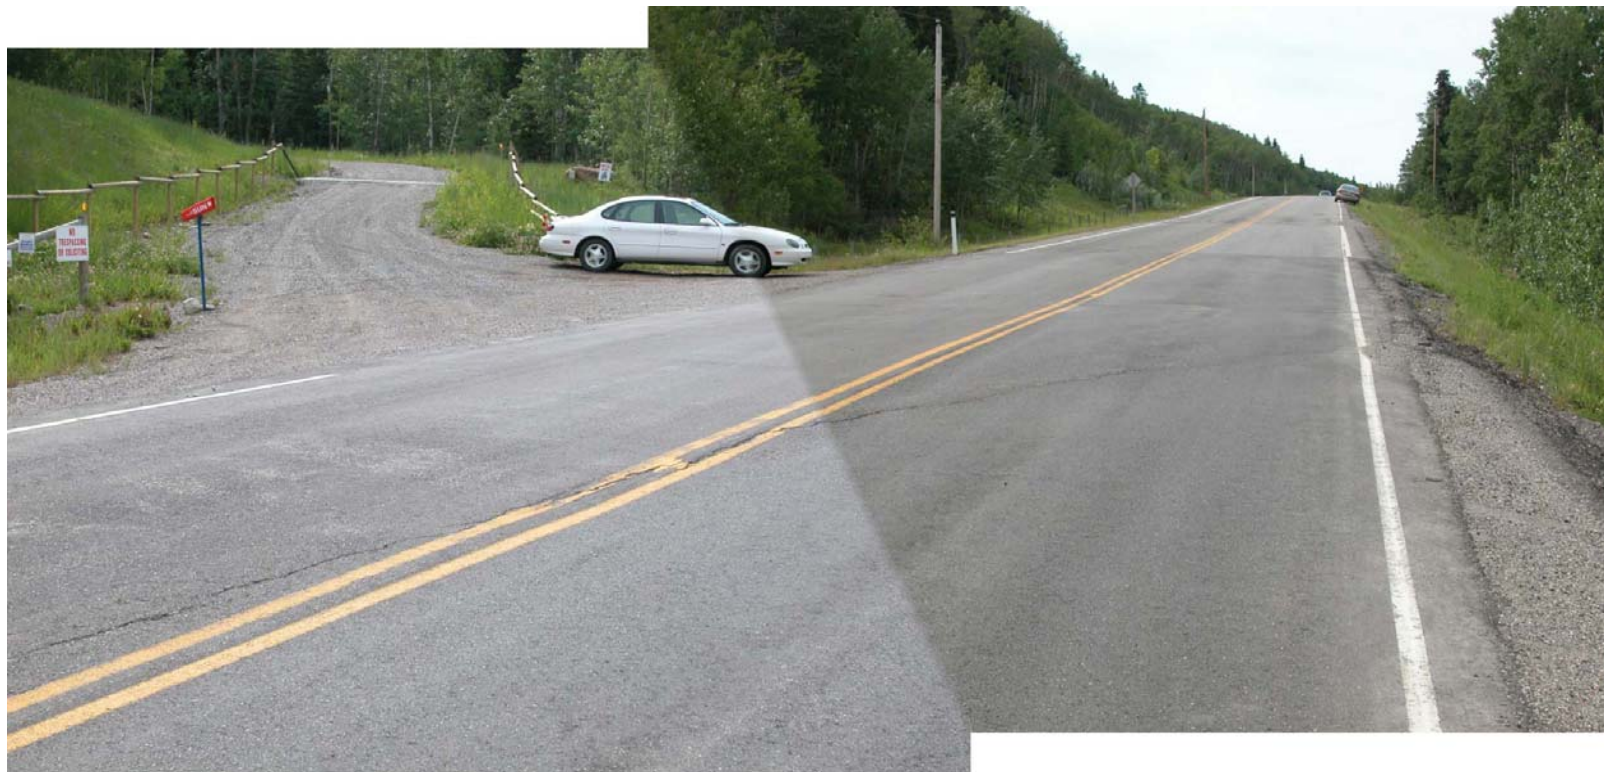
Photo 6 (lower left) Site A
 Closer view, facing south, of settlement and cracking area at Site A.

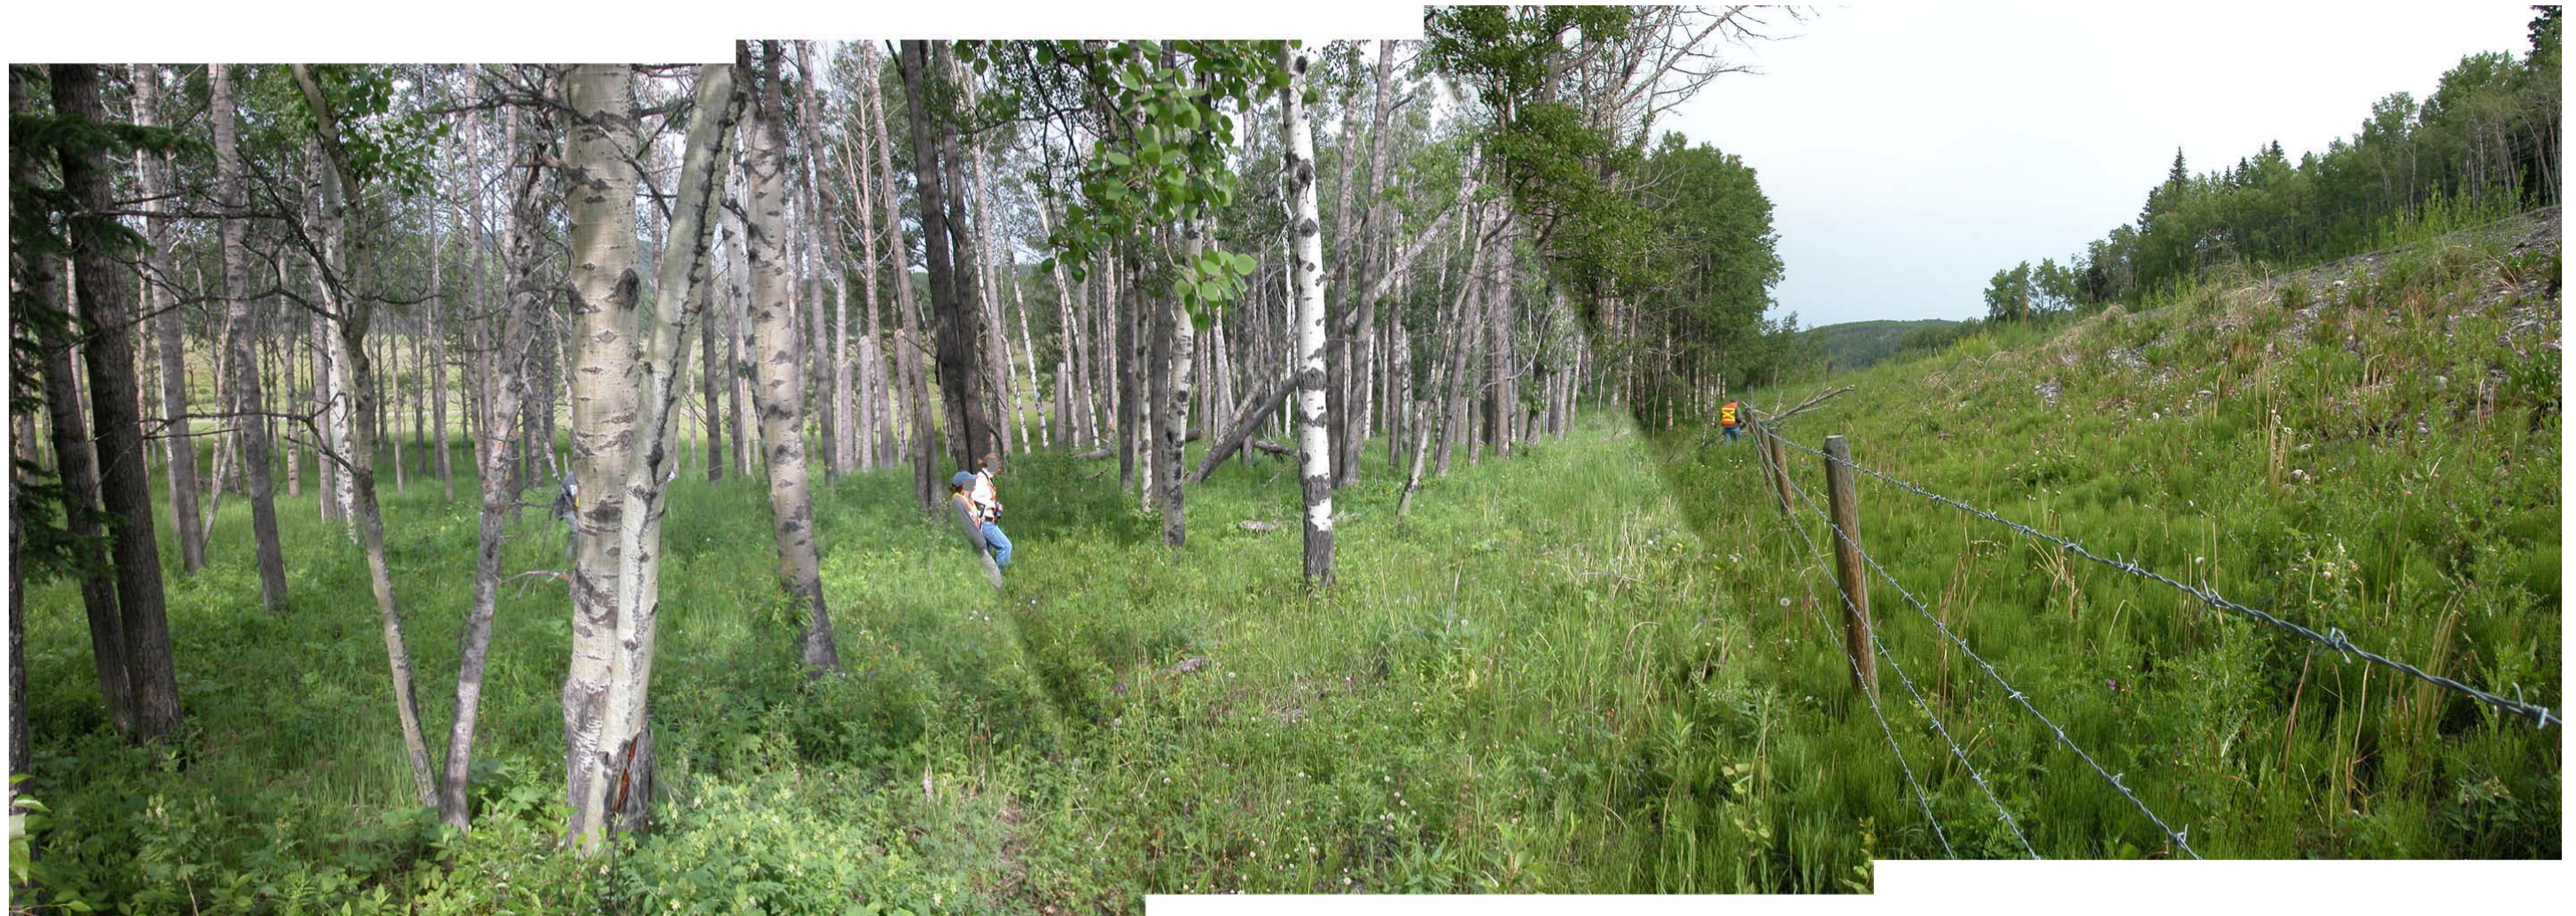
Photo 7 Site A
 Slope profile below the cracking area on road at Site A. Although difficult to see in this photo, the slope profile suggests an old slump that would have encompassed the road. There is an area of dead and tilting trees on the lower portion of the possible slump area. This may be related to the 1999 slope movement that damaged the southbound lane of the road, rather than indicating ongoing movement.
