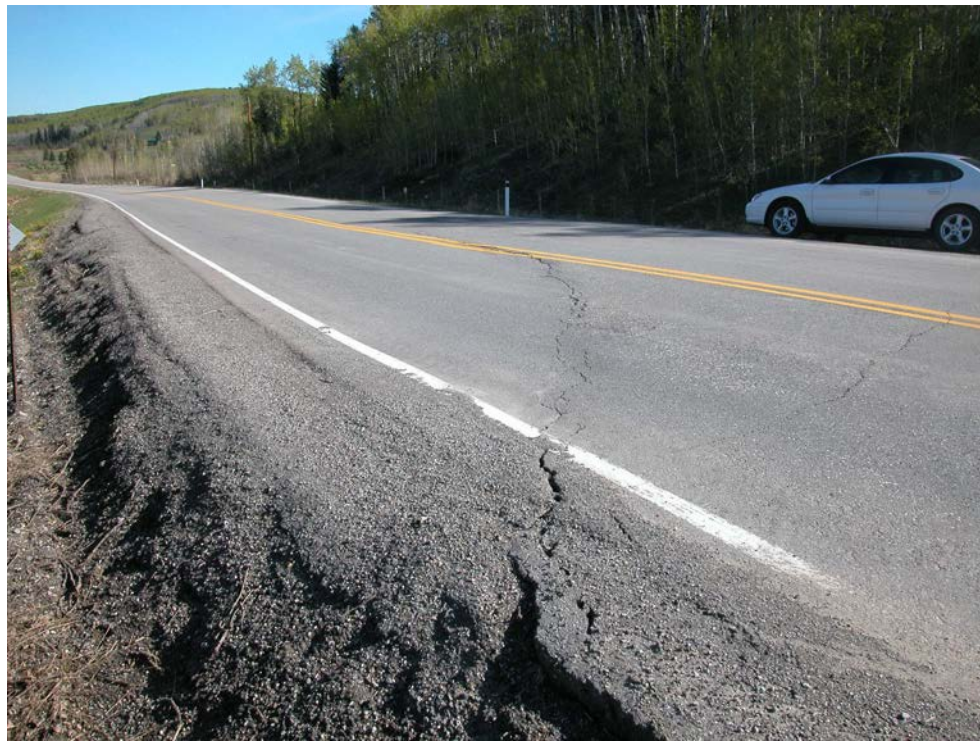
Photo S10A-1 (upper left) – May 2004 – facing north across the cracking and settlement area affecting the southbound lane at this site. This pattern of cracking and settlement at this location has been noted in previous inspections. The visible cracking and settlement has developed since the most recent repaving in July 2003.

It is understood that a “fill failure” occurred at this site in the mid-1990’s and resulted in loss of service of the southbound lane. It is understood that the road was reconstructed with granular fill, however no details on the associated investigation and repair are available at this time.

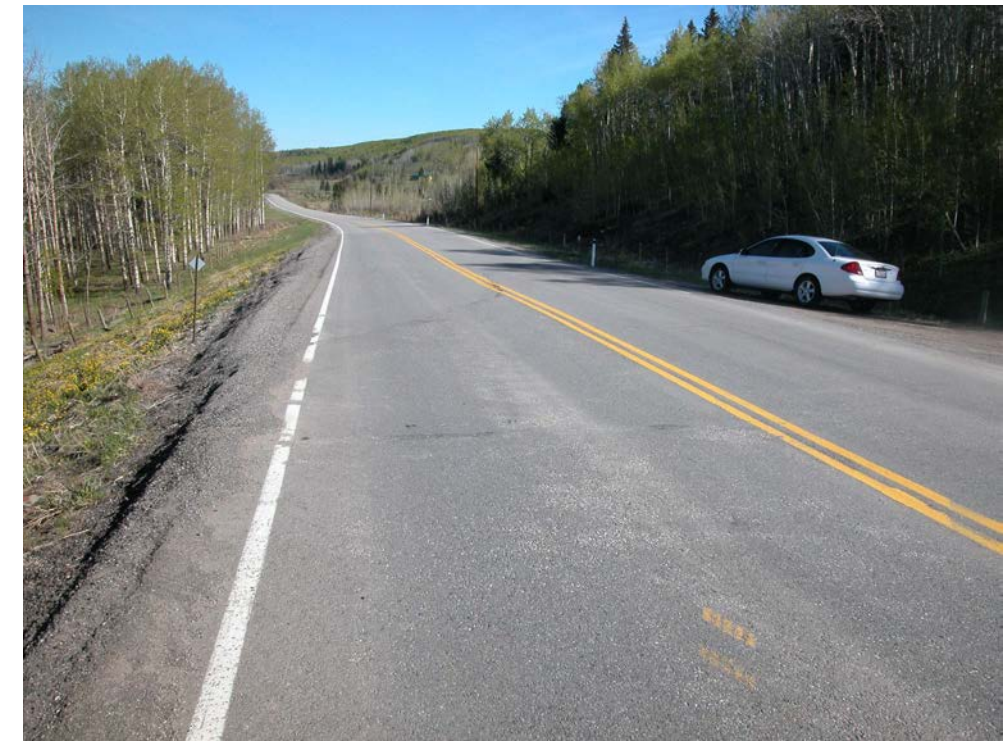
Photo S10A-2 (upper right) – May 2004 – wider view of the area shown in Photo S10A-1. The shape of the affected area suggests a slump downwards to the west (left).

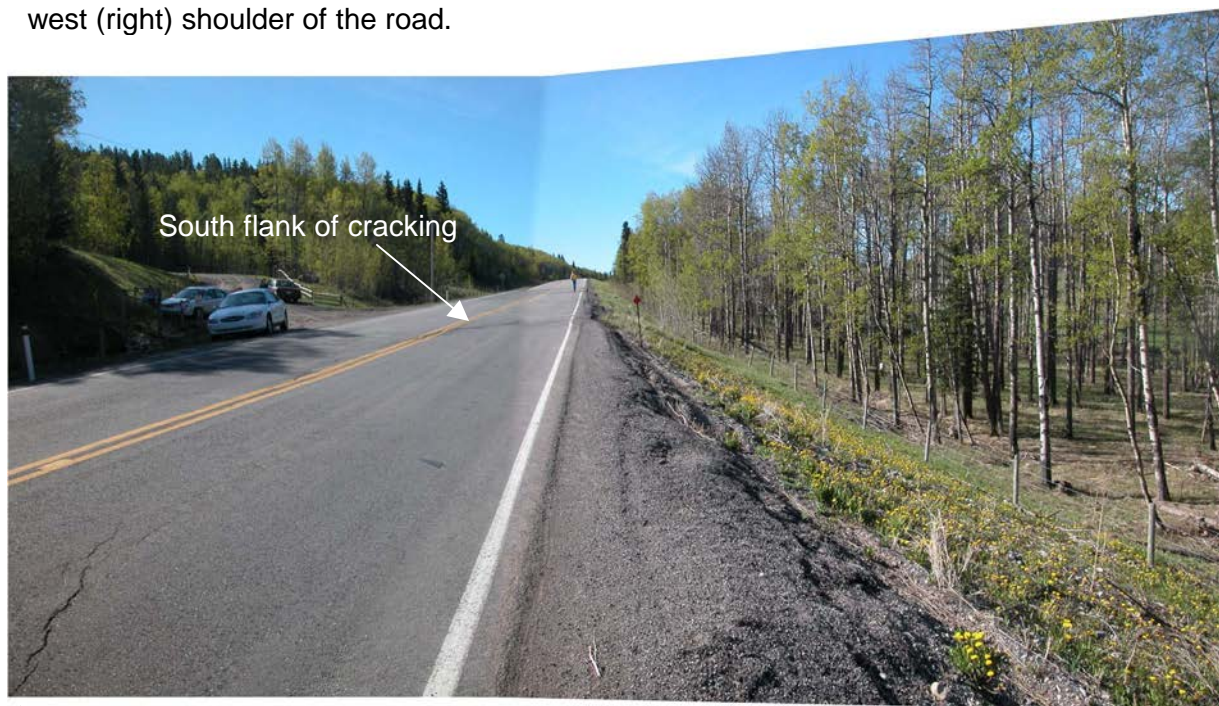
Photo S10A-3 (lower left) – May 2004 – facing south across the settlement and cracking area shown in Photos S10A-1 and S10A-2. The north flank of the cracking is visible in the lower left corner of the photo and the south flank is visible in the middle background. The segment of the road surface between the edges of the cracking measures approximately 30 m along the west (right) shoulder of the road.

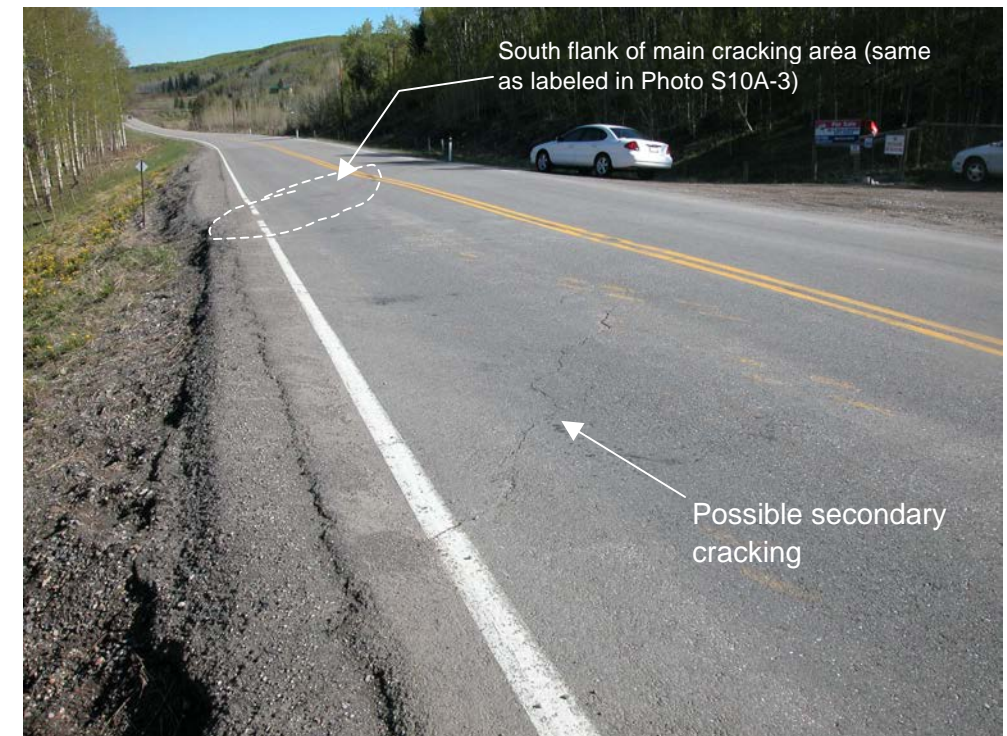
Photo S10A-4 (lower right) – May 2004 – possible secondary cracking in the southbound lane, approximately 15 m south of the south flank of the main cracking area shown in Photos S10A-1 to S10A-3.

North flank of cracking

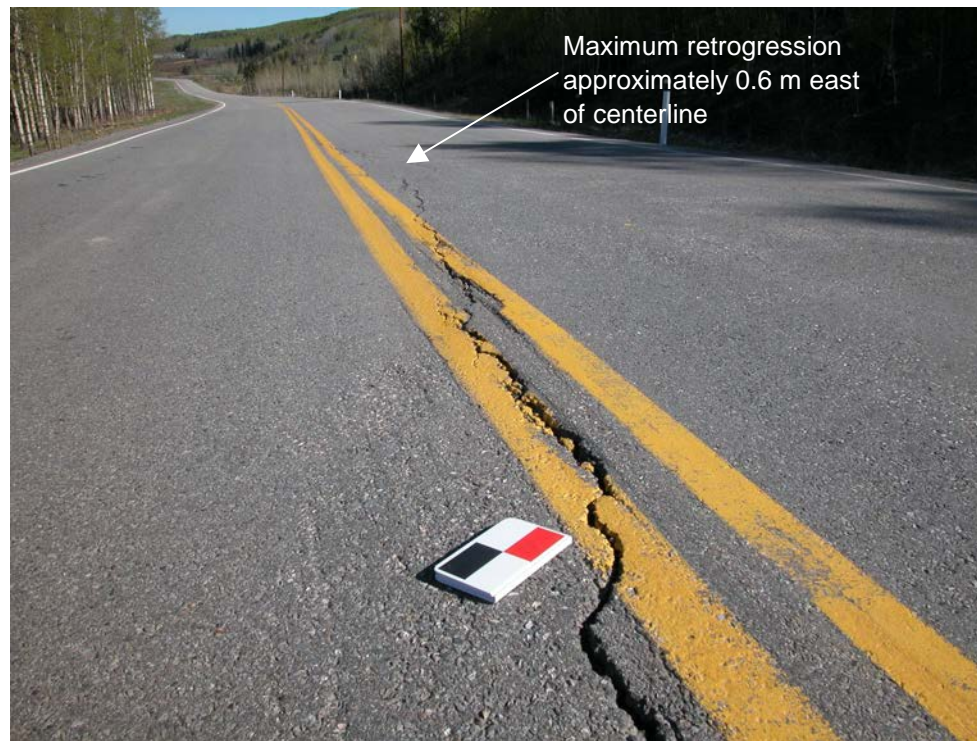
Photo S10A-5 (left) – May 2004 – close-up view (facing north) of the cracking along the centerline in the main cracking area. Lateral separation approximately 20 to 25 mm. Vertical displacement approximately 25 to 50 mm. It appears that the visible cracking and displacement has developed since the July 2003 inspection and subsequent repaving of the road through this area.

The overall layout and appearance of the cracking suggests a slumping failure down to the west (left). The maximum eastward retrogression of the cracking is approximately 0.6 m east of the centerline, at the location labeled the middle background of this photo.

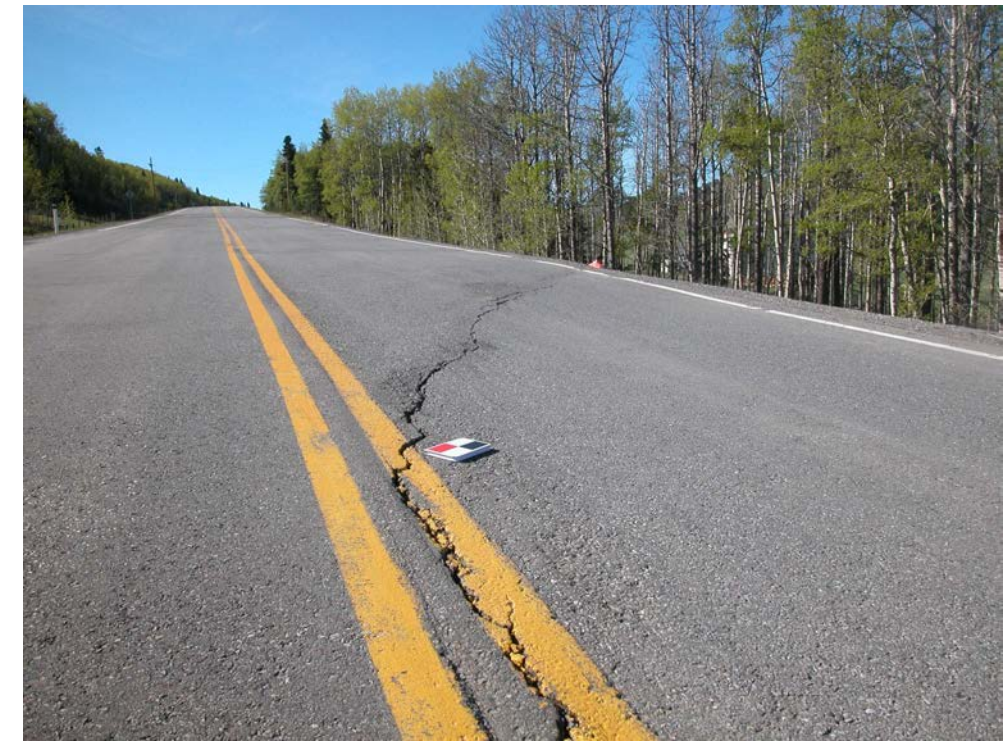
Photo S10A-6 (right) – May 2004 – close-up view (facing south) of cracking along centerline in main cracking area. Same area as shown in Photo S10A-5.
