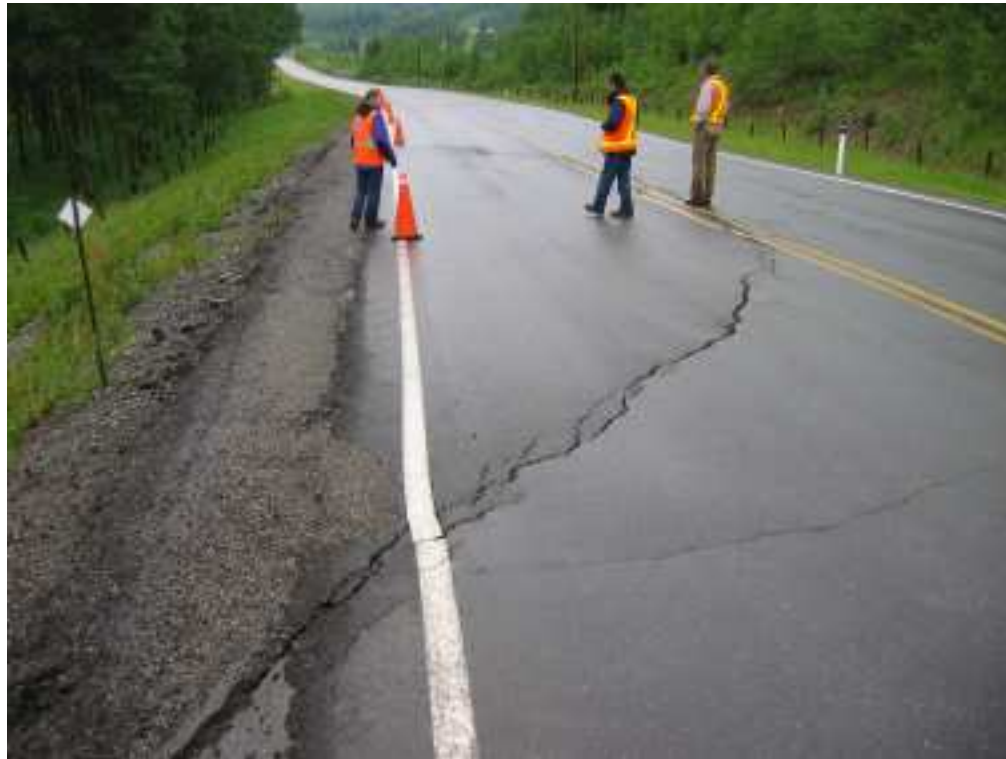
Photo S10(A)-1 (upper left) – June 2005 – facing north across the settlement and cracking area in the southbound lane. This area was repaved in 2004 and the current cracking is in the same location and pattern noted in previous years.

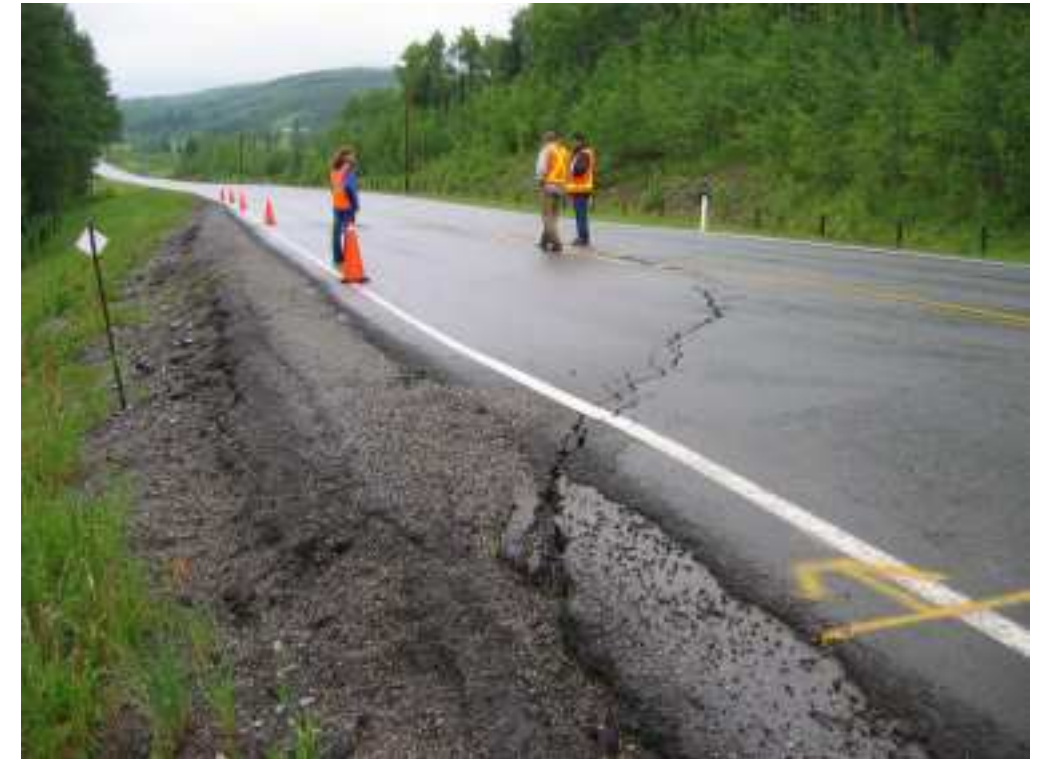
Photo S10(A)-2 (upper right) – June 2005 – another view of area shown in Photo S10(A)-1. The damaged portion of the road is marked for repaving.

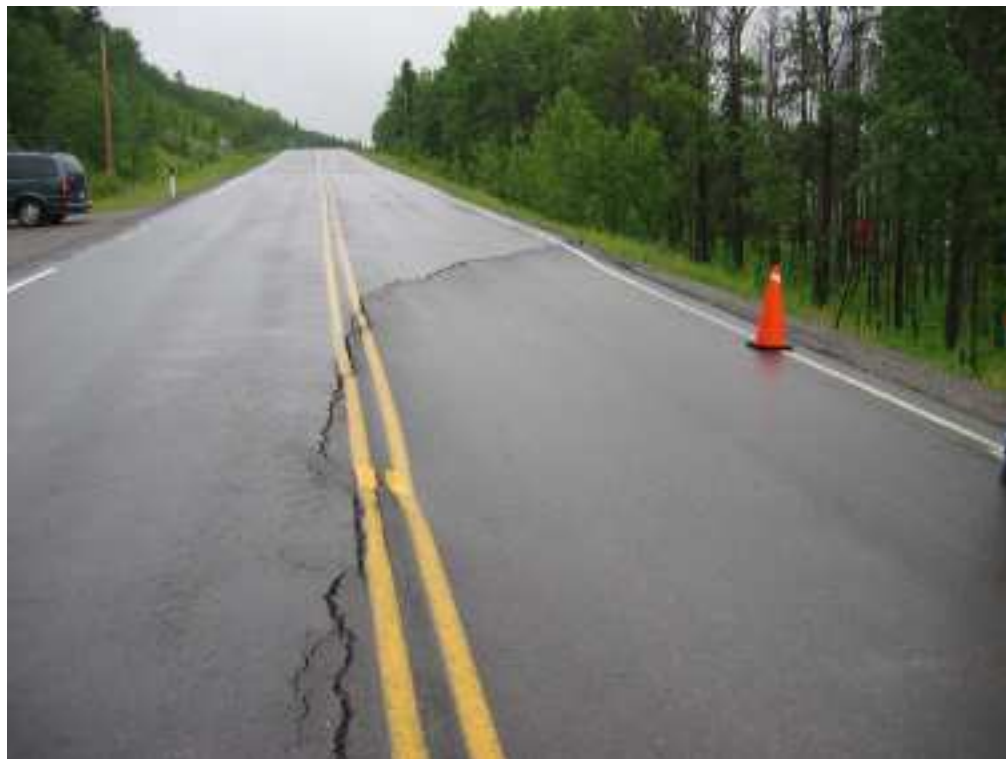
Photo S10(A)-3 (lower left) – June 2005 – facing south across site S10(A). The southbound lane has settled up to approximately 100 mm, apparently mostly during and after the heavy rains in June 2005.

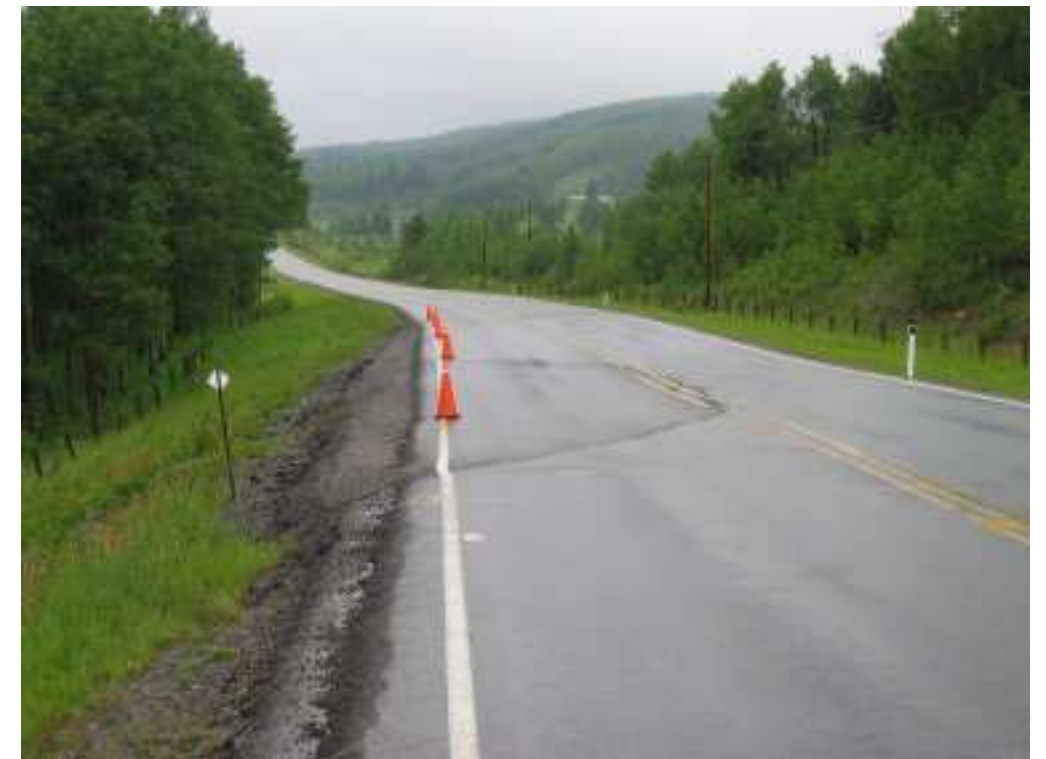
Photo S10(A)-4 (lower right) – June 2005 – wider view across site, facing north. The pattern of the damage to the road indicates landslide movement down to the west (left).
