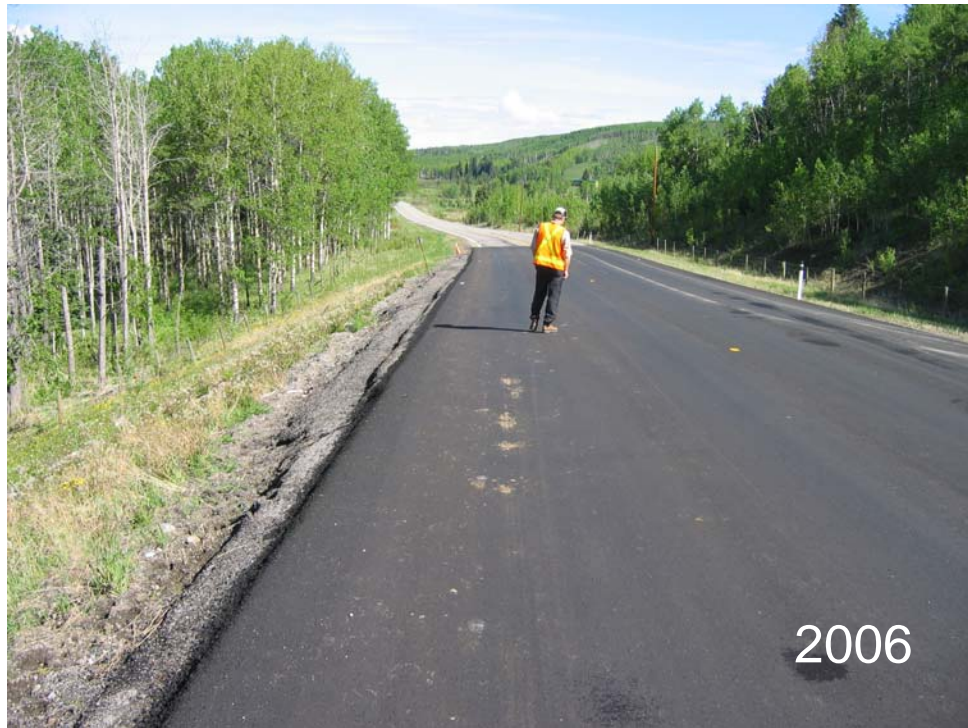
**Photo S10(A)-1** (upper left) – May 2006 – facing north across the segment of the road where ongoing cracking and settlement has been noted since 2000. The area was repaved shortly before the time of the annual inspection, therefore it was not possible to check for further development of the previously noted cracking and settlement. Compare with Photos S10(A)-3 and S10(A)-4 which show the settlement and cracking in this area in June 2005.

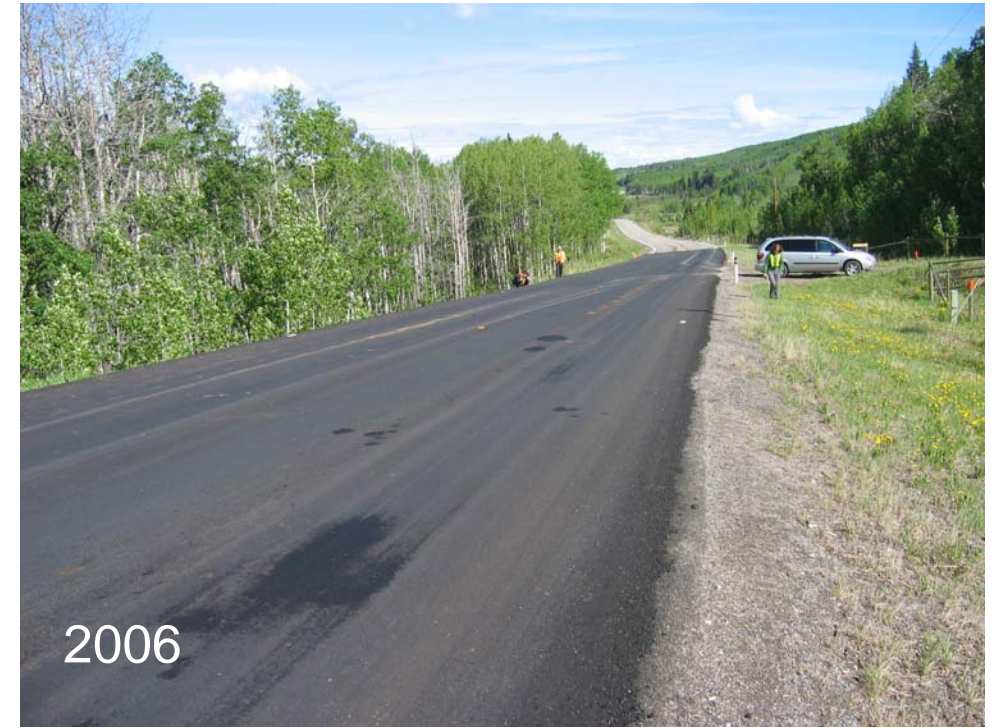
**Photo S10(A)-2** (upper right) – May 2006 – another view of the previously-noted cracking and settlement area, facing north along the road. The area was repaved shortly before the time of the annual inspection. Compare with Photos S10(A)-3 which show the same area in June 2005.

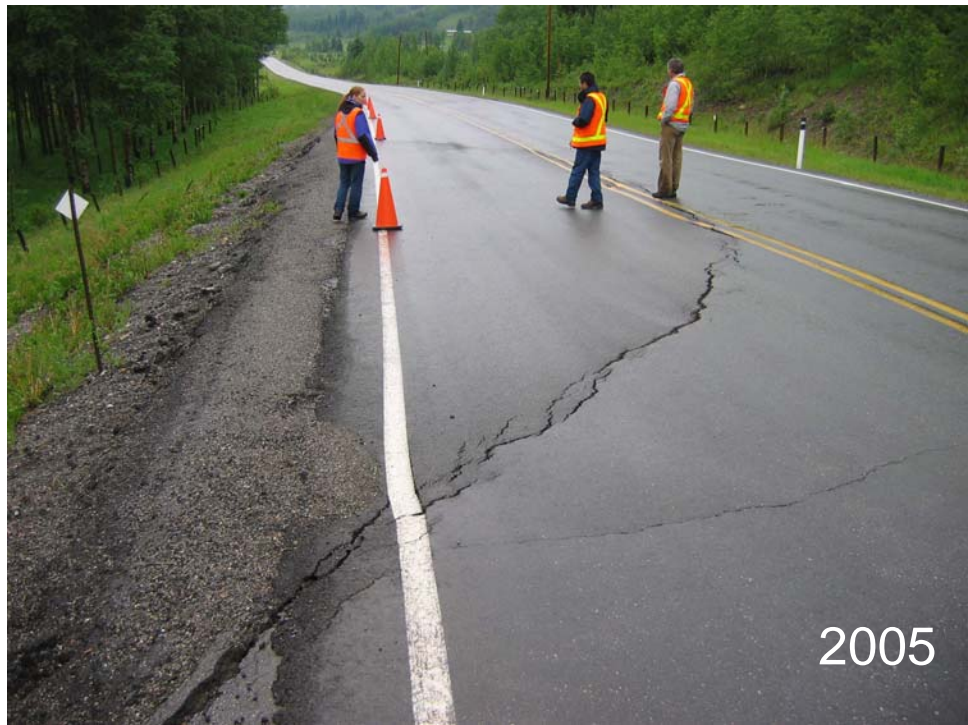
**Photo S10(A)-3** (lower left) – June 2005 – facing north across the settlement and cracking area observed at the time of the 2005 site inspection. The pattern of damage to the road surface suggests a slump failure down towards the west (left on the photo).

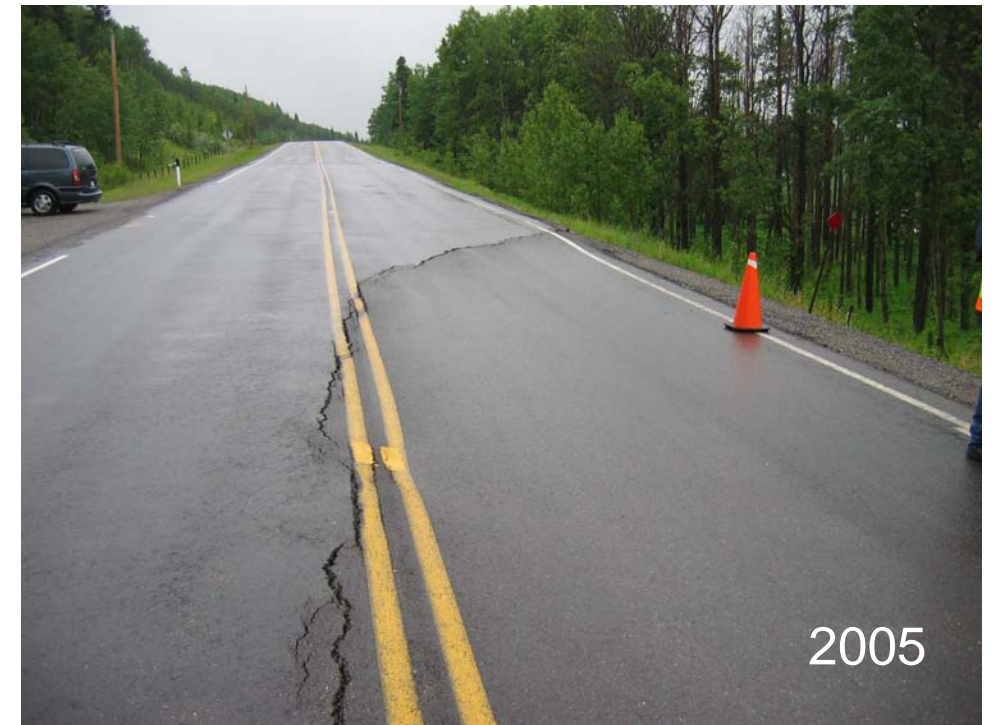
**Photo S10(A)-4** (lower right) – June 2005 – facing south across the settlement and cracking area observed at the time of the 2005 site inspection.

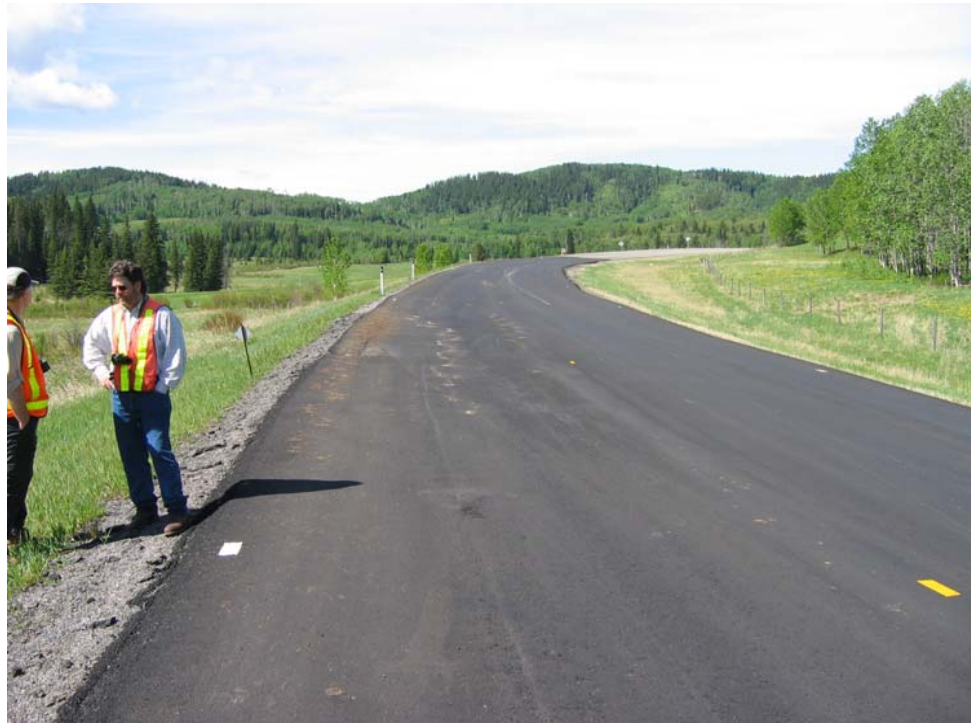
**Photo S10("S" Curve)-1** (left) – May 2006 – facing northwest across the recently repaved area where AIT had previously noted settlement and cracking of the road surface.

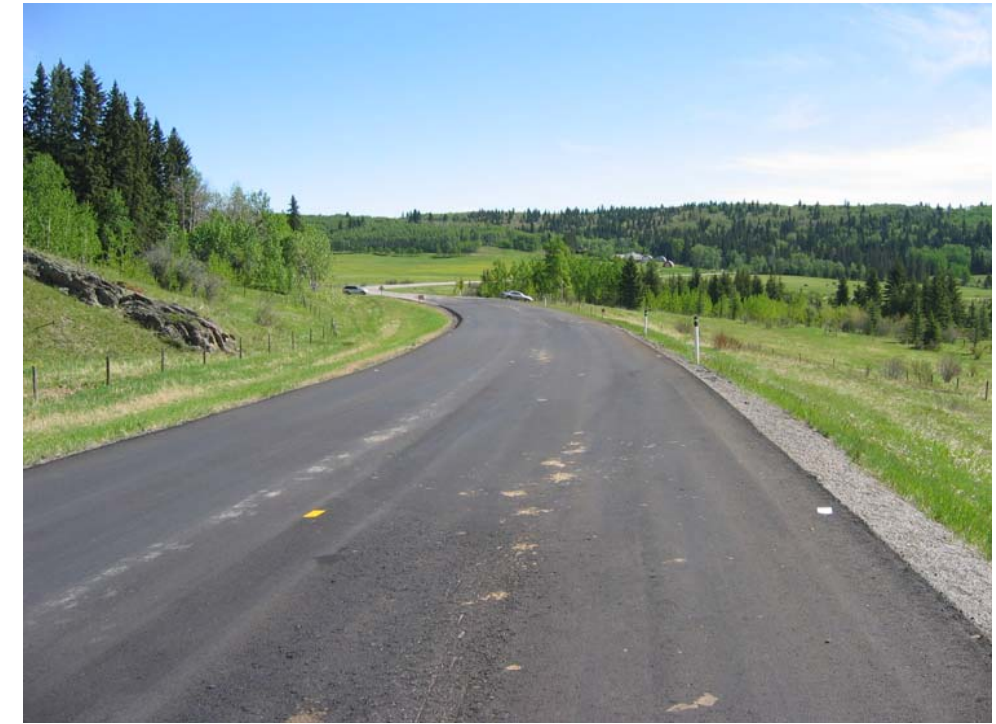
**Photo S10("S" Curve)-2** (right) – May 2006 – facing south/southeast across the recently repaved area where AIT had previously noted settlement and cracking of the road surface. Note the bedrock exposed in the cut slope on the left side of the photo.
