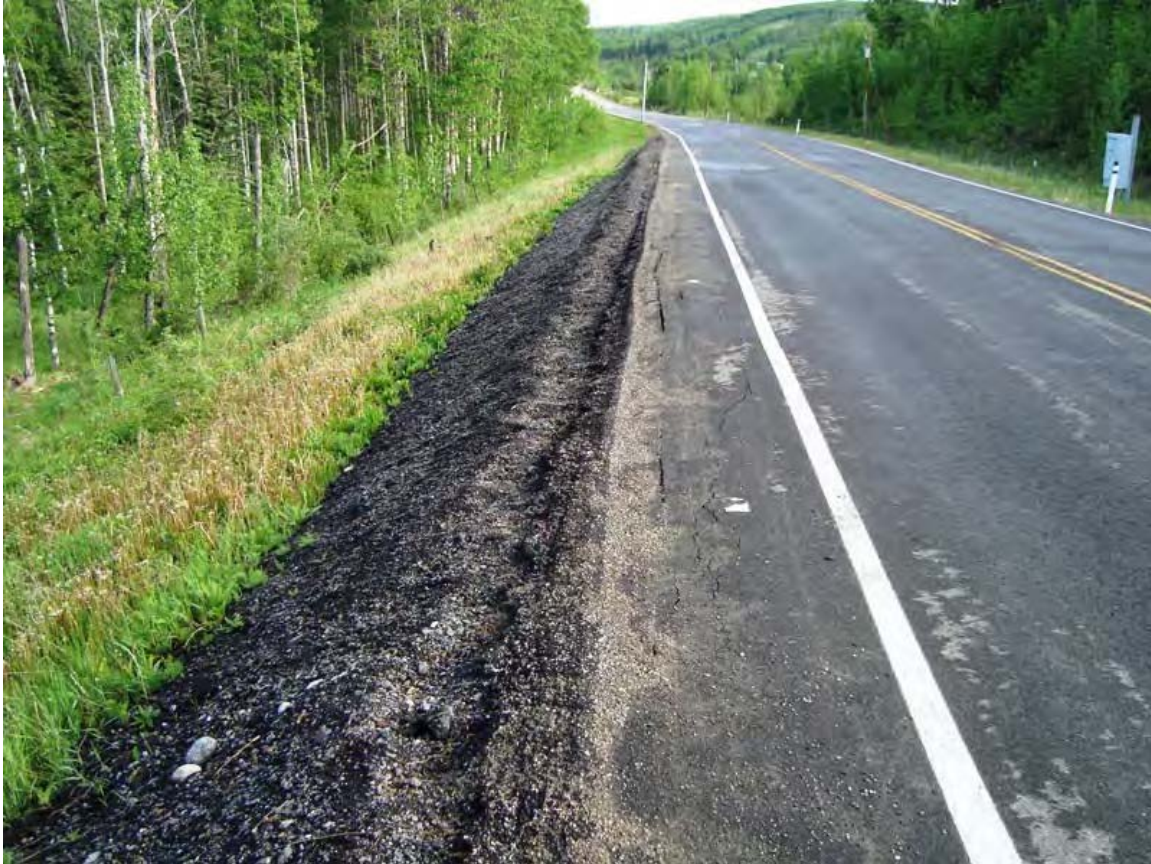
**Photo S10A - 1 (June 2012)** - Facing north from the south end of the site. An overlay was placed at the site in late 2011. Subtle cracking and settlement had formed through the overlay following similar extent as was observed in 2011 and in previous inspections.
