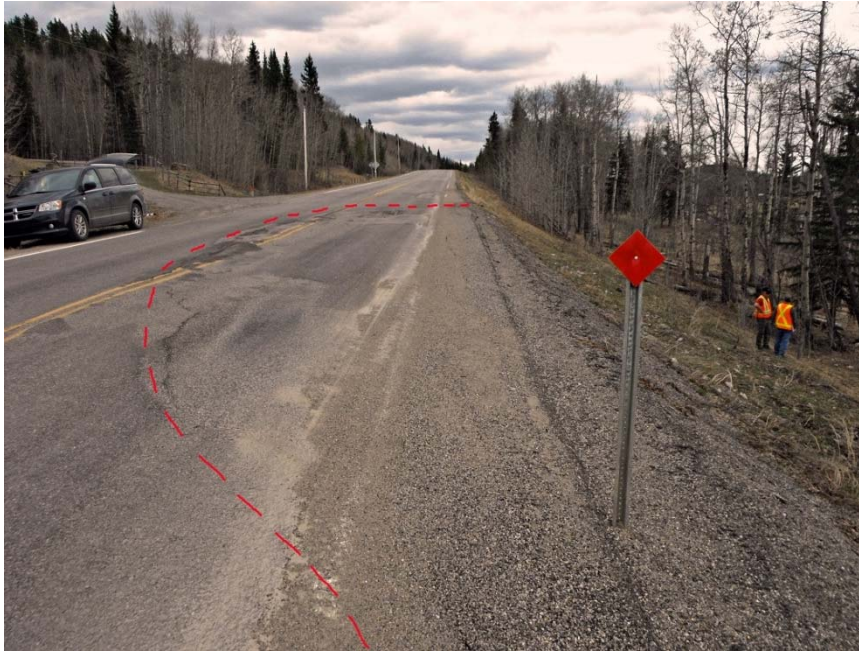
Photo S10A - 1 (May 2014) - Facing south from the north end of the site. Cracking and settlement had formed through the previous overlay following similar extent as was observed in 2012 and in previous inspections. The approximate extents of the main slide area within the road is outlined in red.

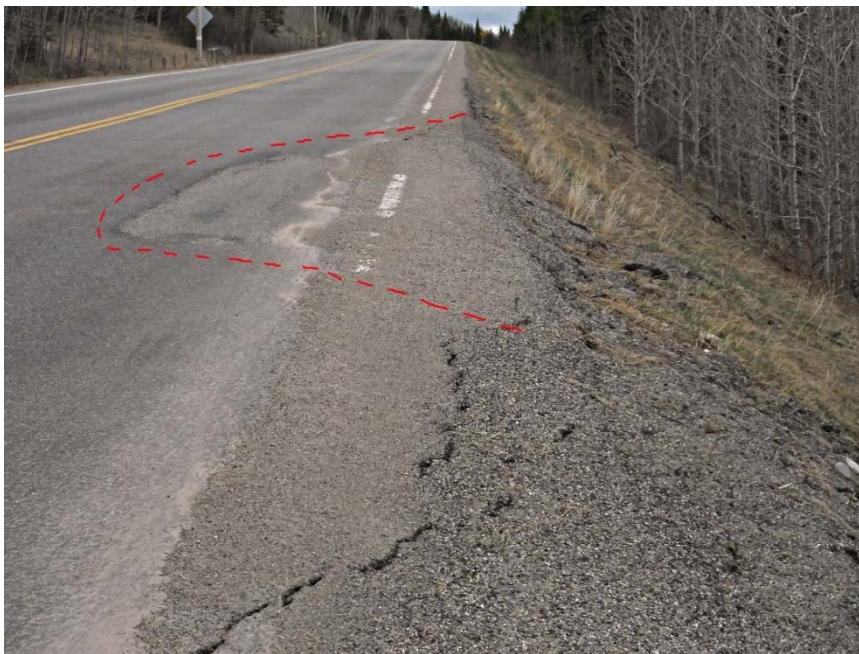
Photo S10A - 2 (May 2014) - Facing south at the new damage observed in the road surface, at the south end of the main slide area seen in the previous photo. The approximate extents of the newly observed damage is outlined in red.
