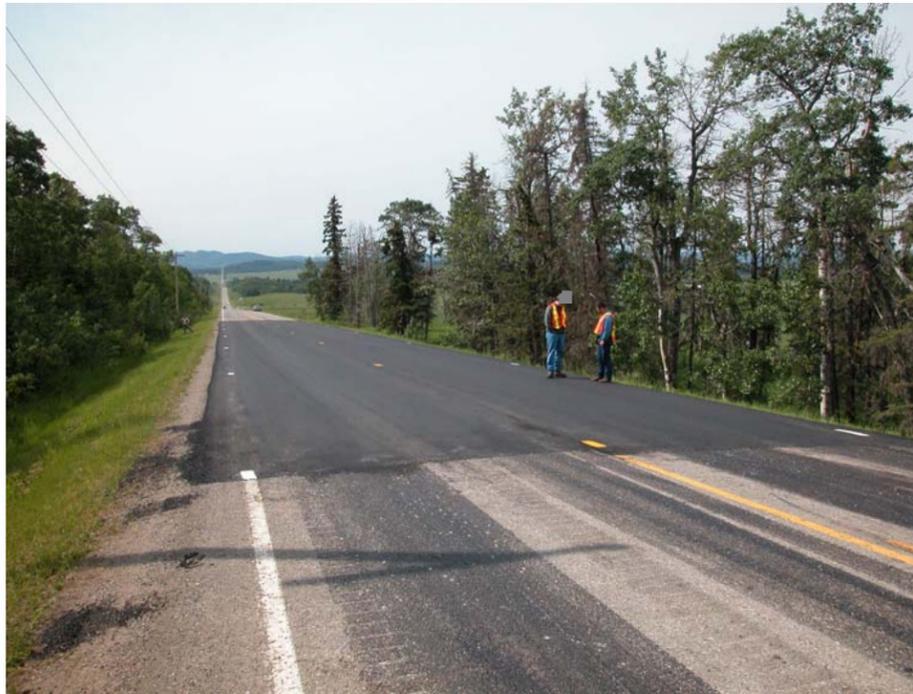
**Photo 8** (upper left) Site B  
Facing south across Site B. This site appeared to have been repaved only a few hours before the inspection.

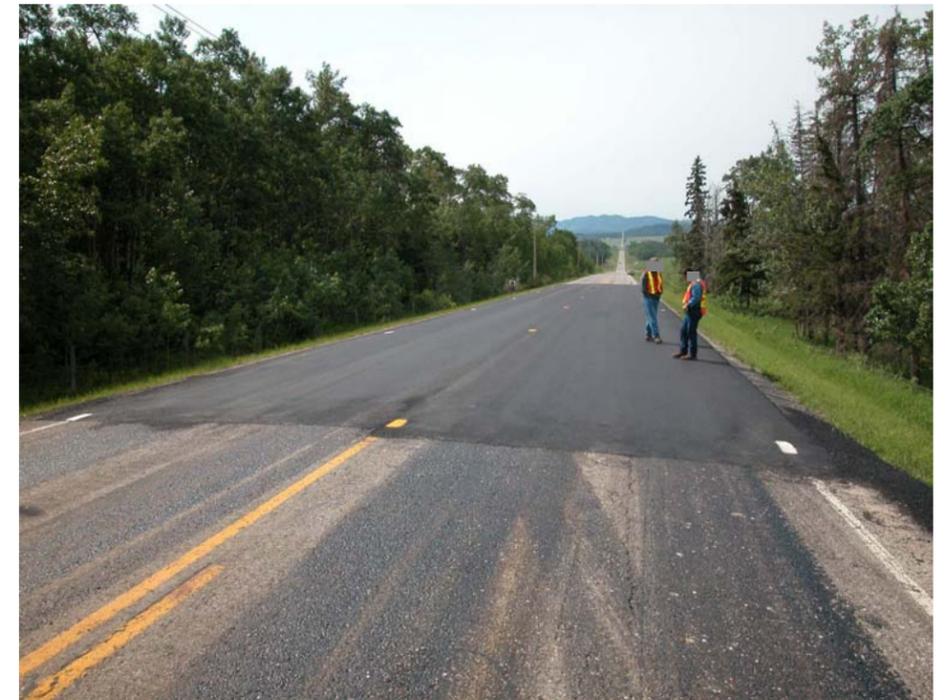
**Photo 9** (upper right) Site B  
Another view facing south across Site B.

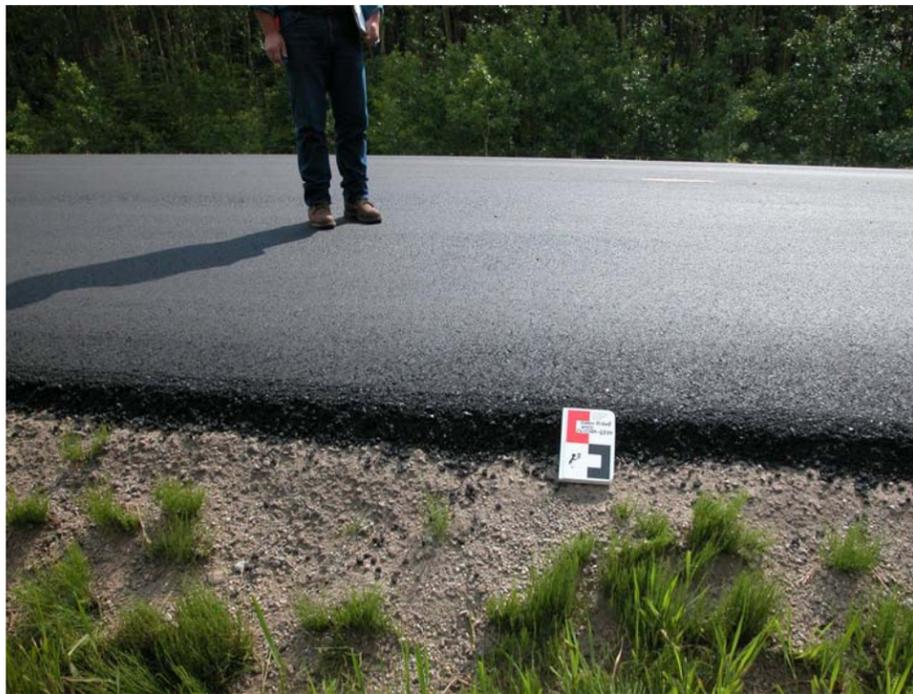
**Photo 10** (lower left) Site B  
West shoulder of the road in the repaved area. Notebook provides scale for the fresh asphalt thickness in this area.
