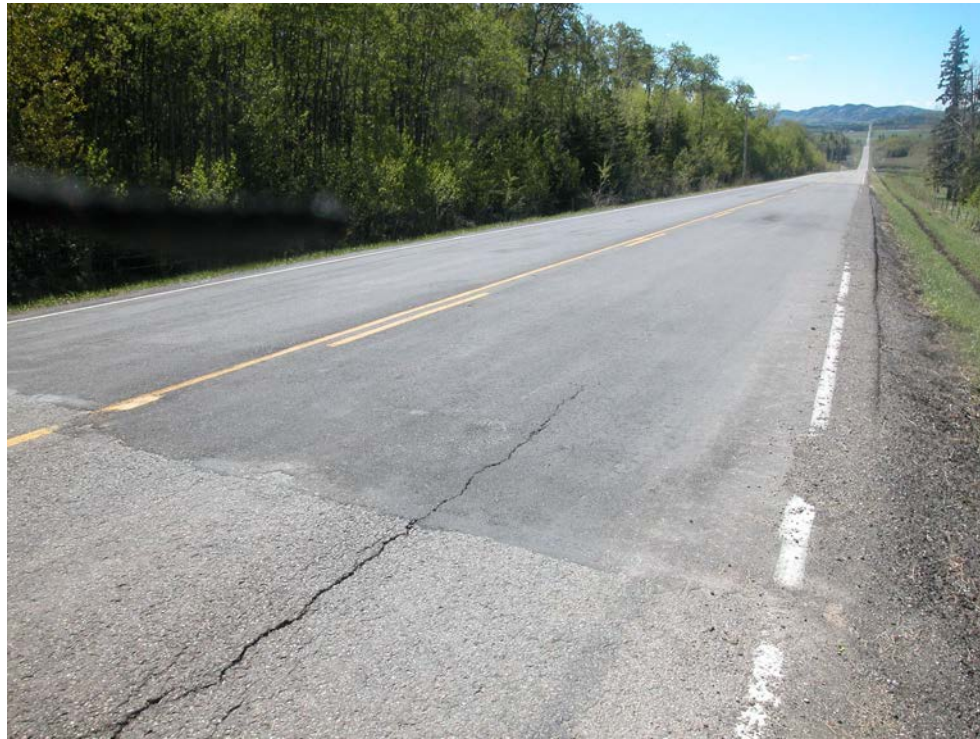
**Photo S10B-1** (upper left) – May 2004 – facing south across the July 2003 overlay at Site B. There is longitudinal cracking visible at the north end of the overlay (foreground of photo) but judged to be a pavement phenomenon rather than indicating geotechnical instability.

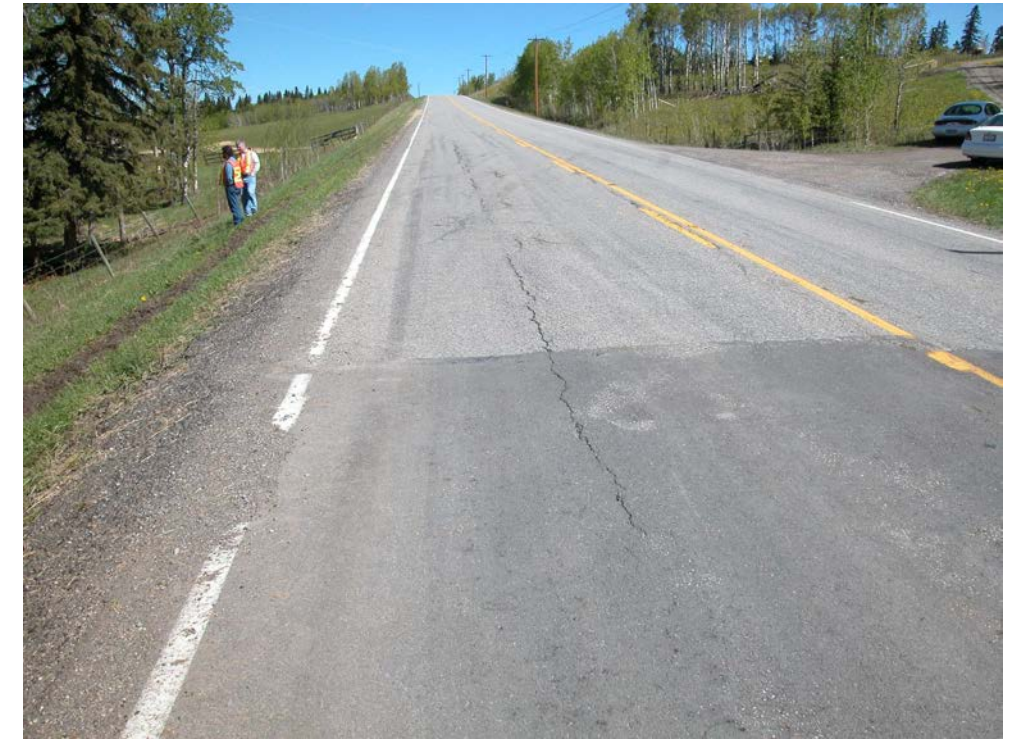
**Photo S10B-2** (upper right) – May 2004 – facing north. Another view of the longitudinal cracking at the north end of the July 2003 overlay at Site B.

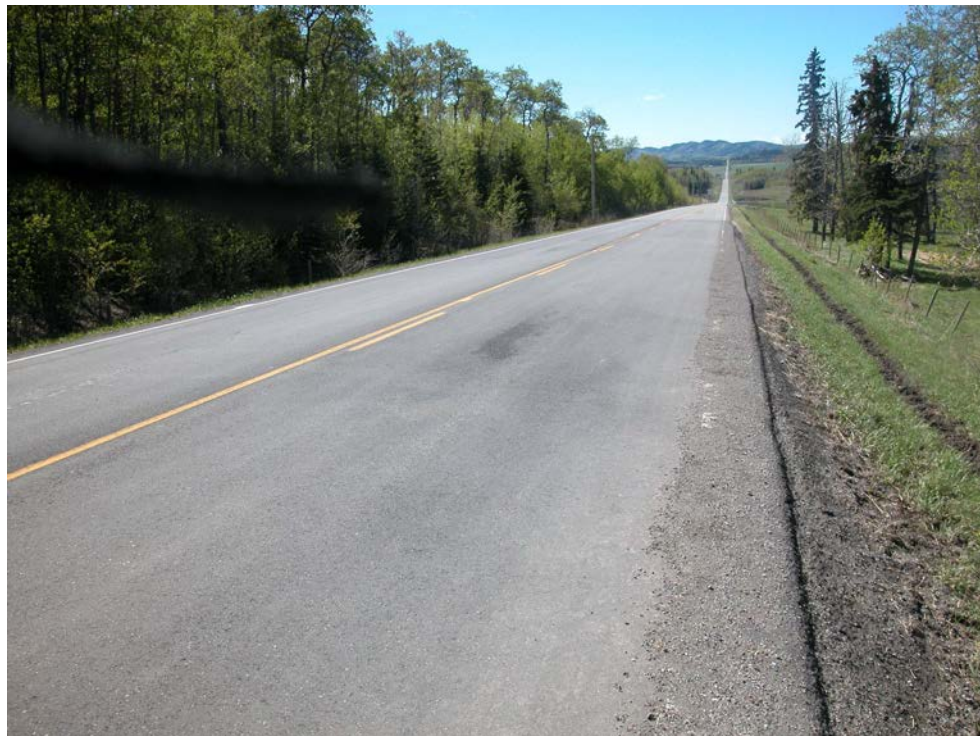
**Photo S10B-3** (lower left) – May 2004 – general view facing south across the July 2003 overlay at Site B.

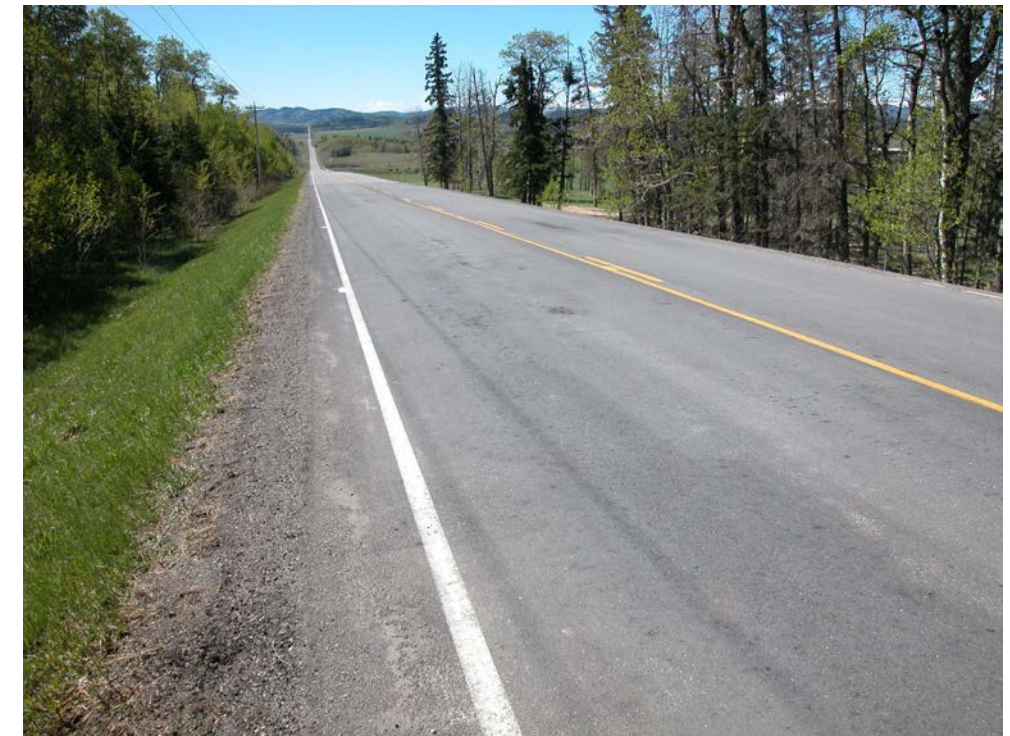
**Photo S10B-4** (lower right) – May 2004 – general view facing south across the July 2003 overlay at Site B.
