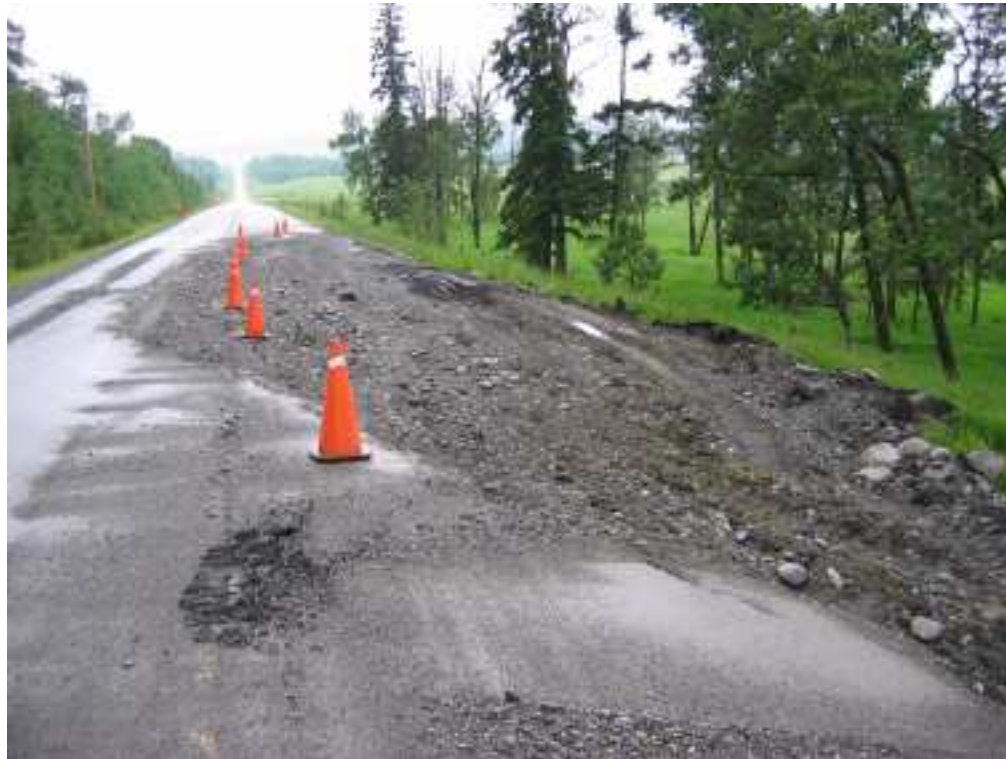
**Photo S10(B)-1** (upper left) – June 2005 – facing south across the portion of the southbound lane damaged by the instability caused by heavy rainfall in June 2005.

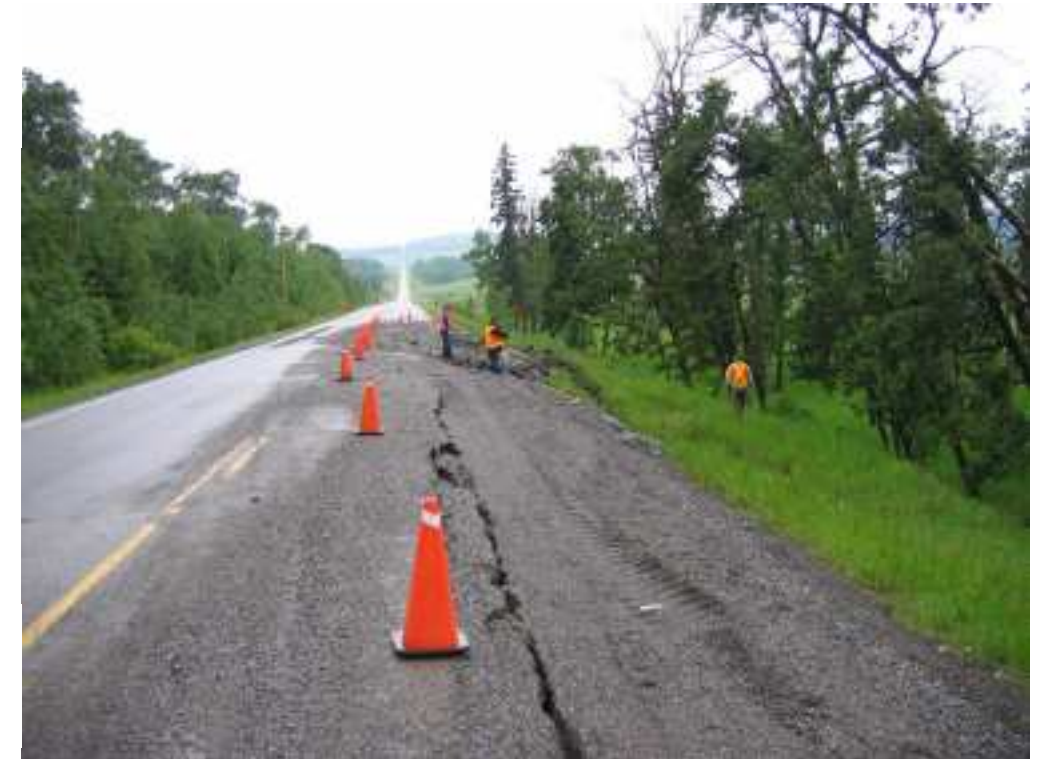
**Photo S10(B)-2** (upper right) – June 2005 – wider view facing south showing tension cracking and dropdown along the west shoulder to the north of the main failure area.

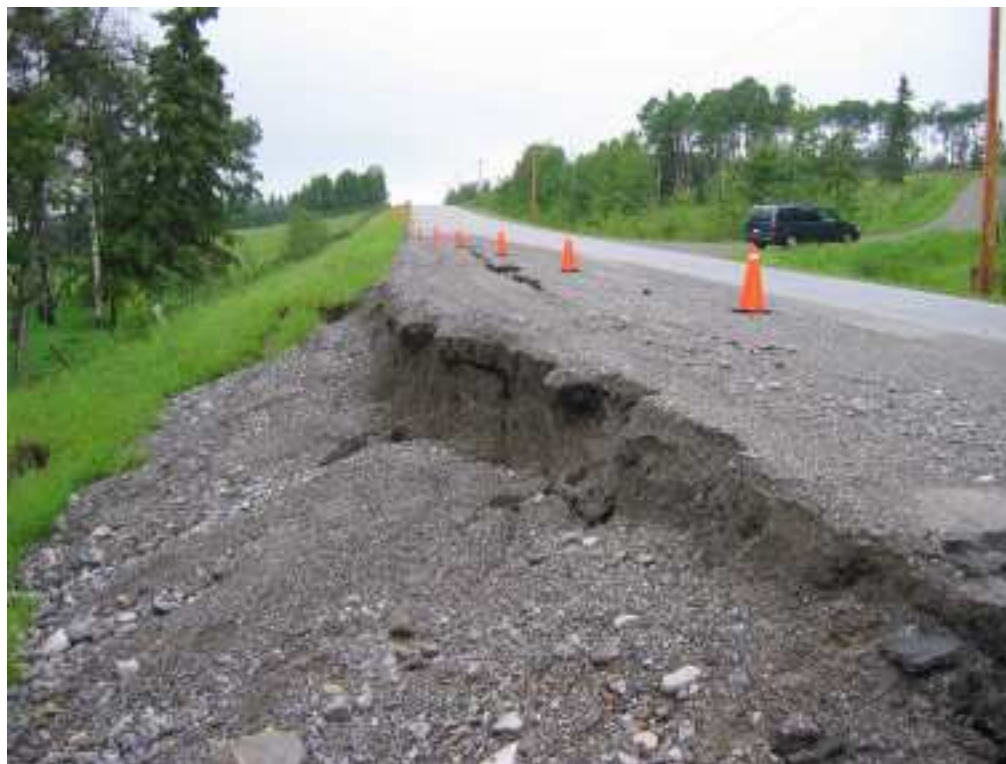
**Photo S10(B)-3** (lower left) – June 2005 – closer view of north flank of the main failure area.

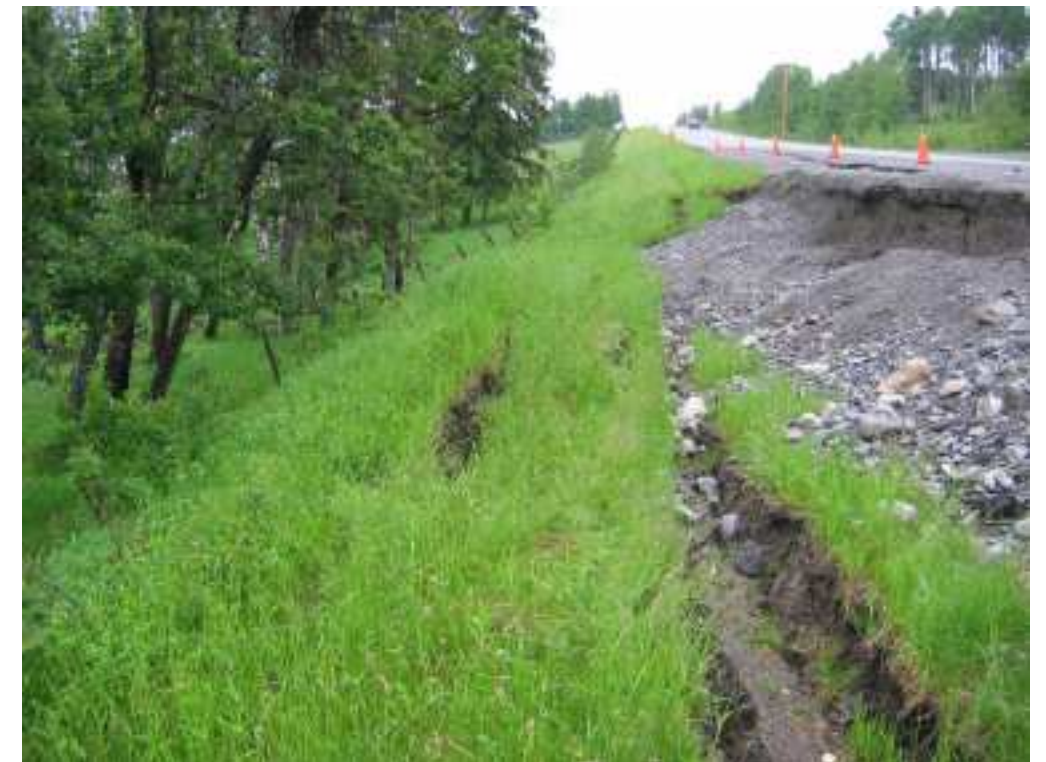
**Photo S10(B)-4** (upper left) – June 2005 – deformation of slope face to west of road and tilted trees indicate that the overall toe of the failure extends to the west of the fence line.
