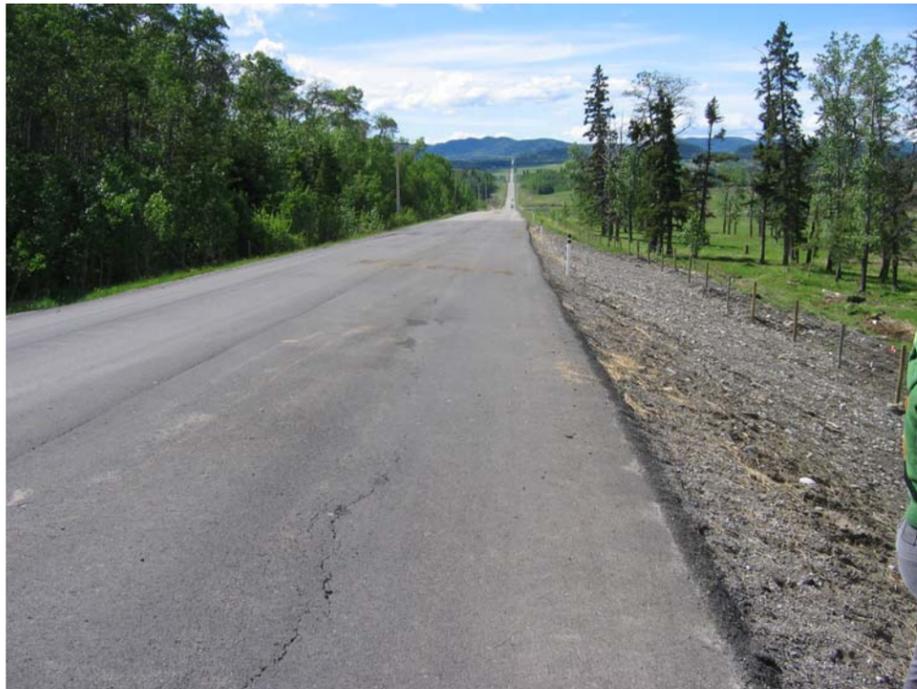
Photo S10(B)-1 (upper left) – May 2006 – facing south along the road. The area was repaved since the 2005 inspection. Minor longitudinal cracking visible in the repaved surface.

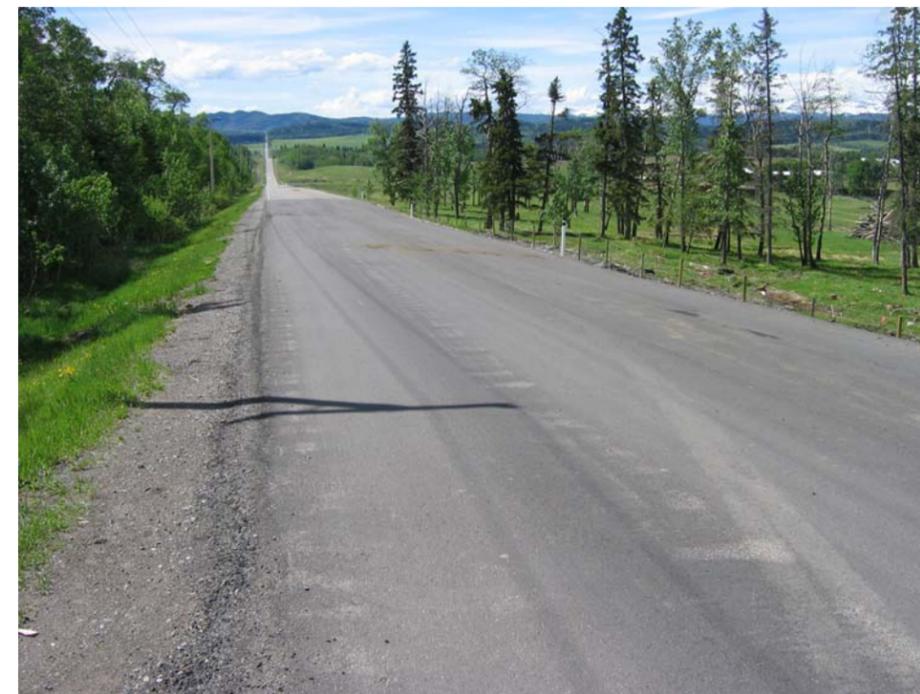
Photo S10(B)-2 (upper right) – May 2006 – facing south along the road. The area was repaved since the 2005 inspection. Compare with Photo S10(B)-3 (lower left) which shows the same area in June 2005.

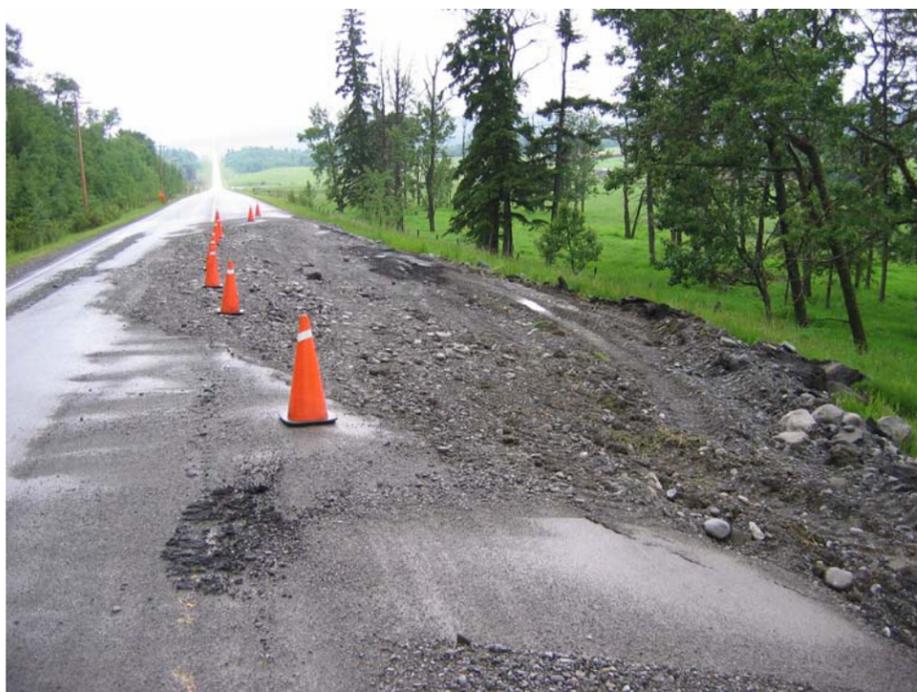
Photo S10(B)-3 (lower left) – June 2005 – shows same area as Photo S10(B)-2, as it appeared in June 2005.

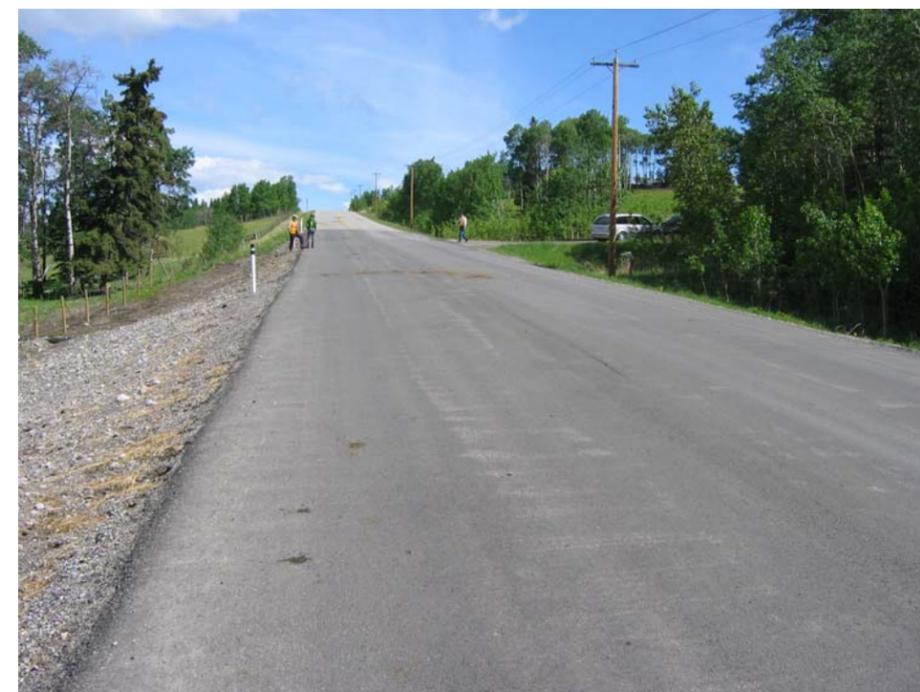
Photo S10 (B)-4 (lower right) – May 2006 – facing north along the road. The area was repaved since the 2005 inspection. Compare with Photo S10 (B)-5 (next page) which shows the same area in June 2005.

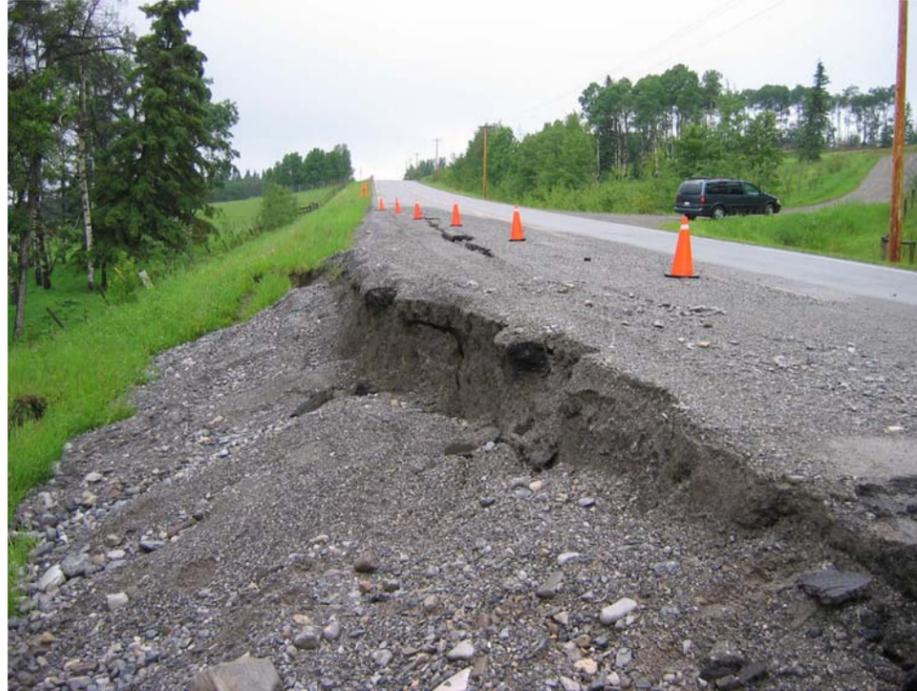
Photo S10(B)-5 (upper left) – June 2005 – shows the same area as Photo S10(B)-4, as it appeared in June 2005.
