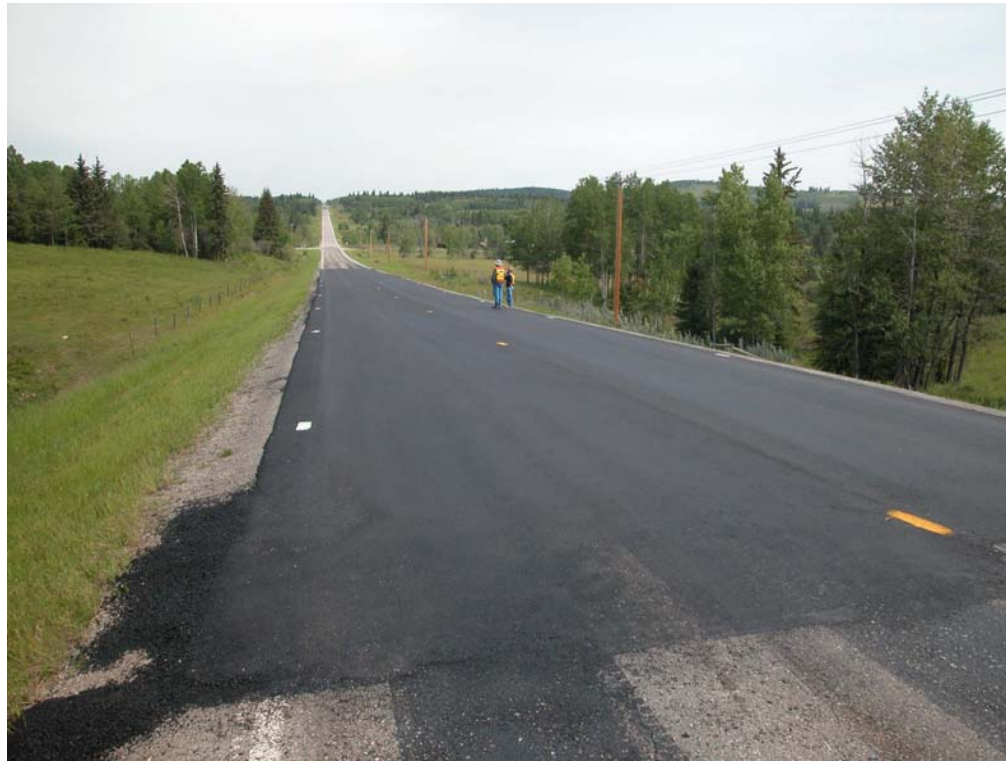
**Photo 11** (left) Site C  
Facing north across Site C. This site had also been repaved a few hours before the inspection, therefore it was not possible to tell if further cracking or settlement had occurred since the May 2002 inspection.

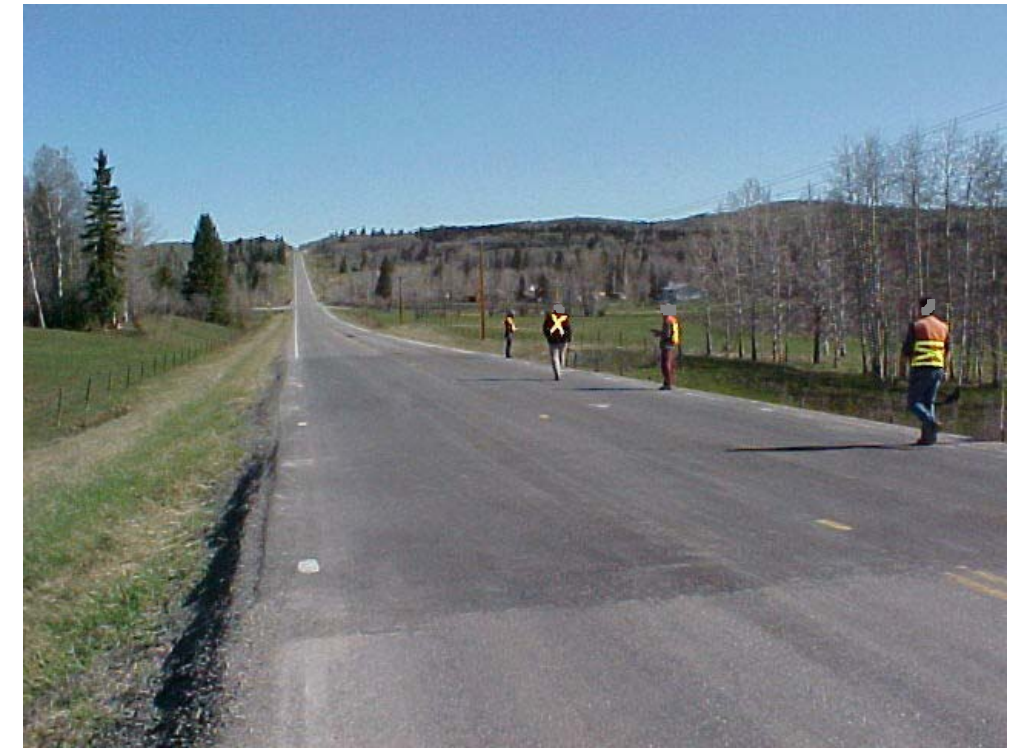
**Photo 12** (right) Site C  
Same area as Photo 11, as seen during the May 2002 inspection.
