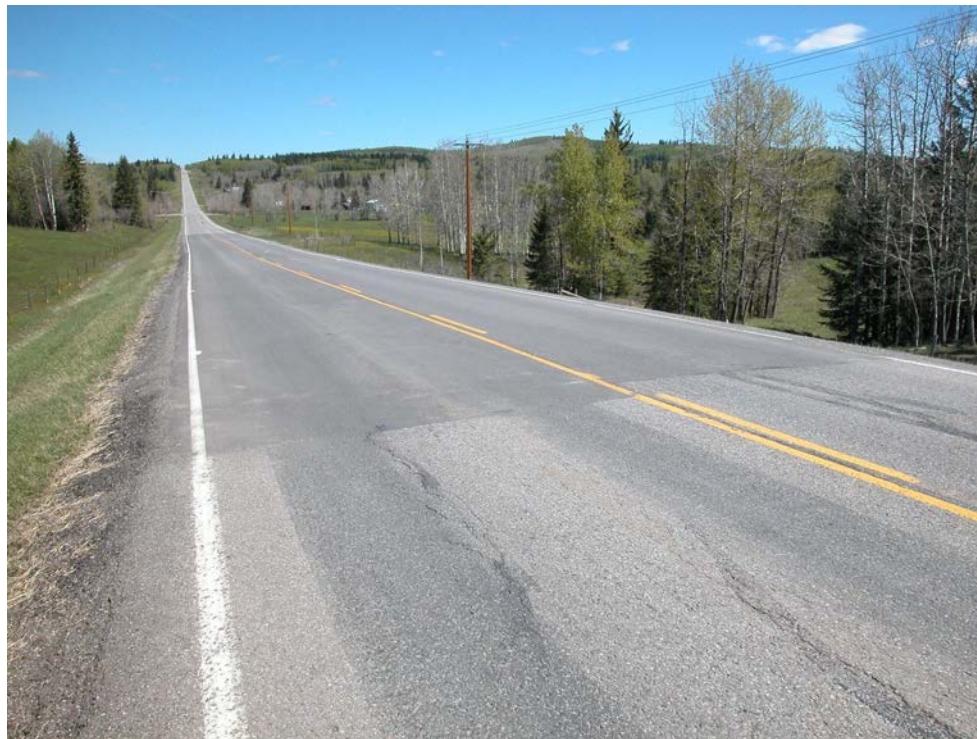
Photo S10C-1 (upper left) – May 2004 – facing north across the July 2003 overlay at Site C. No recent cracking noted in the road surface.

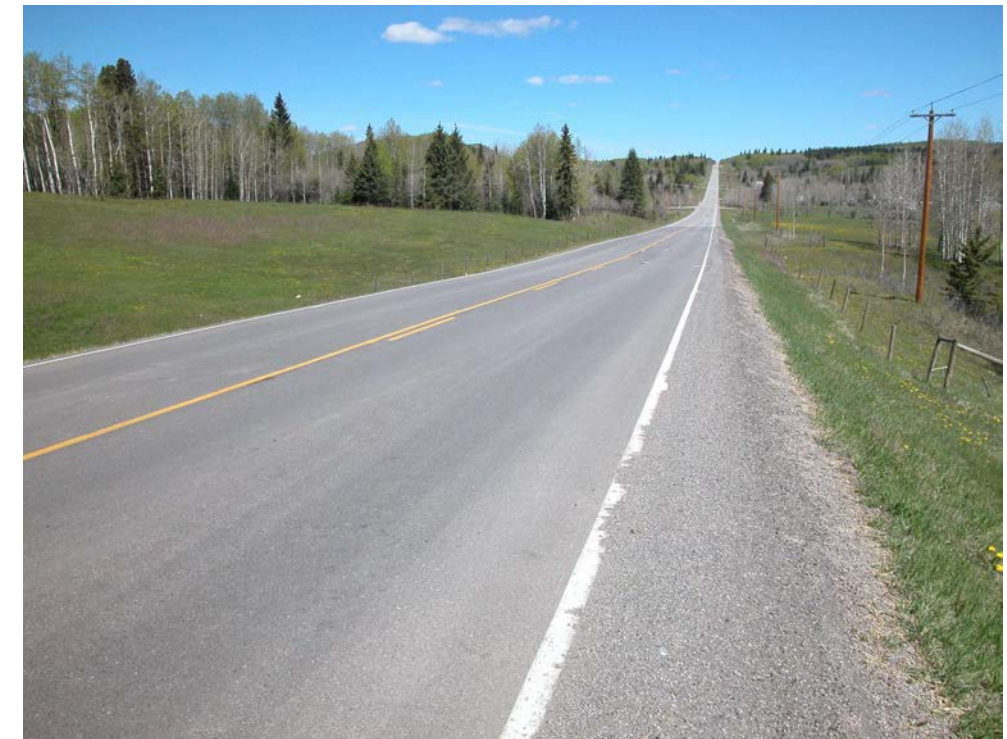
Photo S10C-2 (upper right) – May 2004 – Another view of the July 2003 overlay at Site C, facing north. No recent cracking noted in the road surface.

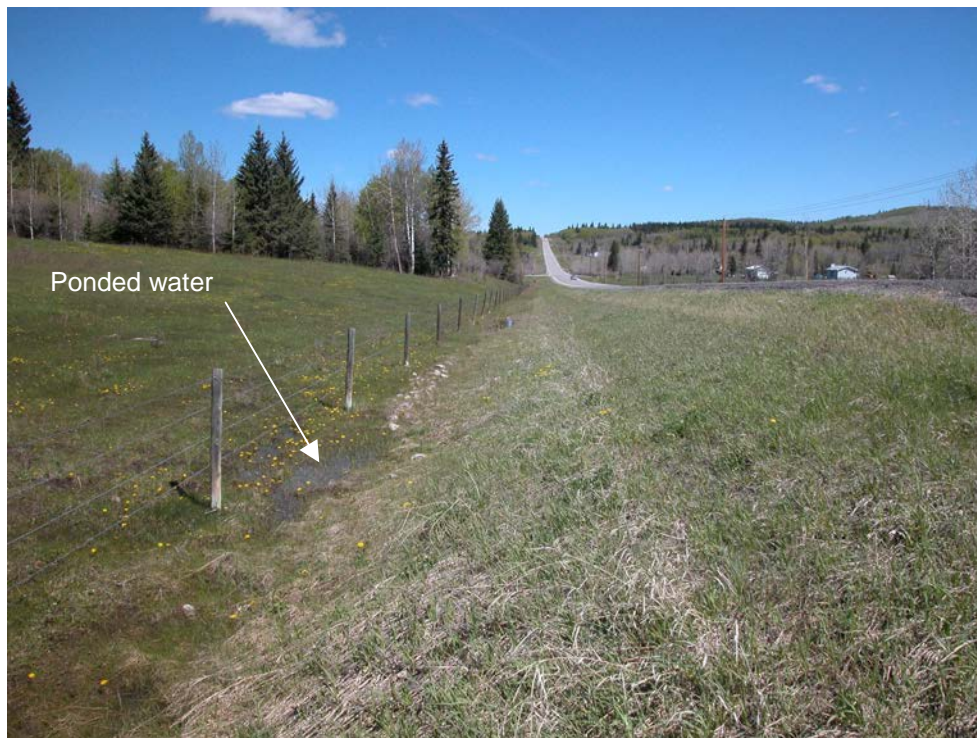
Photo S10C-3 (lower left) – May 2004 – facing north along the west ditch downslope of the highway. Note the ponded water in the ditch. It appeared that the ponding of the water was due to the lack of ditch gradient through this area as well as groundwater seepage discharging from the toe of the slope.

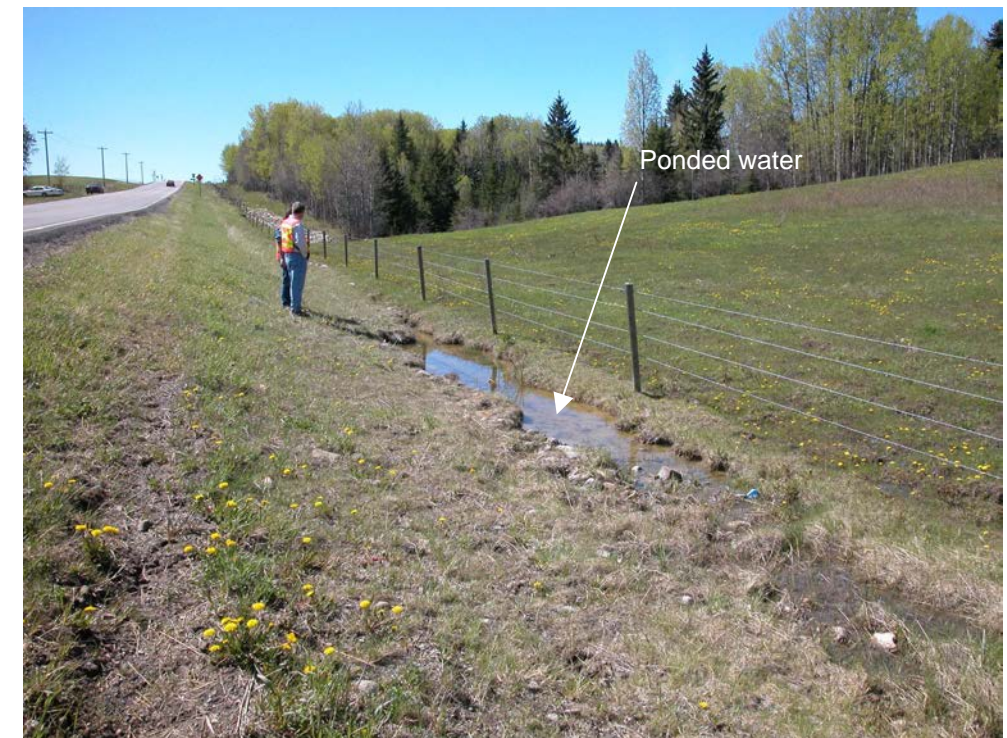
Photo S10C-4 (lower right) – May 2004 – facing south along the west ditch below the highway. It is recommended that a weeping tile drain be installed in this ditch to pick up accumulated surface runoff and groundwater seepage from this area. The weeping tile should drain to the south.
