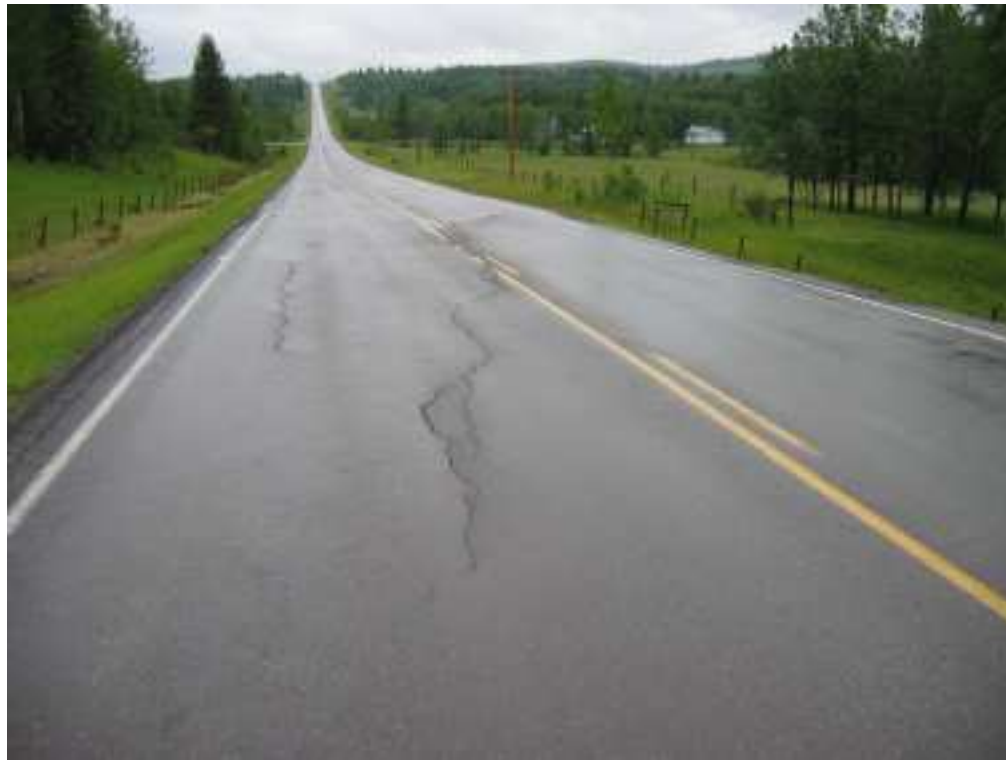
Photo S10(C)-1 (upper left) – June 2005 – facing north across recent cracking that extends in an arc from the east shoulder to the southbound lane. The center of the cracking is approximately 45 m north of the culvert below the road.

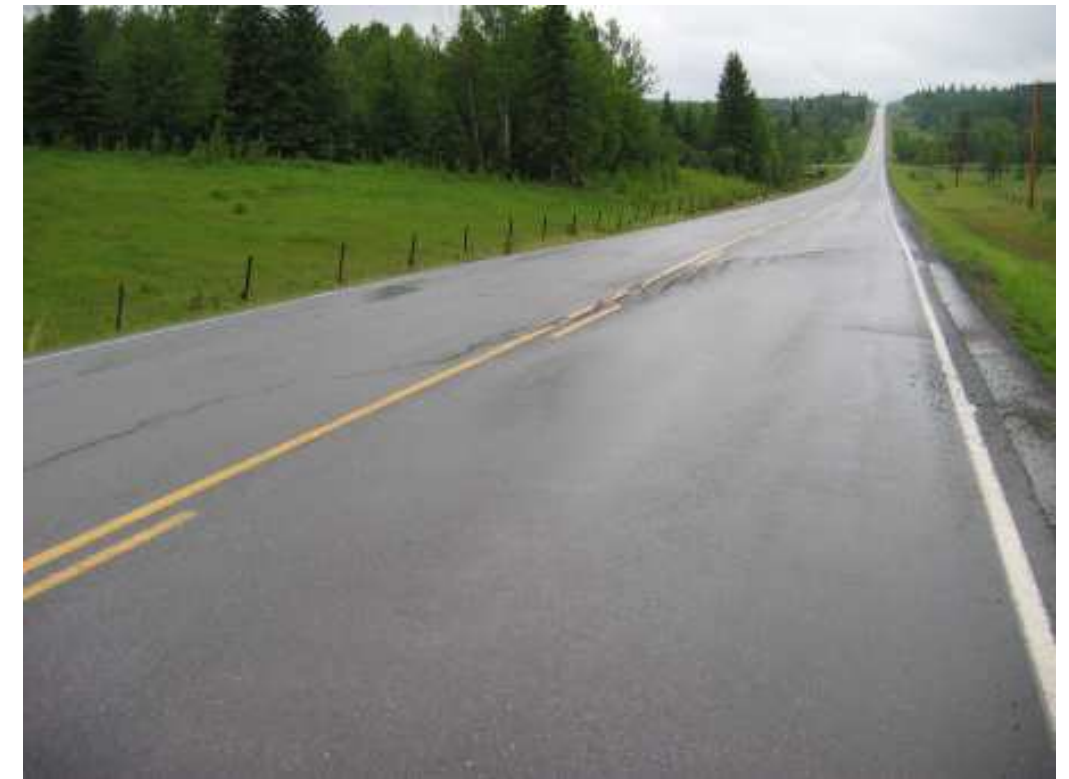
Photo S10(C)-2 (upper right) – June 2005 – facing northwest across the same area shown in Photo S10(C)-1. This view shows the settlement of the southbound lane.

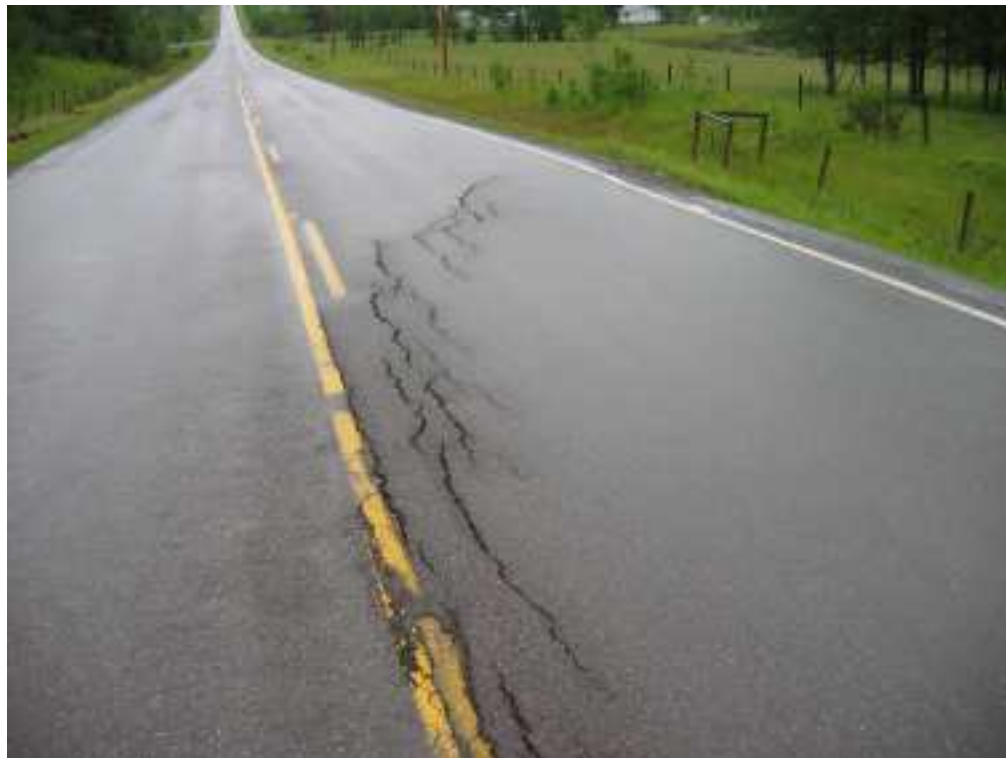
Photo S10(C)-3 (lower left) – June 2005 – closer view of the north end of the cracking and settlement in the southbound lane.

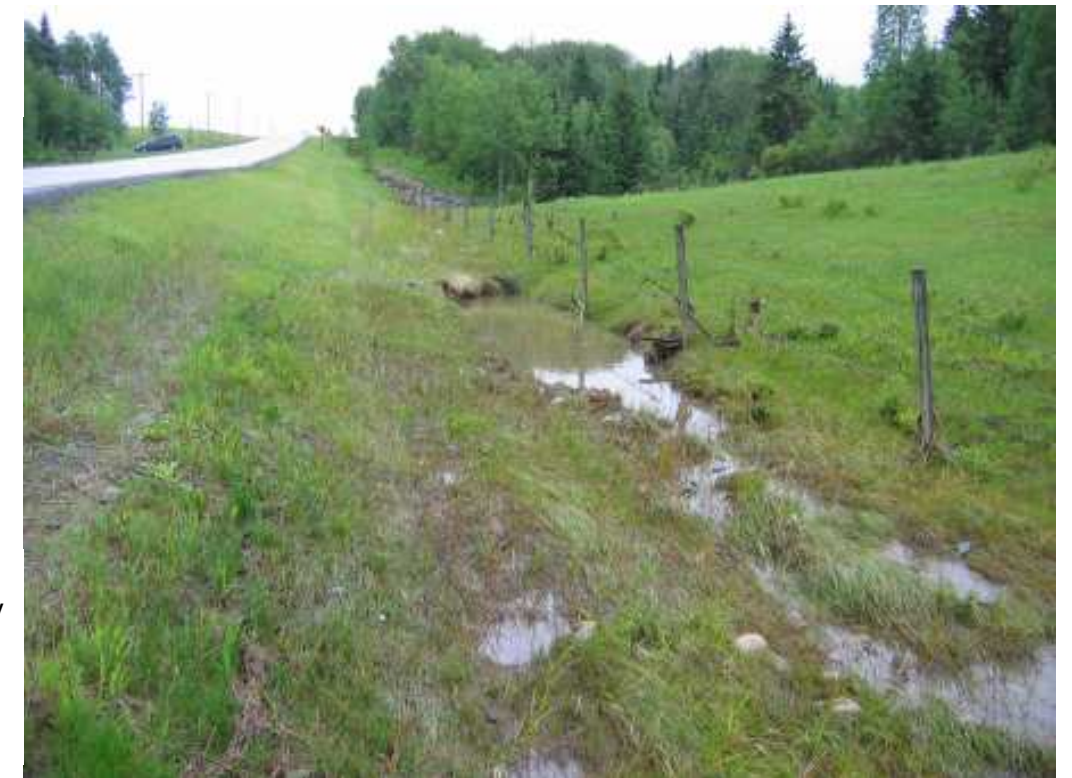
Photo S10(C)-4 (lower right) – June 2005 – Ponded water in the west ditch to the north of the creek culvert following heavy rains in June 2005. The lack of positive drainage along this segment of the ditch has been identified as an issue in previous inspections.

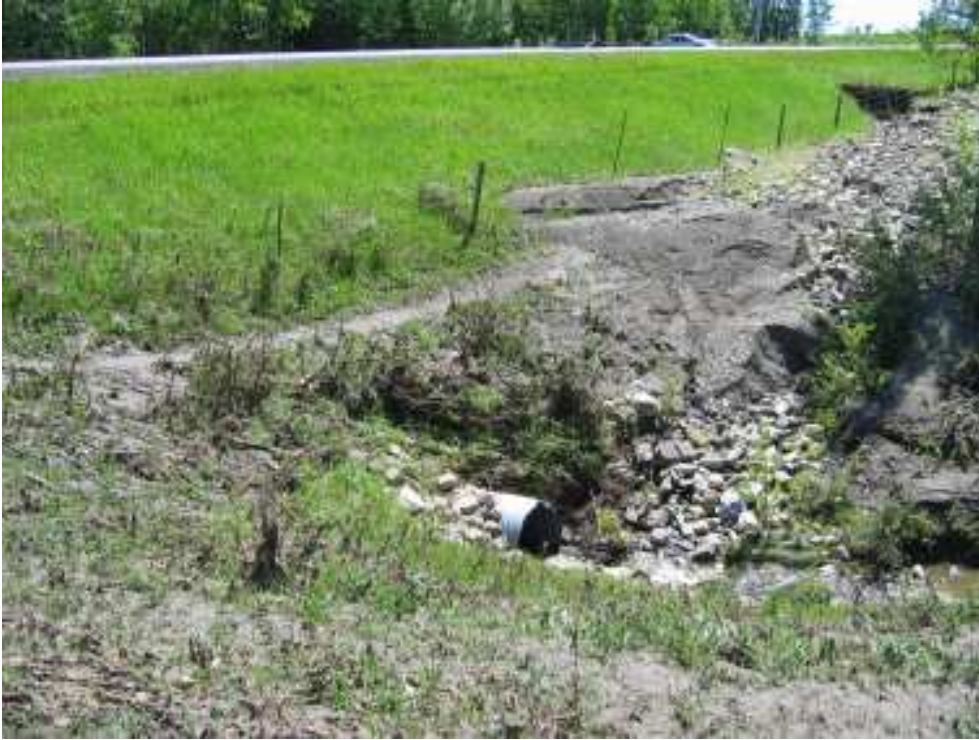
Photo S10(C)-5 (above) – June 2005 – erosion damage in west ditch, south of the culvert.
