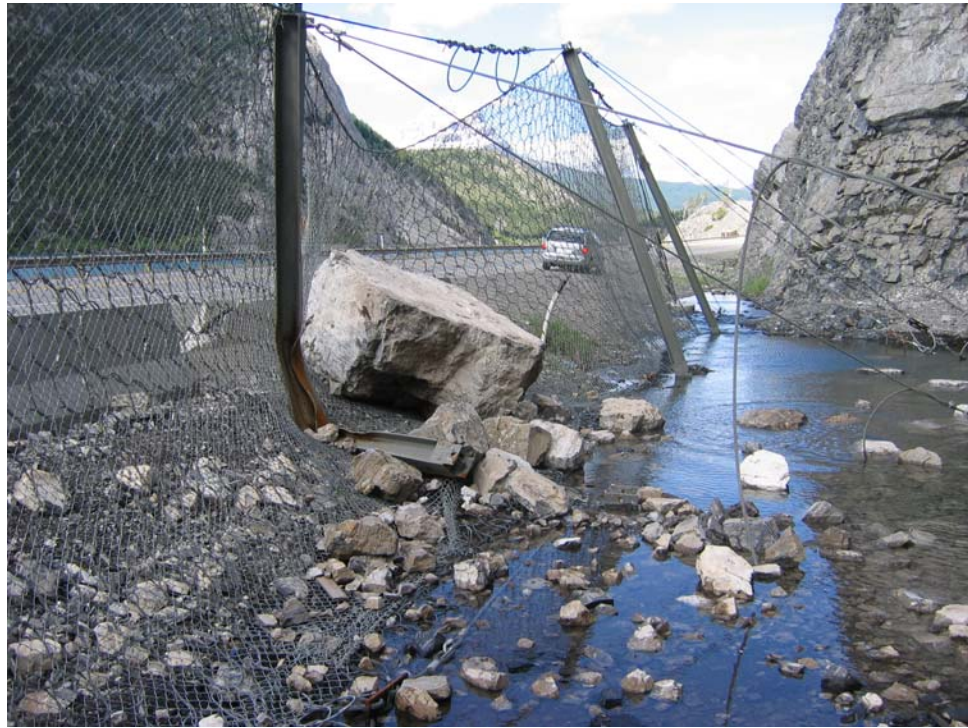
**Photo S15-1** (upper left) – May 2006 – boulder from April 2006 rockfall event that struck and destroyed one of the support posts but was retained by the barrier.

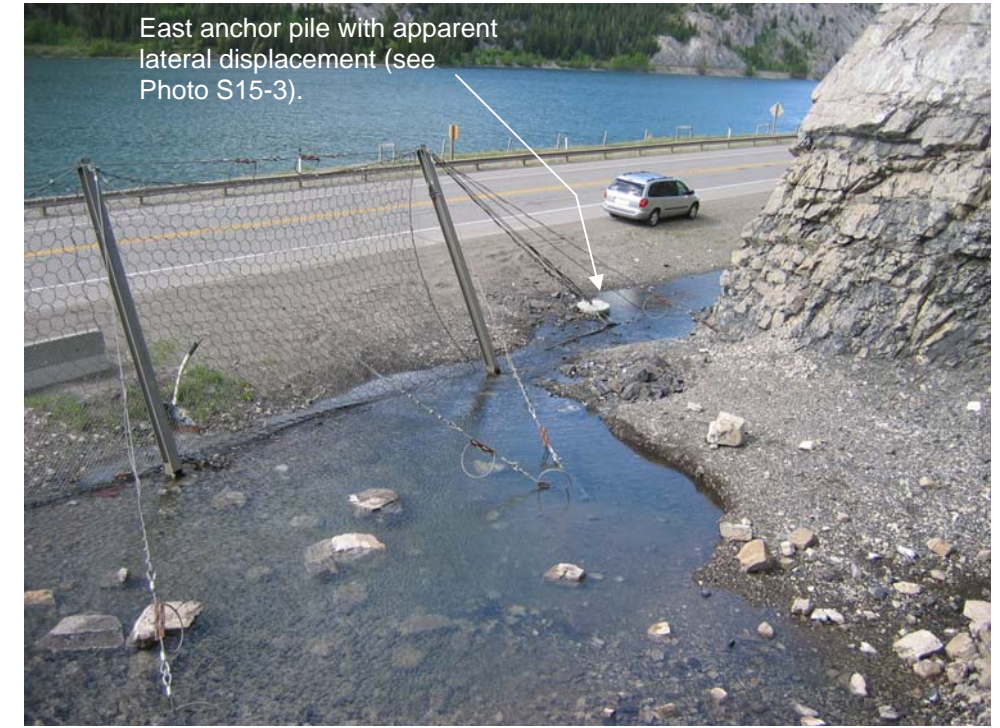
**Photo S15-2** (upper right) – May 2006 – facing downslope towards the rockfall barrier. Note the seasonal accumulation of standing water around the barrier, due to groundwater discharge from the rock cut slope.

East anchor pile with apparent lateral displacement (see Photo S15-3).

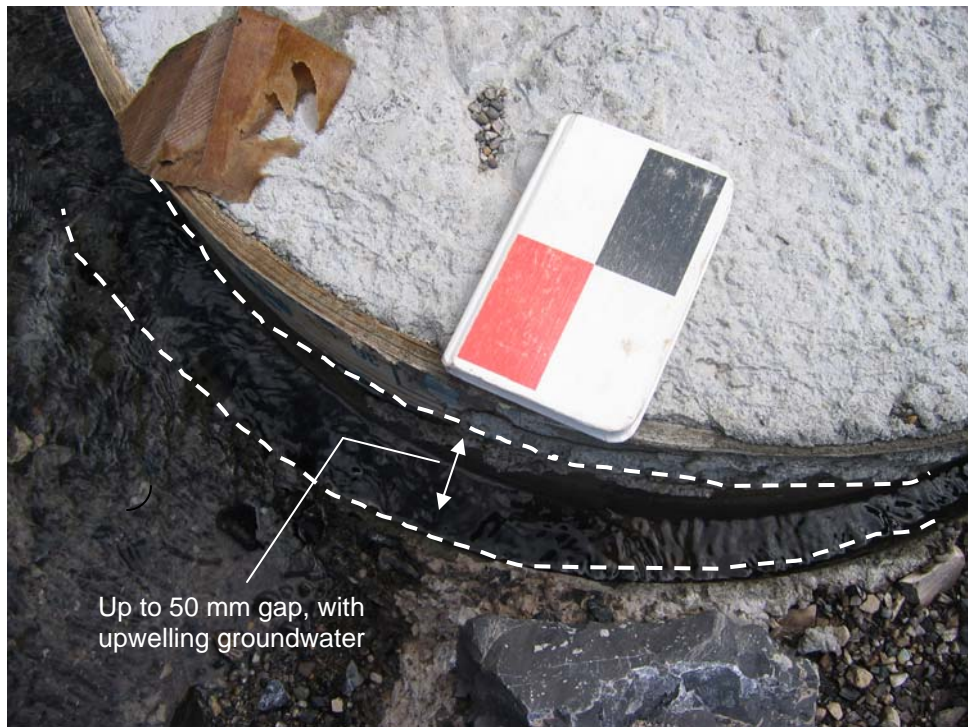
**Photo S15-3** (lower left) – May 2006 – open gap along the east side of the east anchor pile for the barrier. It appeared that the pile had been pulled towards the west with up to approximately 50 mm lateral displacement at ground surface. It also appeared that there was groundwater discharge upwelling around the pile at the time of the inspection.

Up to 50 mm gap, with upwelling groundwater
