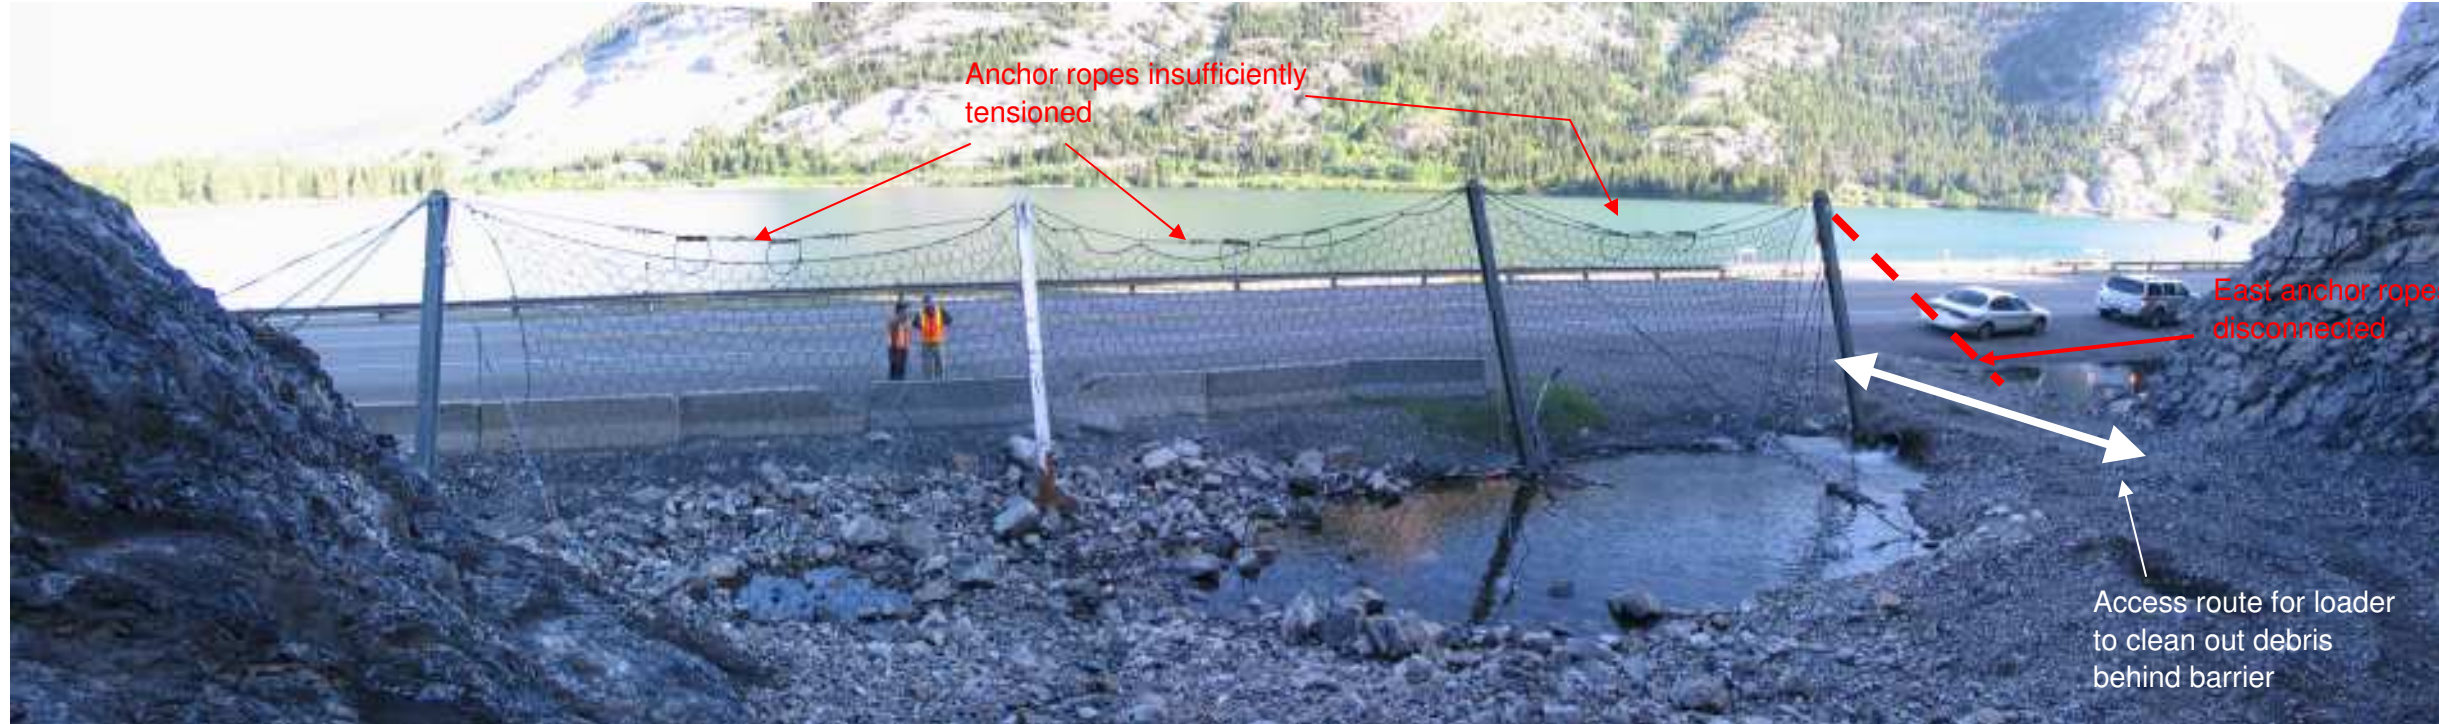
Photo S15-1 – June 2007 (top)

Facing downslope towards the rockfall barrier net. Note the ponded water behind the barrier net. The east anchor ropes have been left disconnected after the most recent clean-out of the debris behind the barrier.

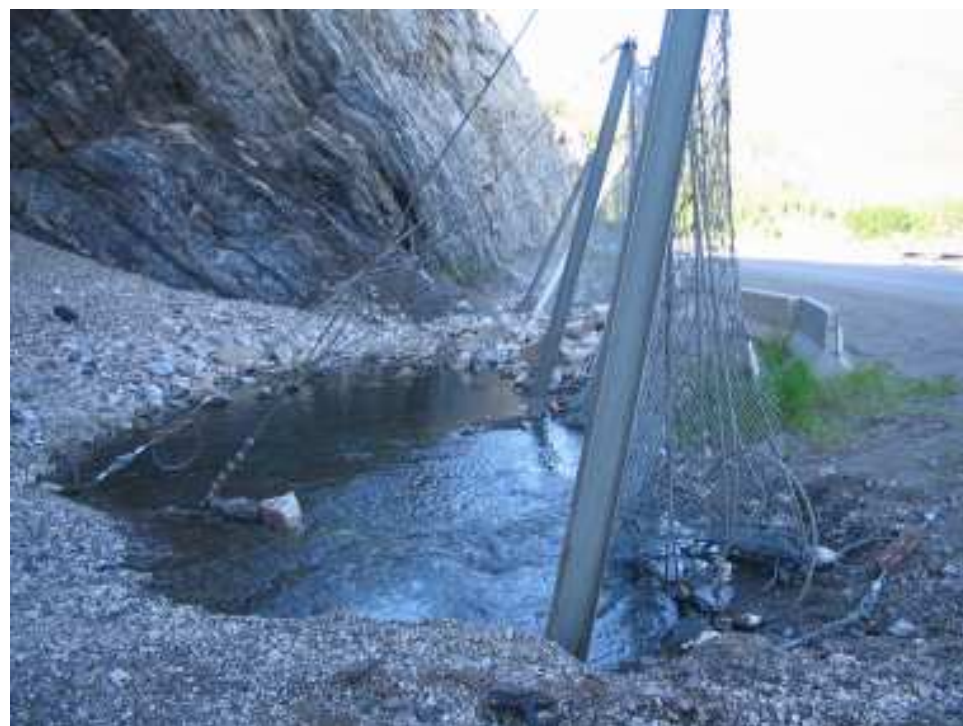
Photo S15-2 – June 2007 (lower left)

Facing west along the barrier net. Note the ponded water behind the net and the accumulation of rockfall debris since the most recent cleaning approximately 3 weeks prior to this photo being taken.

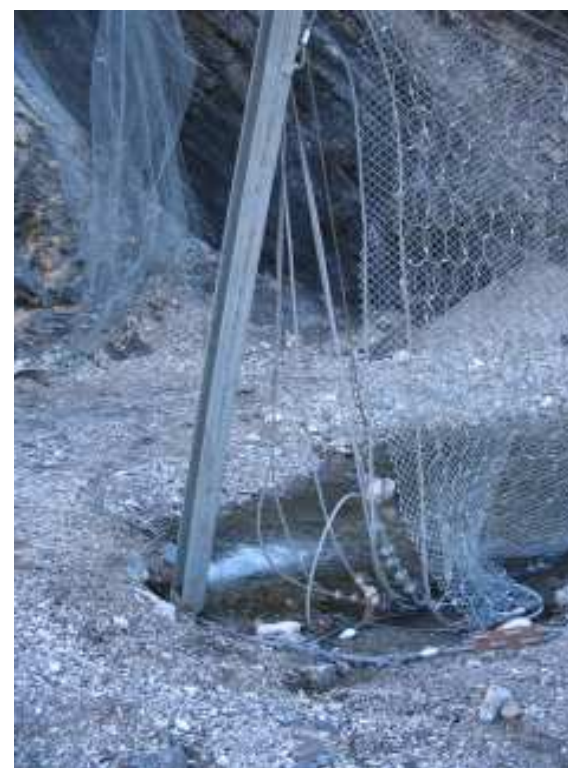
Photo S15-3 – June 2007 (lower right)

Closer view of the disconnected east anchor ropes.

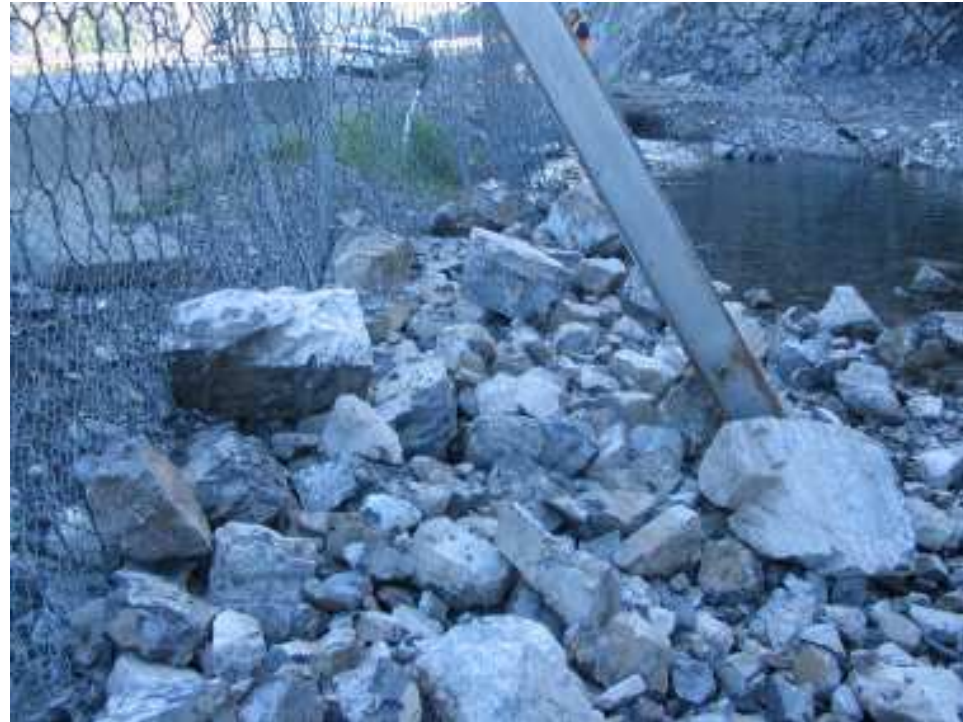
Photo S15-4 – June 2007 (upper left)
Rockfall debris that has accumulated around the base of one of the barrier support posts. This post also appeared to be leaning too far forwards, compared to design angle of 15° from vertical.

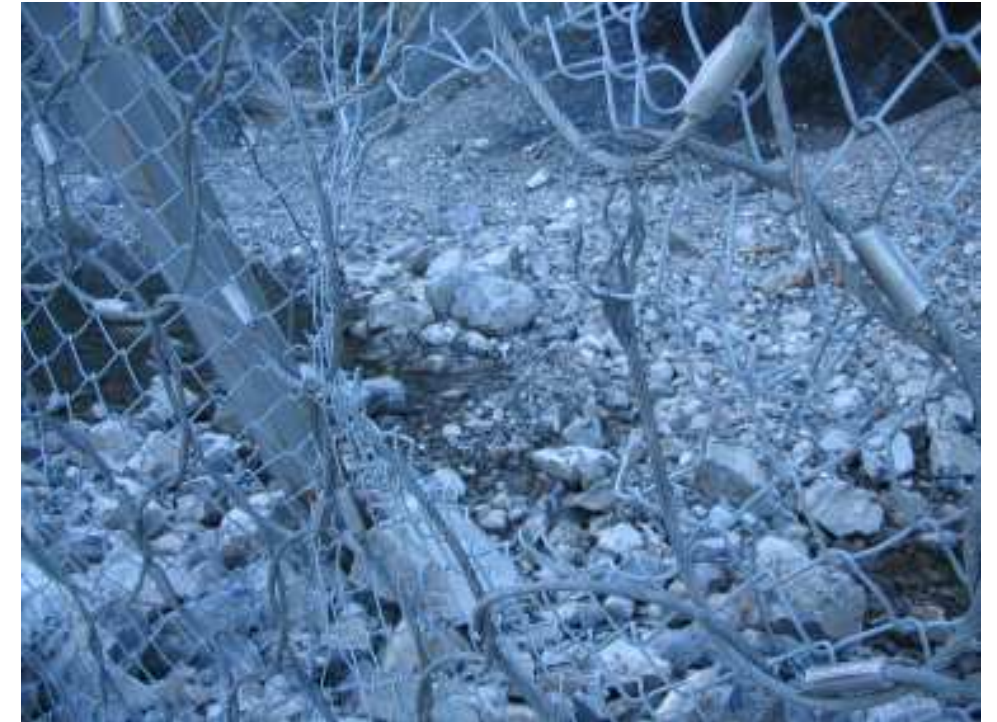
Photo S15-5 – June 2007 (upper right)
Severed seam rope and apparent missing barrier net ring(s) around the barrier post shown in Photo S15-4.

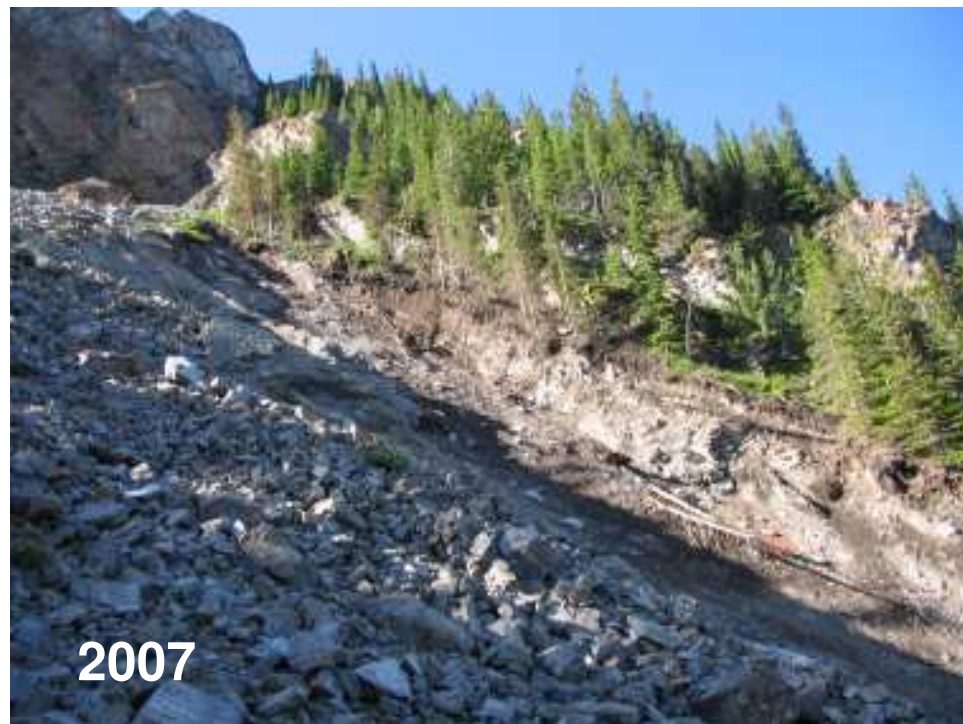
Photo S15-6 – June 2007 (lower left)
The gully headwall on the slope above the barrier net. This headwall has eroded and expanded in recent years. Compare with Photo S15-7 that shows the same area as it appeared in September 2003.

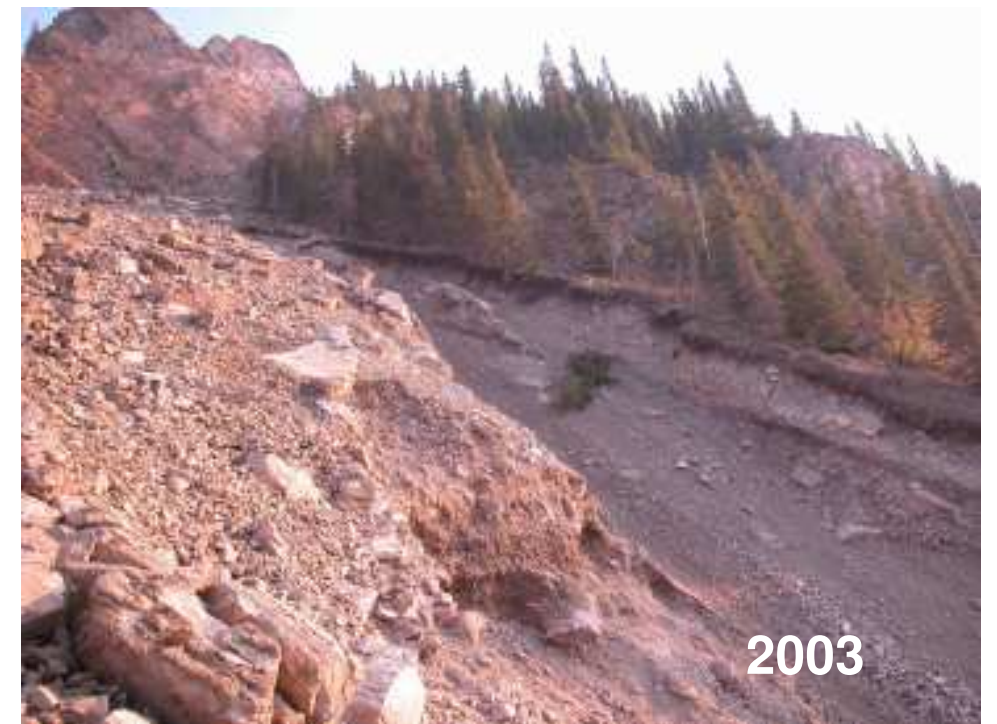
Photo S15-7 – September 2003 (lower right)
The gully headwall on the slope above the road as it appears in September 2003.
