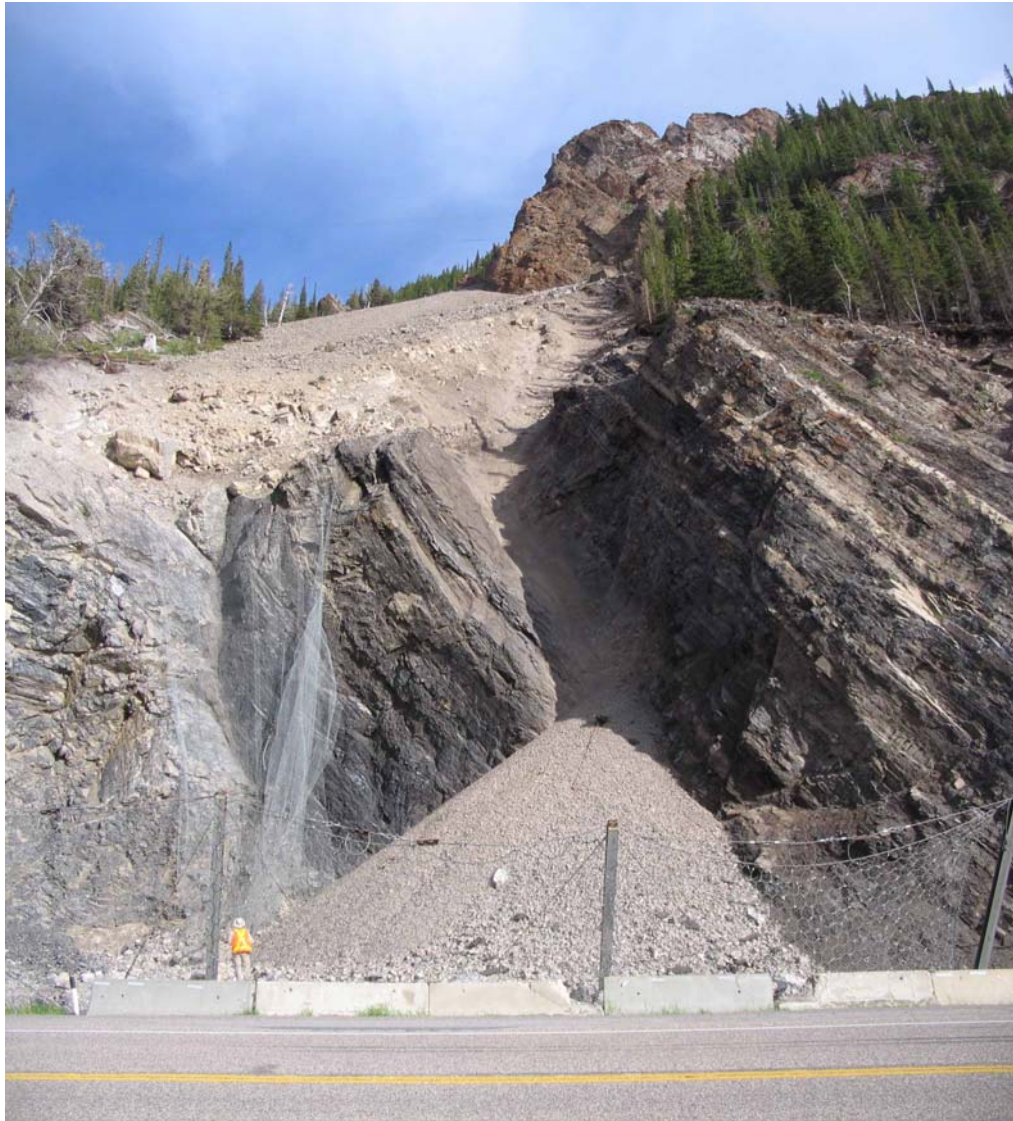
Photo S15-1 – June 2008

Facing upslope at the barrier net and towards the rockfall source area on the slope above the highway. Note the extremely large volume of accumulated debris behind the net, which could allow a rockfall to bounce and roll all the way to the net without first losing kinetic energy by bouncing on the ground between the net and the gully outlet.

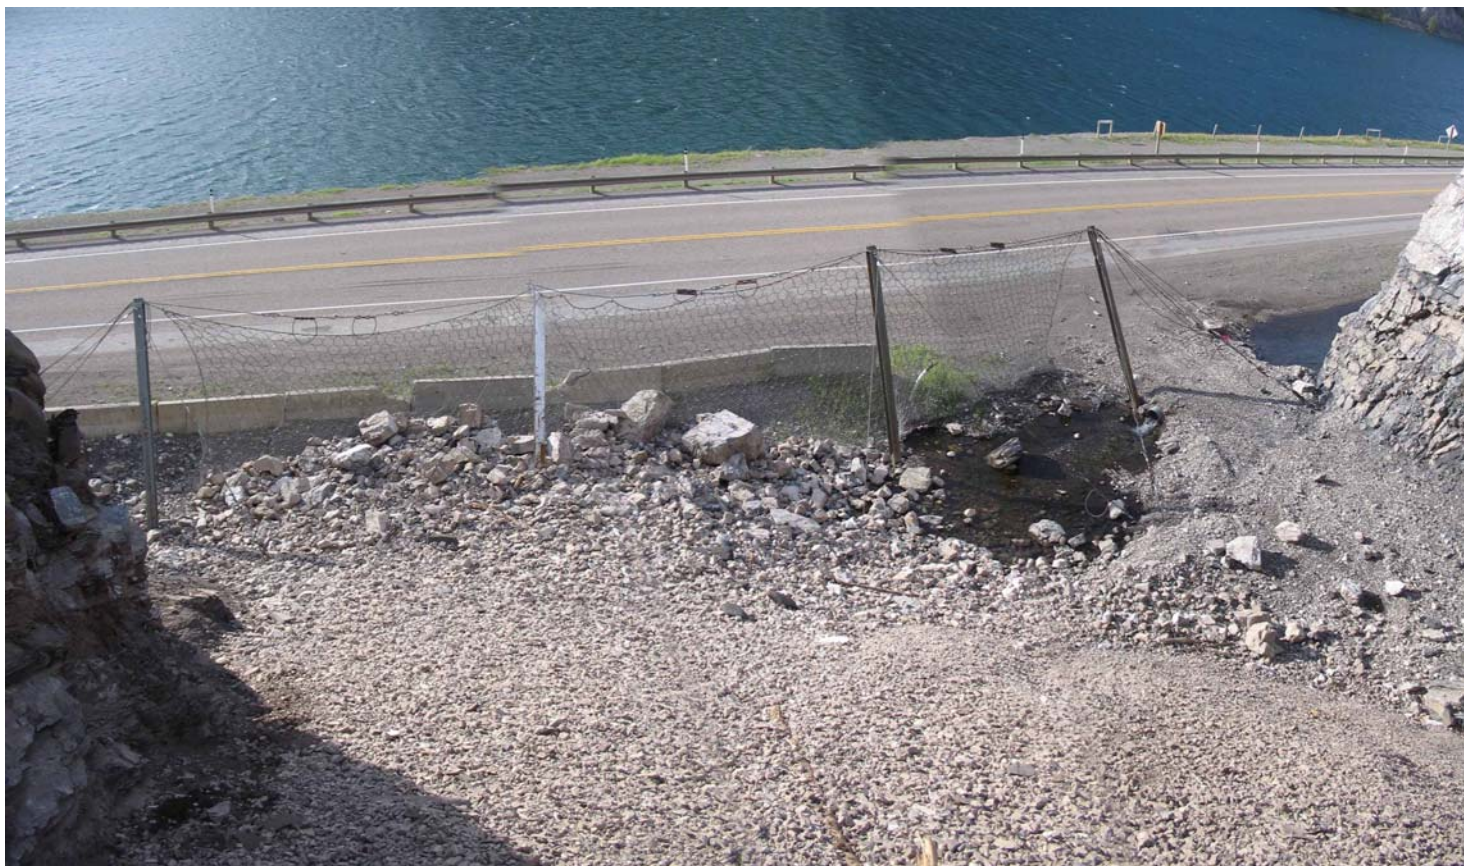
Photo S15-2 – June 2008

Facing downslope from the apex of the rockfall debris cone behind the barrier net. Note the large rocks that have accumulated on the net itself. These are from large rockfall events (but within the design capacity of the barrier net if the net is properly maintained) that have fallen over the past year.

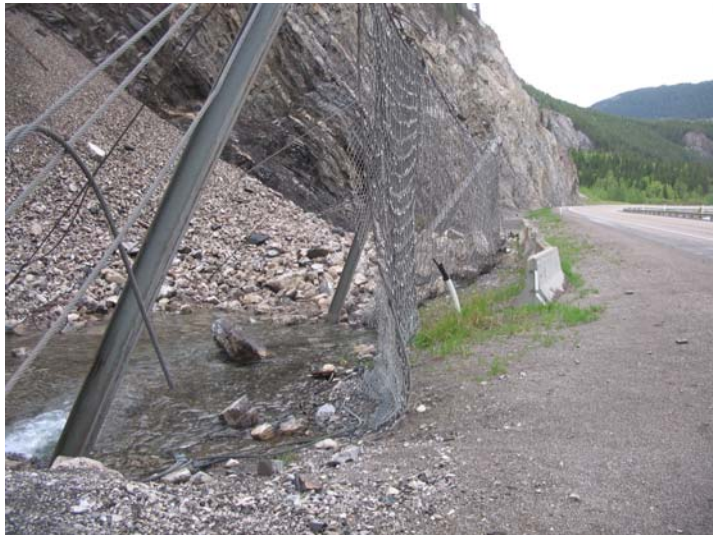
Photo S15-3 – June 2008 (left)

Facing west across the barrier net. Note how the lack of tension in the lower seam cable has allowed the net to bulge outwards towards the highway. Also note how the toe of the debris cone is encroaching onto the net.

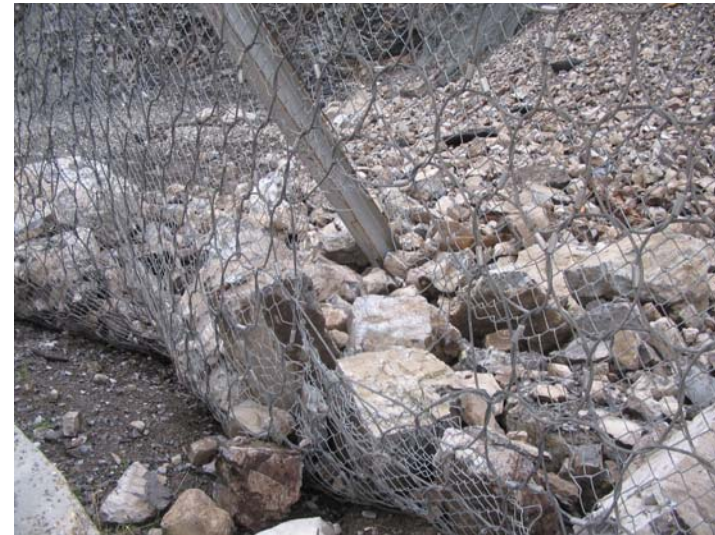
Photo S15-4 – June 2008 (right)

Closer view of the debris cone encroaching onto the net, in proximity to a gap in the ring net that could allow rocks to roll and fall through the net and onto the highway. The ring net can be repaired by replacing the individual broken rings, as per the inspection and maintenance procedures listed in the manufacturer's guidelines for the barrier net.
