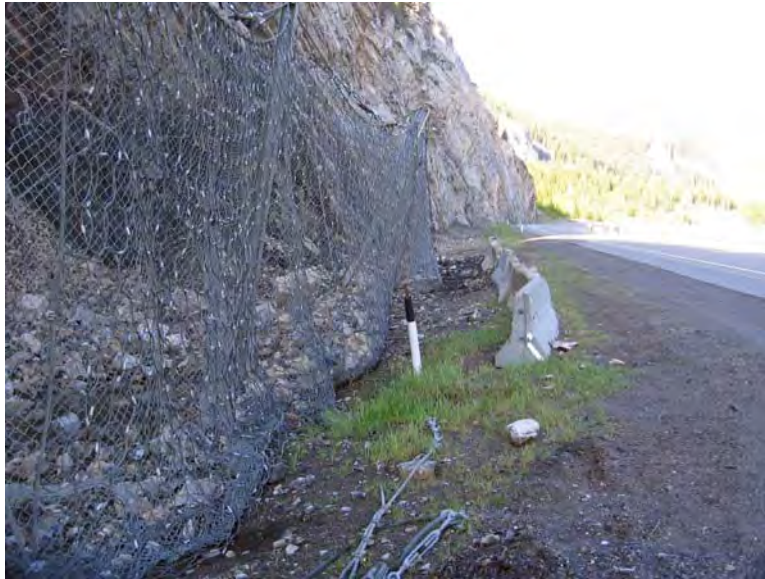
Photo S15-1 – June 2009

Looking west along the barrier net. The net is in fair condition, however a post is bent and a braking element has been activated (Photo S15-2) in the spring of 2009. The debris cone has been cleaned out recently.

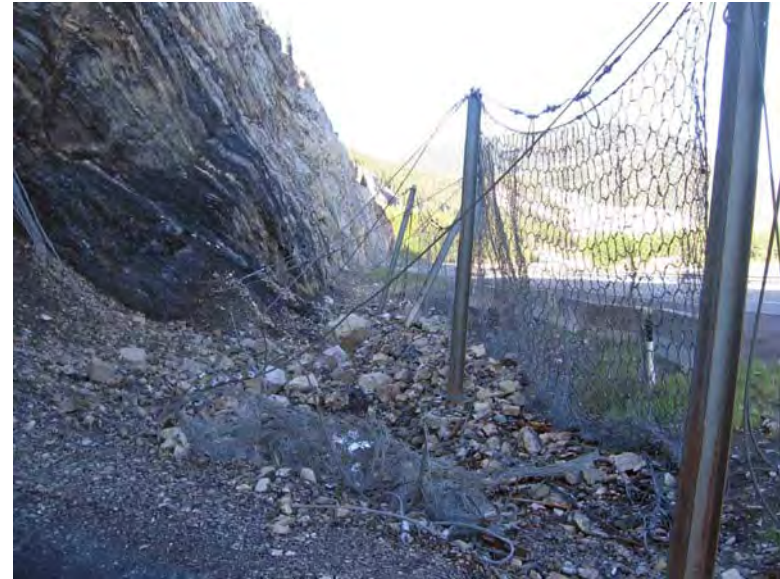
Photo S15-2 – June 2009

Looking west along the barrier net. The second last post has been struck by a rock and is bent, and an anchor cable has an activated braking element.

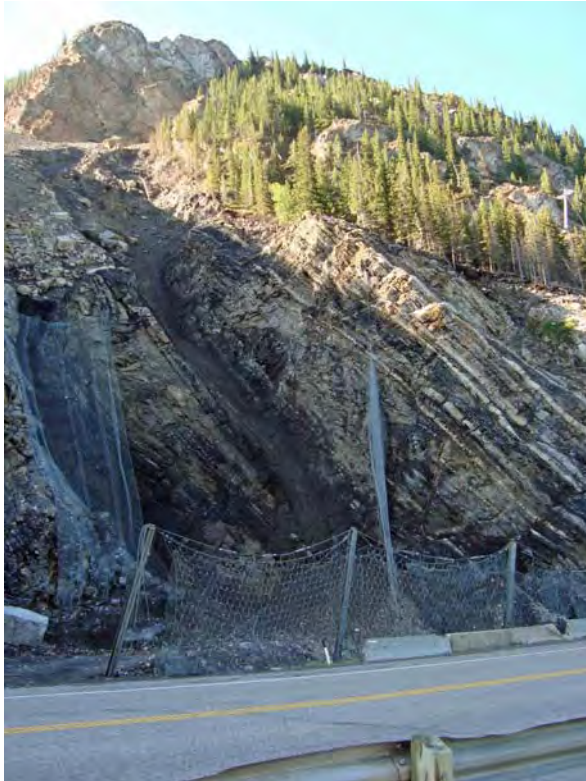
Photo S15-3 (top left) – June 2009
The gully erosion in the talus slope above the net has expanded since the 2008 inspection (the left gully fork). Compare with Photo S15-5.

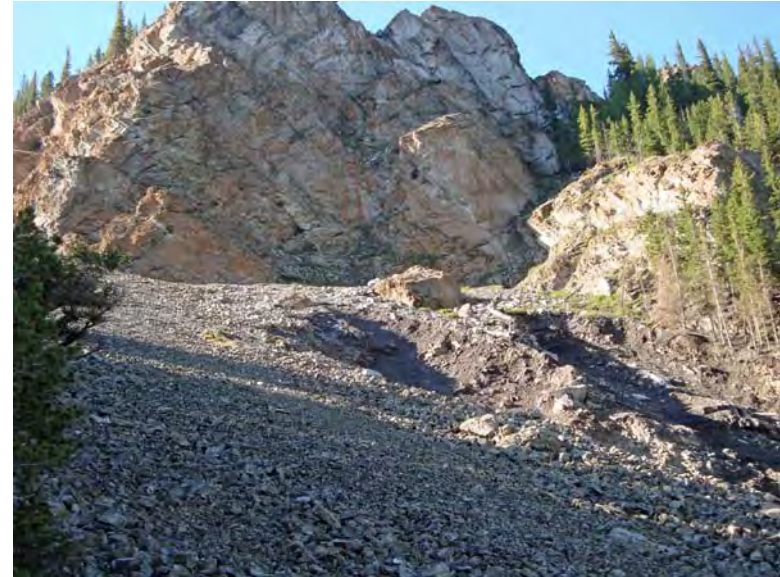
Photo S15-4 (top right) – June 2009
A close-up view of the new gully fork that is developing in the upper portion of the talus slope.

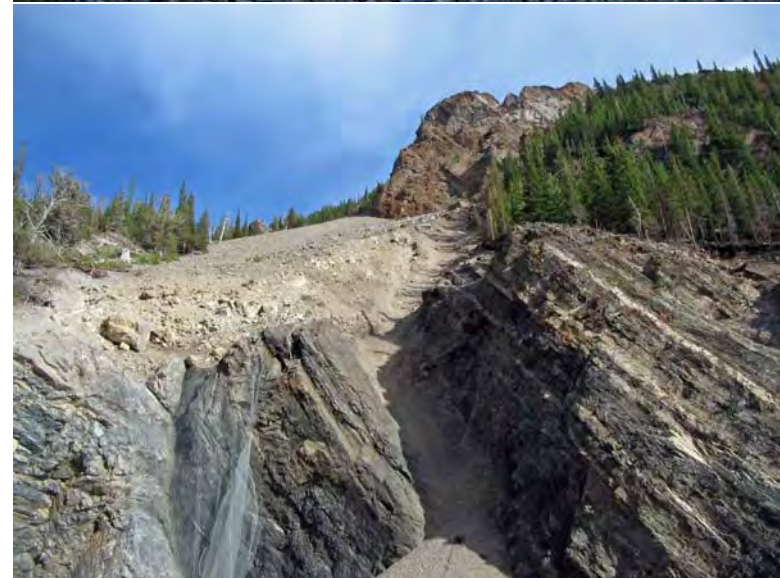
Photo S15-5 (right) – June 2008
A photo from June 2008 of the talus slope for comparison.

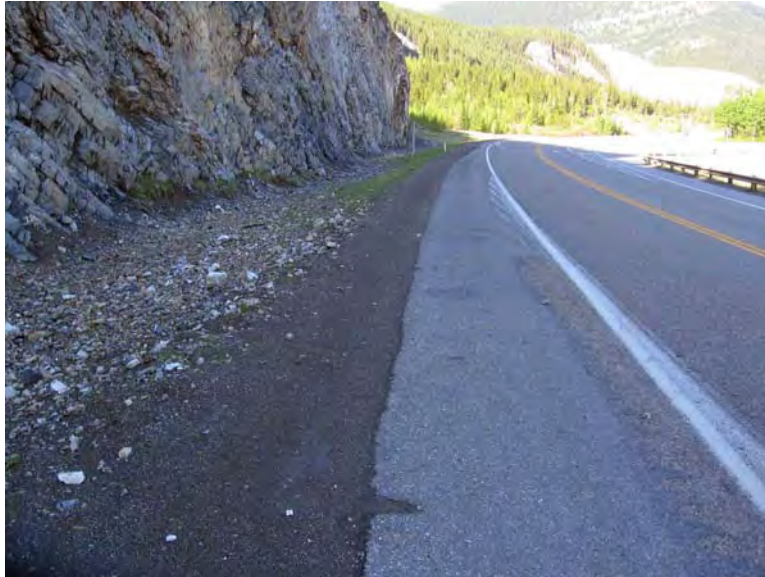
Photo S15-6 – June 2009

Looking west along the road edge from west of the barrier net. Rockfall has continued and consists of gravel to cobble sized rocks that are mostly contained in the ditch. Some rocks land on the road edge.

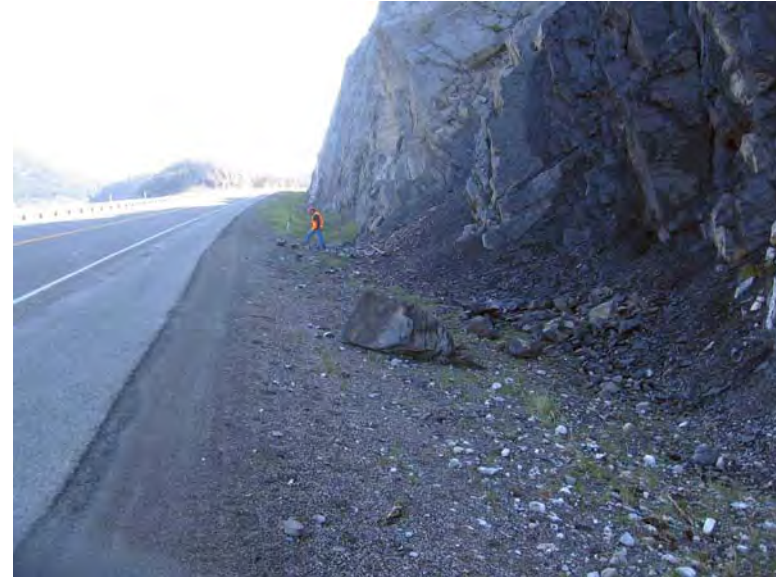
Photo S15-7 – June 2009

Looking east along the road edge from east of the barrier net. Note the large boulder (0.9x0.8x0.6 m) that has recently fallen into the ditch.
