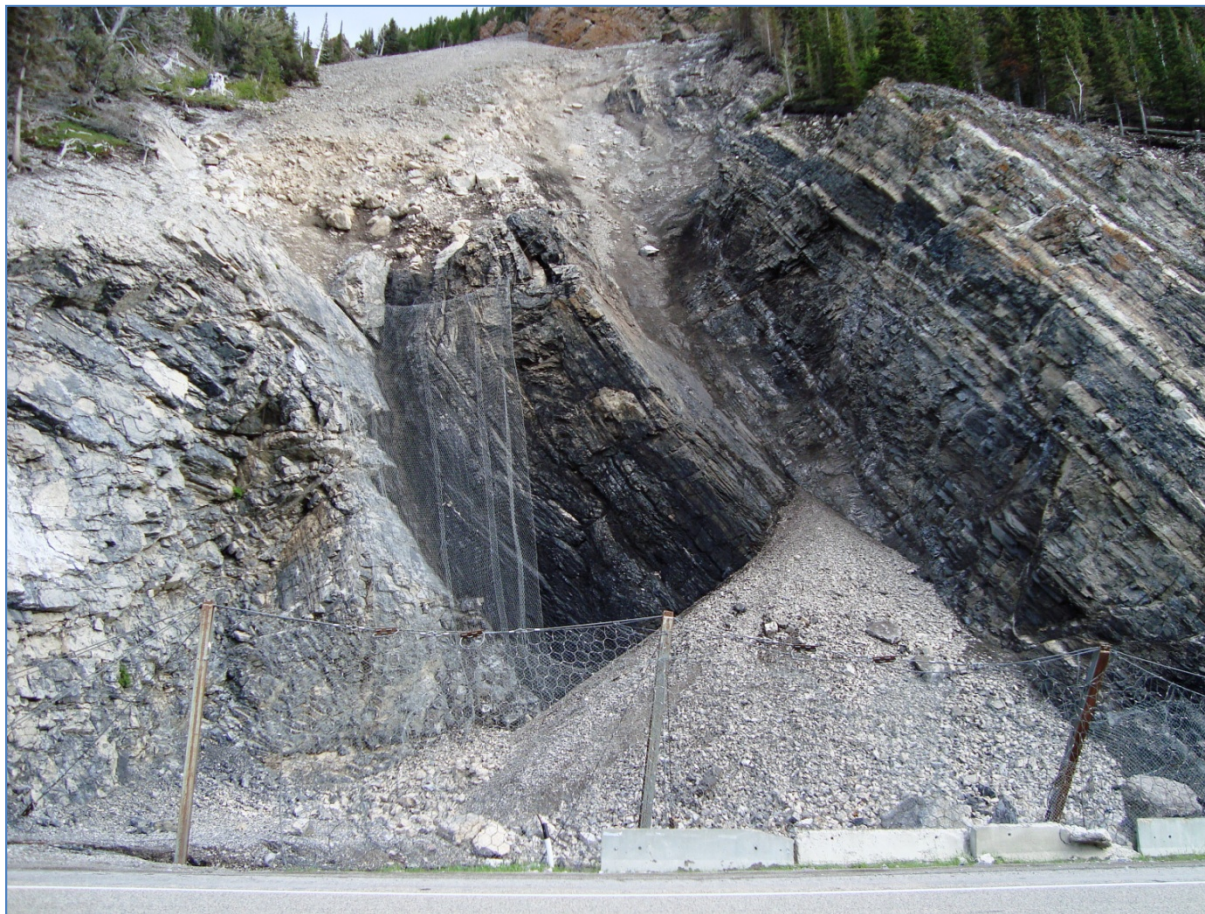
**Photo S15-1 (June 2011) –**

Facing south towards the barrier net and talus slope. The debris cone was large at the time of the inspection. The barrier net has been damaged with several of the braking elements activated. The net is repairable, but is nearly ineffective in its current state.

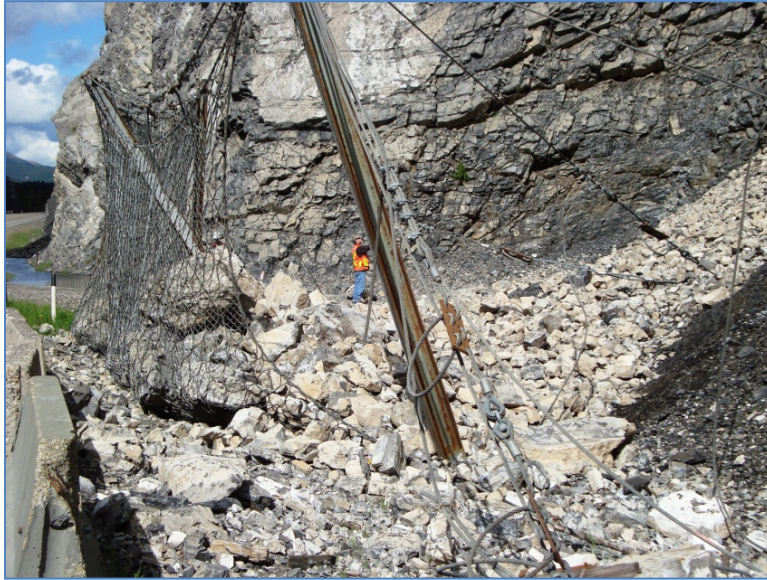
**Photo S15-2 (June 2011) –**

Facing east along the barrier net and jersey barriers. The large rocks that have come to rest behind the net have pushed the net outwards towards the road. The increased damage to the jersey barriers indicate that large rocks continue to strike the net and barriers. The rocks on the road shoulder (adjacent to the left edge of this photo) indicate that gravel to cobble sized rocks are passing through or over the net, and likely landing on the road as well.

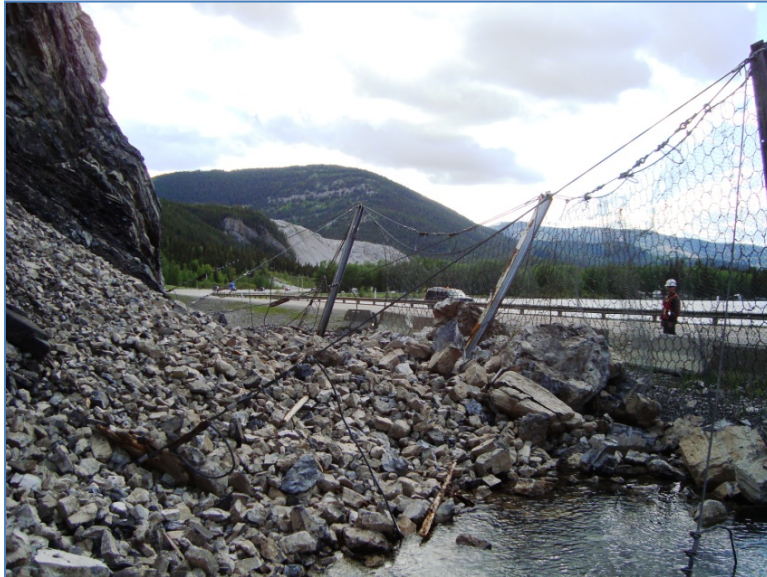
**Photo S15-3 (June 2011) –**

Facing west along the barrier net. The largest rock in the debris pile was approximately 6 m<sup>3</sup>.

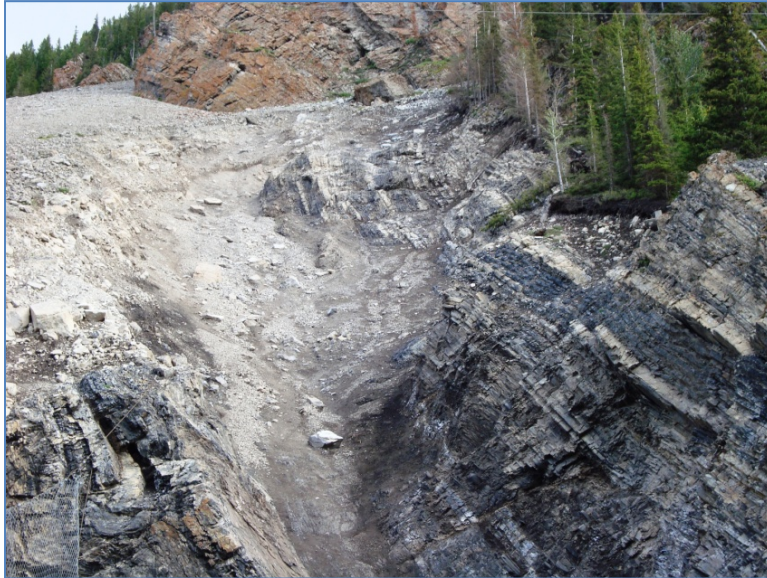
**Photo S15-4 (June 2011) –**

The upper gully in the talus slope has expanded towards the cliff face. The gully appears to have retrogressed slightly since the June 2010 inspection.

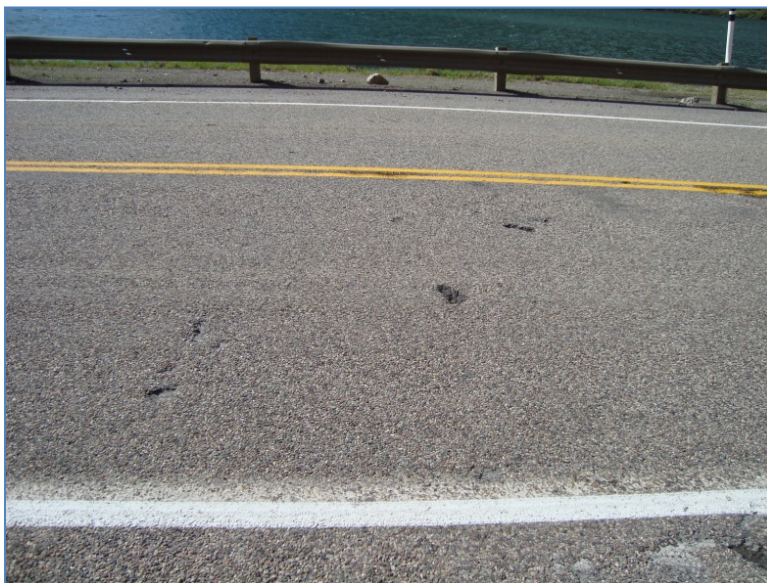
**Photo S15-5 (June 2011) –**

Damage to the road surface is noted, likely due to rock strikes that have come through or over the barrier net. The guardrail was also dented, apparently from rock strikes.

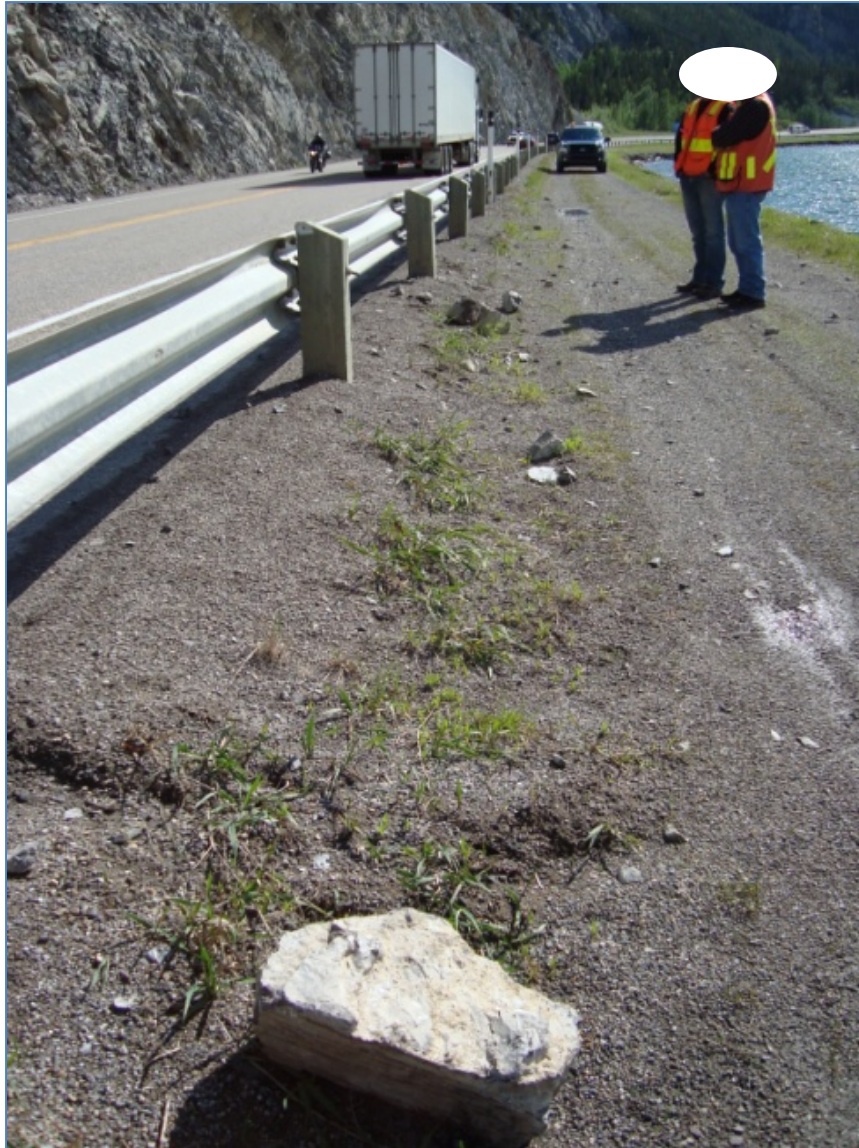
**Photo S15-6 (June 2011) –**

Facing towards the southwest at the guardrail. The rock in the foreground, weighing approximately 10 kg, apparently landed here or was moved to this location after landing on the highway.
