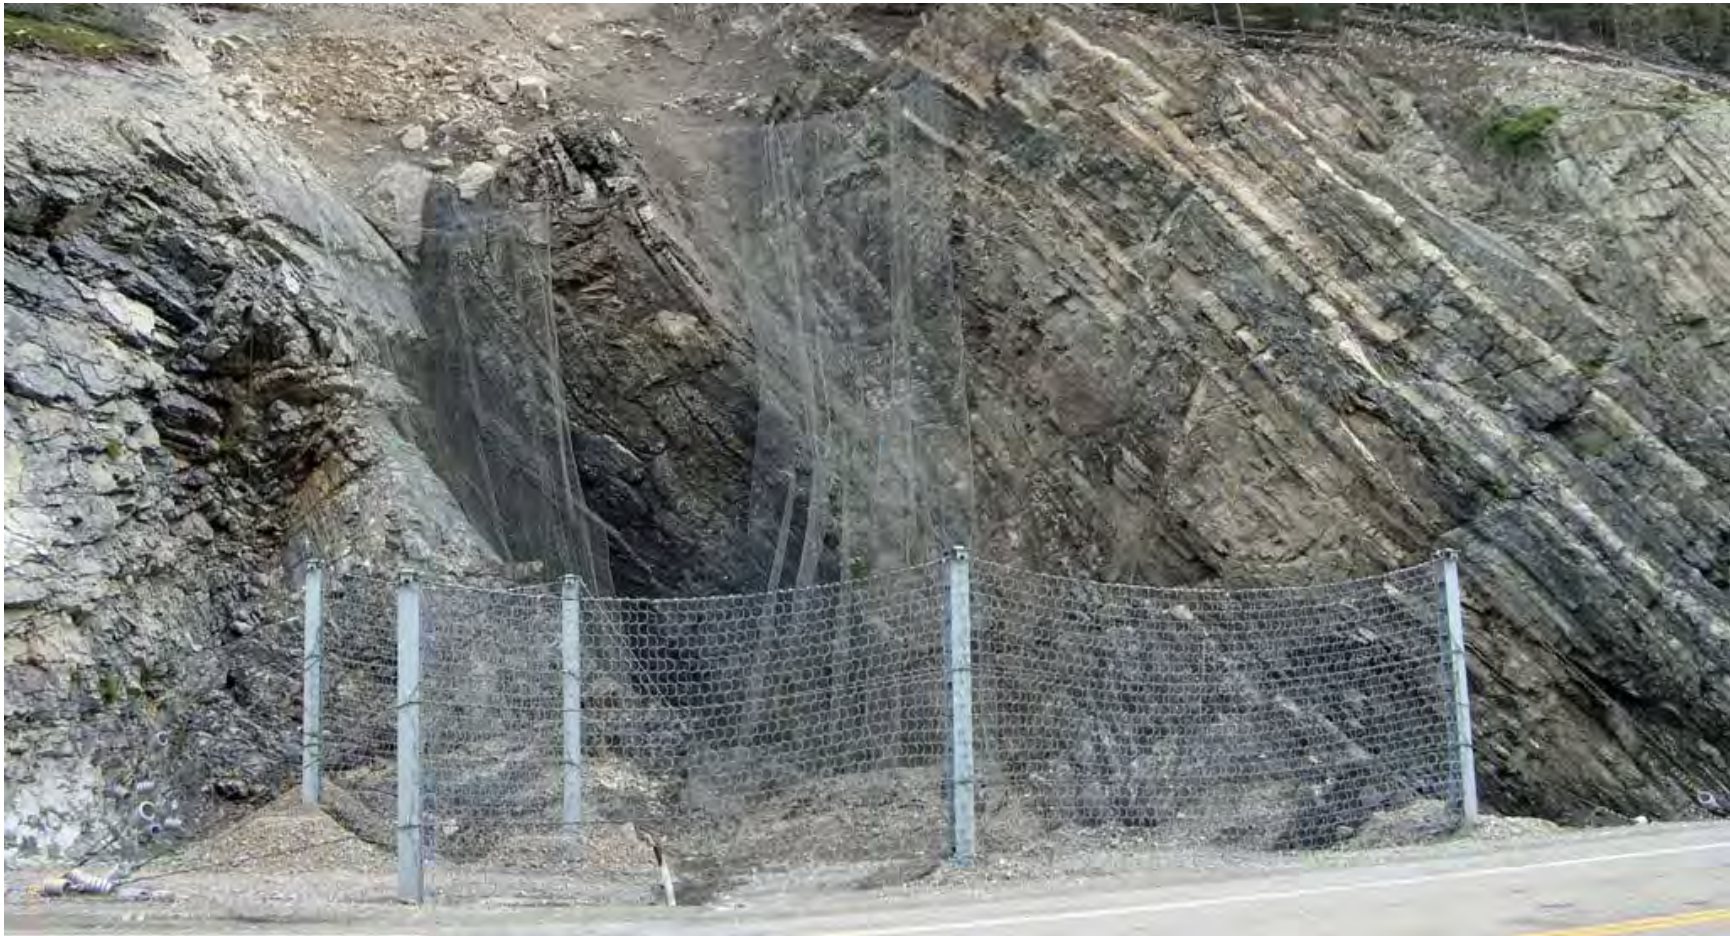
**Photo S15-1 (June 2012) –**

Facing south towards the new barrier net. The previous debris cone has been removed and an additional hanging net has been installed. The barrier net was intact and in good condition during the inspection.

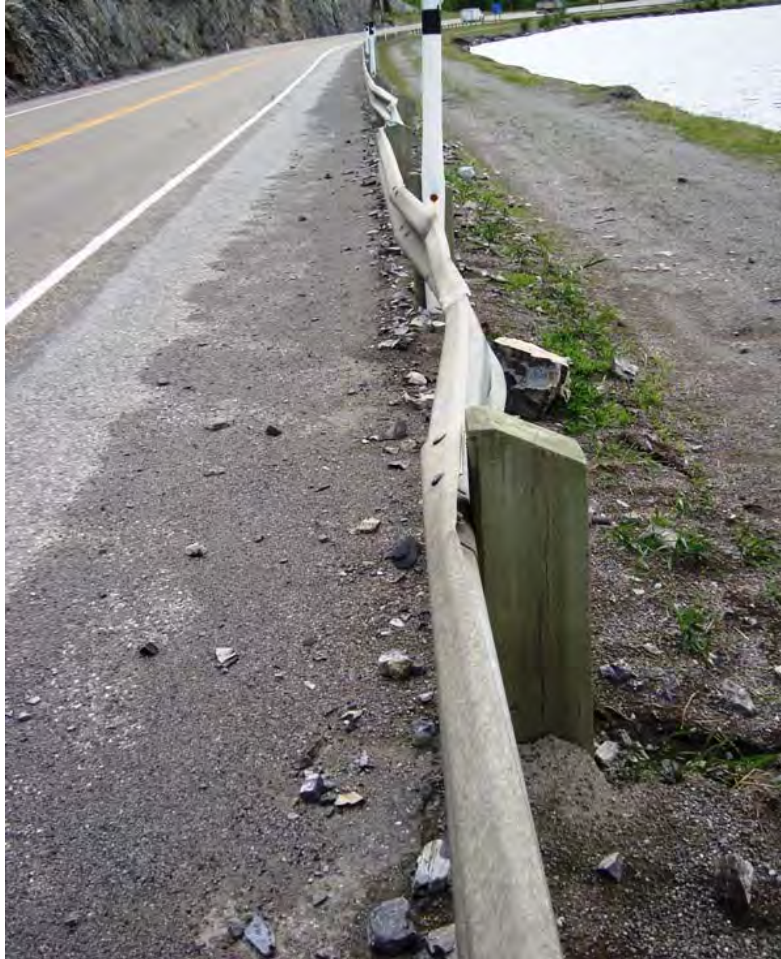
**Photo S15-2 (June 2012) –**  
Facing towards the southwest at the guardrail where impact damage has occurred. Numerous rock fall debris ranging from gravel to cobble size was present along the road shoulder.

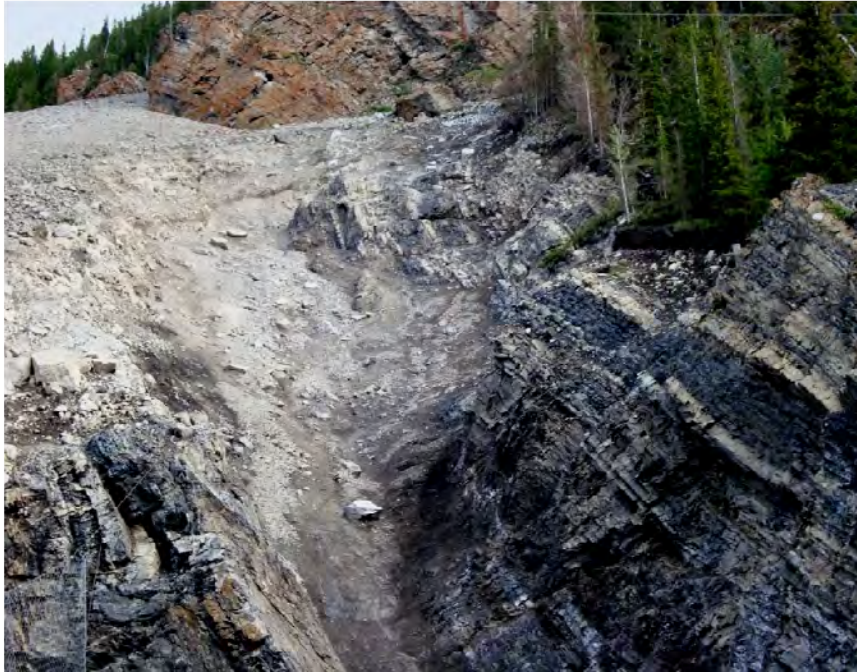
**Photo S15-3 (June 2011)** – The upper gully in the talus slope as observed during the 2011 inspection.

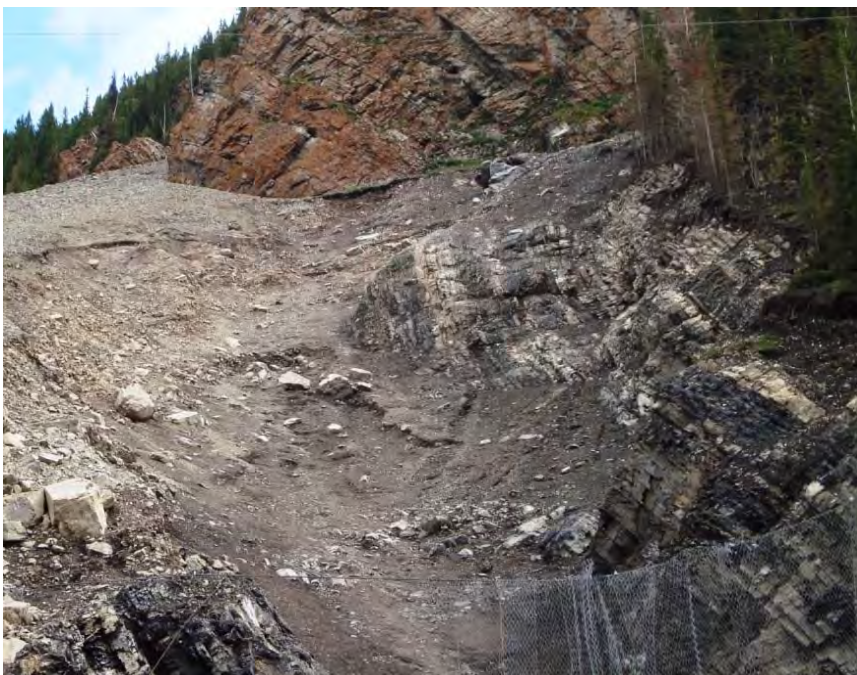
**Photo S15-4 (June 2012)** – The upper gully in the talus slope as observed during the 2012 inspection. It continues to expand toward the cliff face as it appears to have slightly retrogressed since 2011.
