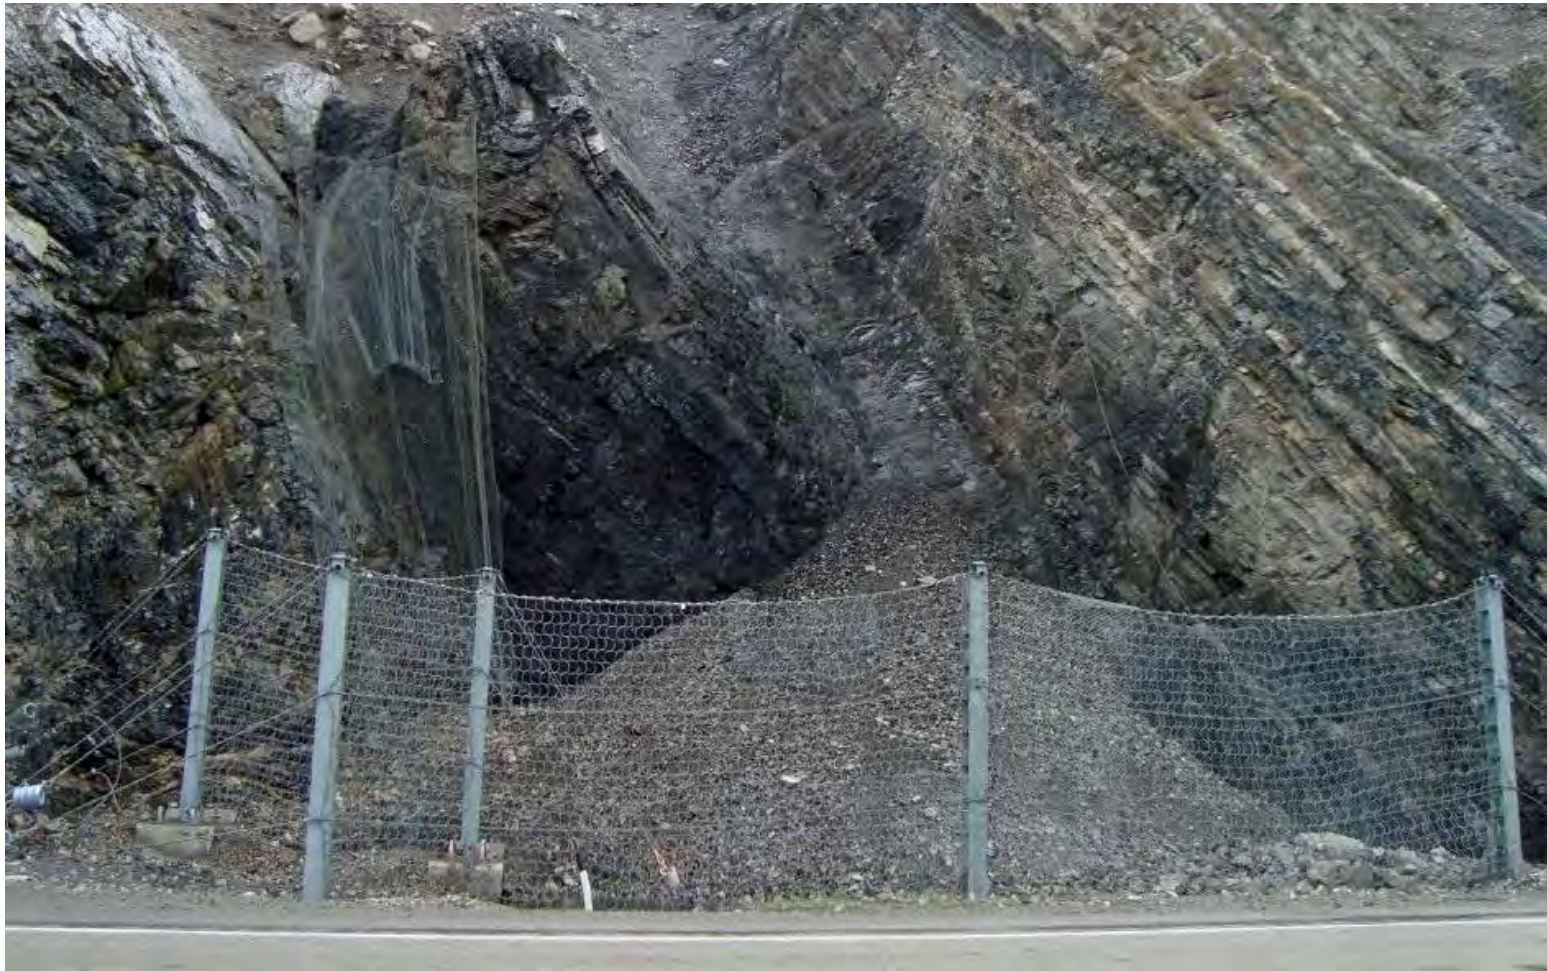
**Photo S15-1 (May 2013) –**

Facing south towards the barrier net. The barrier net was intact and in good working condition during the inspection. A large talus cone of rock debris accumulated behind the net since the 2012 inspection.

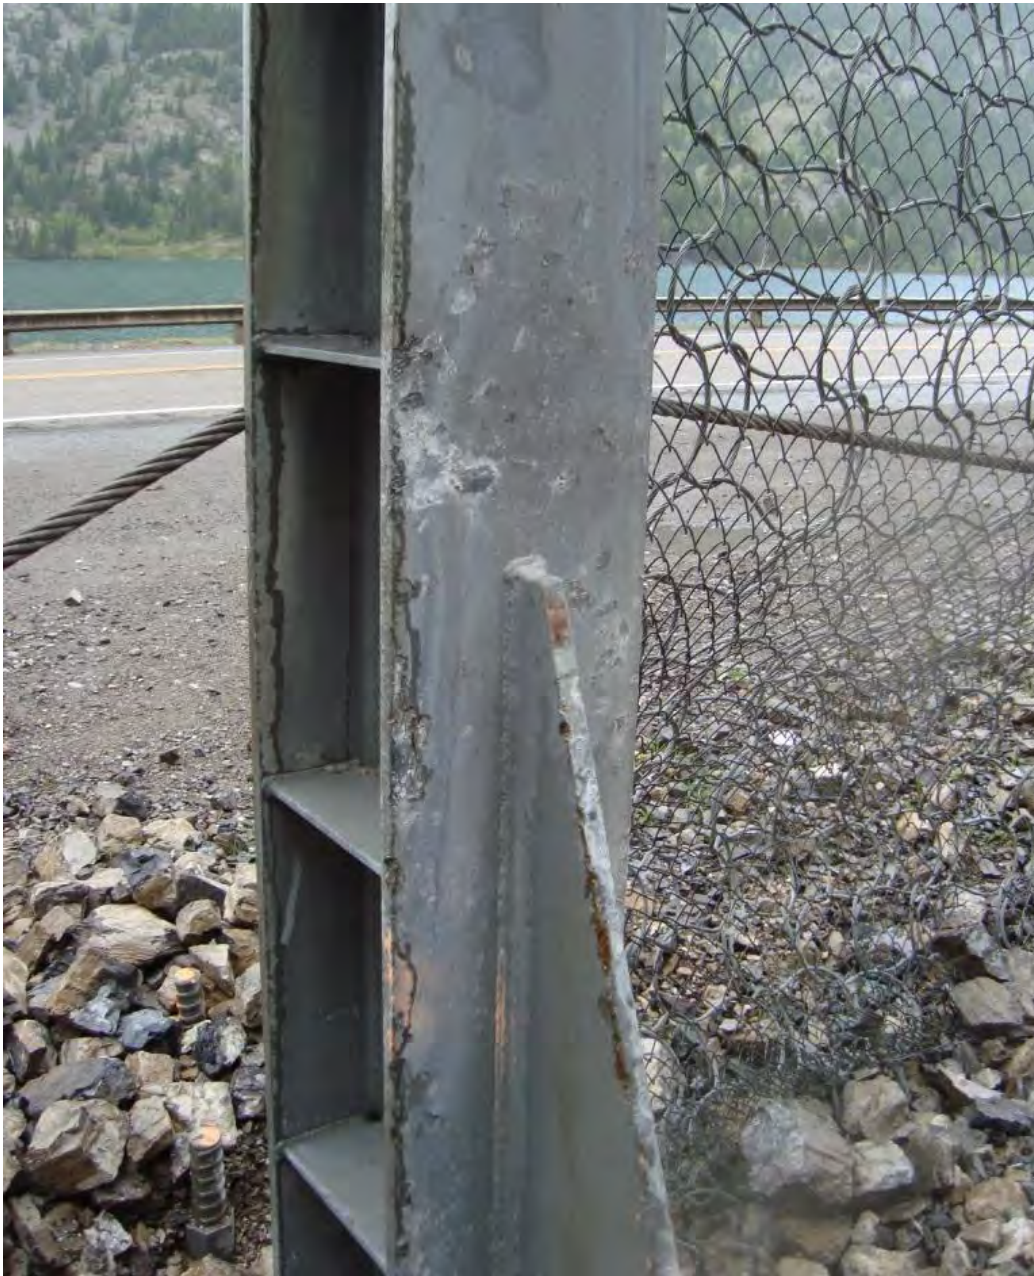
**Photo S15-2 (May 2013) –**  
The support post of the barrier net showing minor damage from rock fall impacts

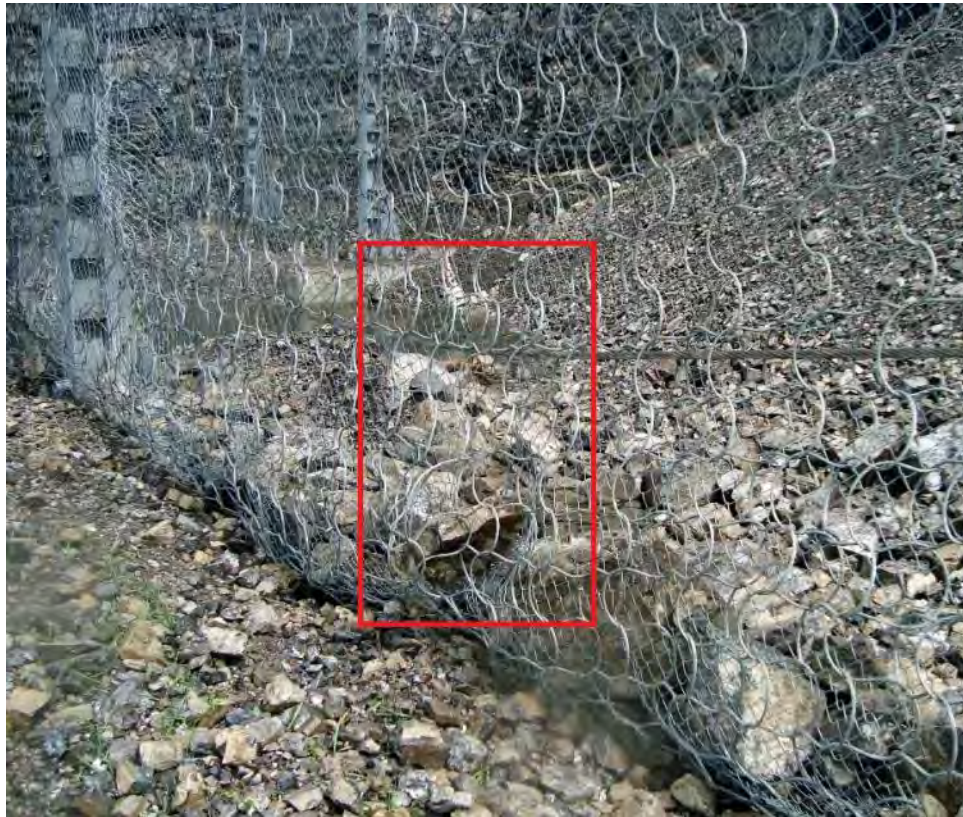
**Photo S15-3 (May 2103)-**

The chain link fence that was placed behind the main cable mesh had numerous holes which allowed the passage of small rocks through it as indicated in red. The larger cable mesh appeared intact with no apparent damage.

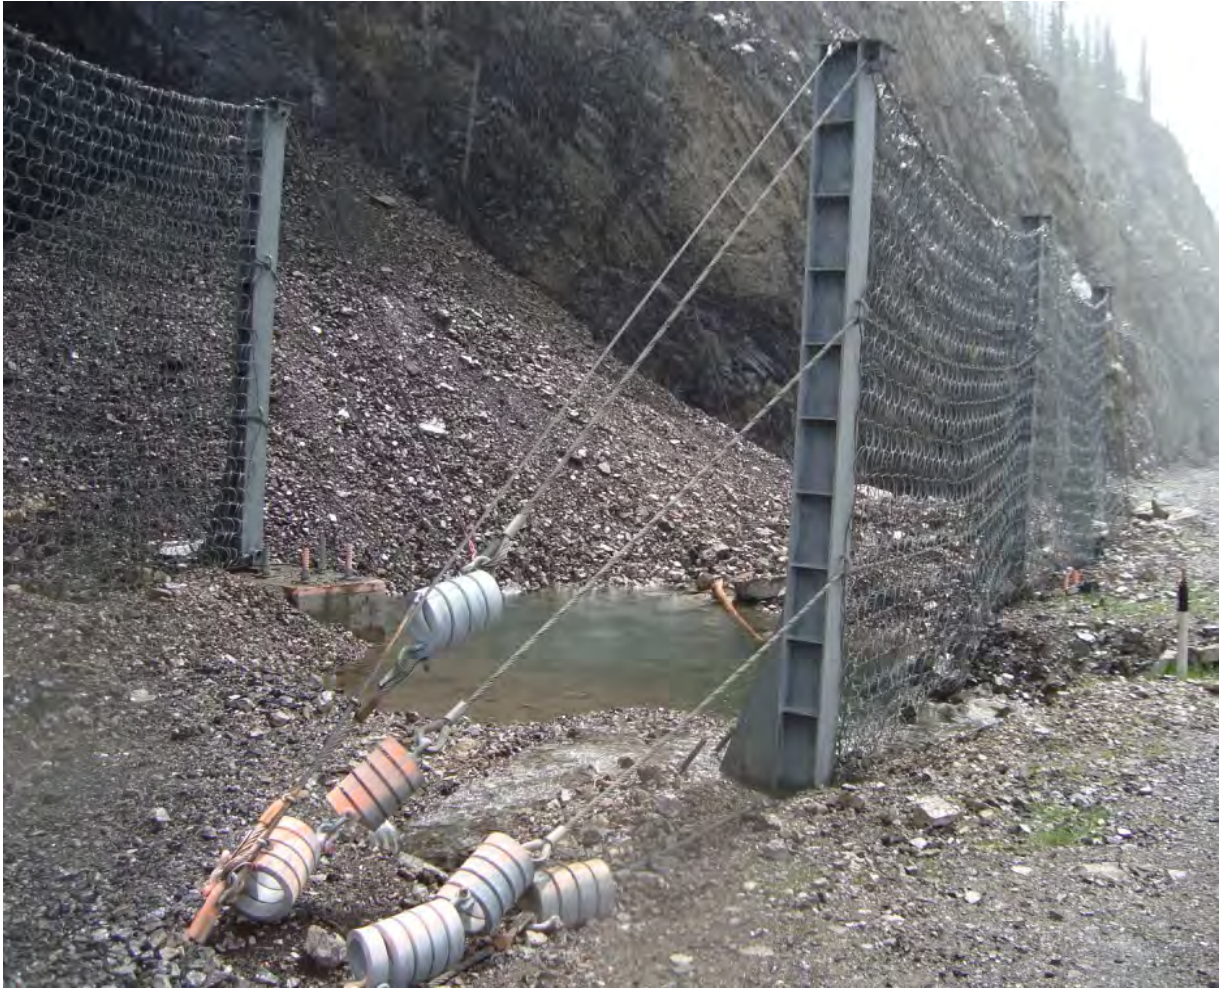
**Photo S15-4 (May 2013) -**

Looking towards the west at the side of the barrier net from the east. A large talus cone of rock debris is visible. None of the braking elements on the cable mesh support cables were activated.

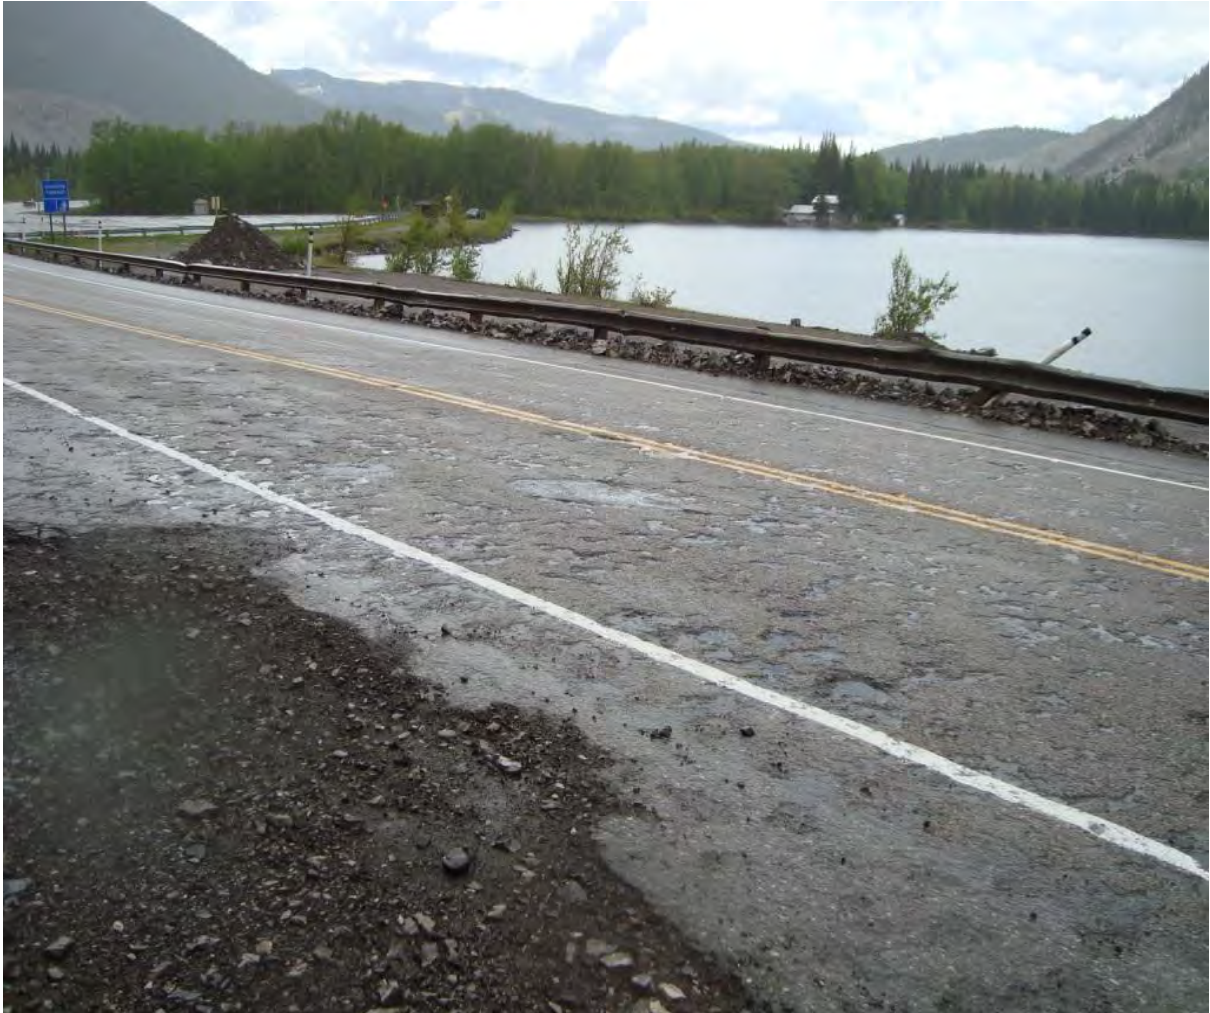
**Photo S15-5 (May 2013) –**  
Impact damage of the road surface and guardrail west of the barrier net due to falling rock from recent scaling work.

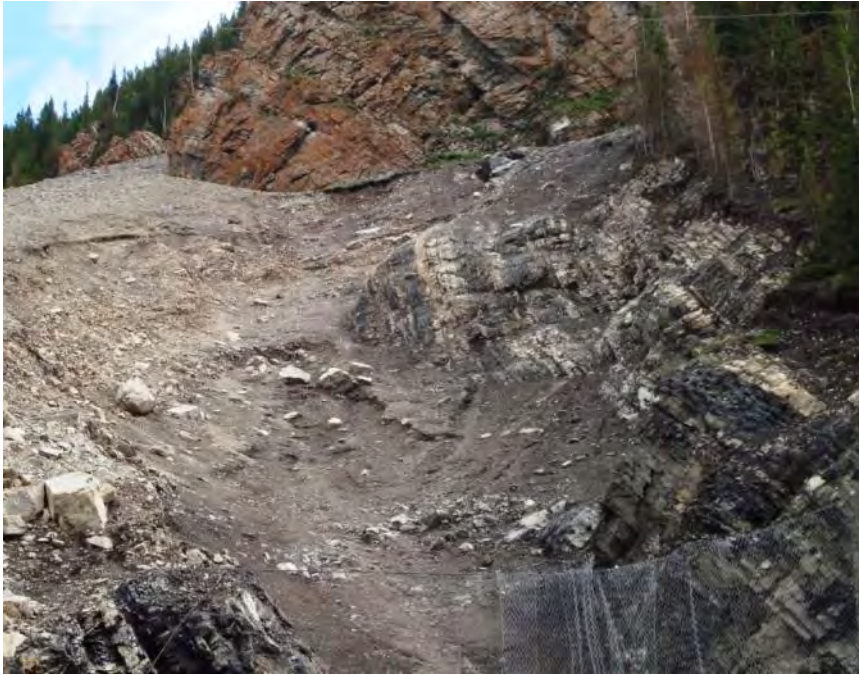
**Photo S15-6 (June 2012) –**  
The upper gully in the talus slope as observed during the 2012 inspection.

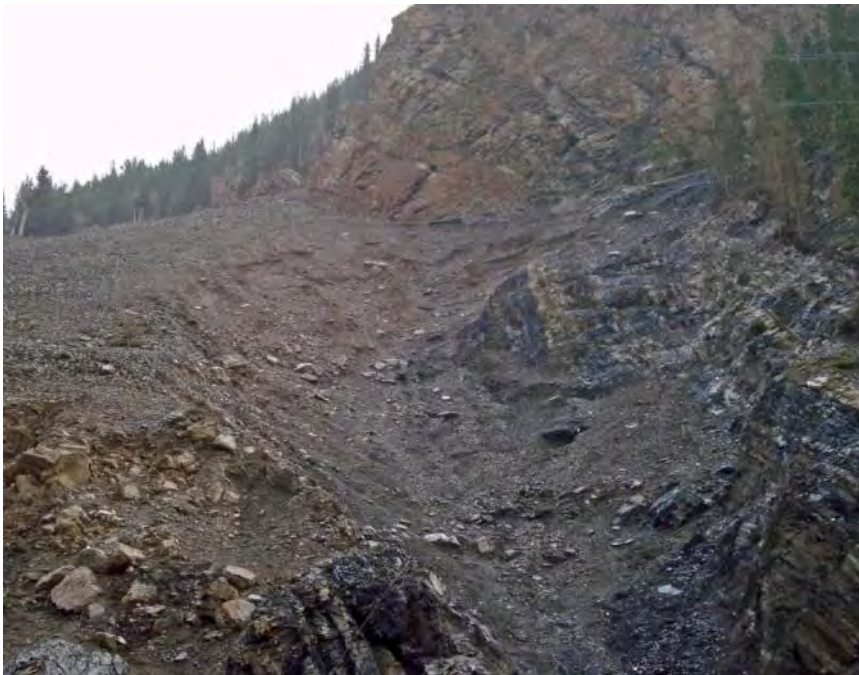
**Photo S15-7 (May 2013) –**  
The upper gully in the talus slope as observed during the 2013 inspection. The gully has continued to expand toward the cliff face. Several of the larger boulders visible in 2012 have since fallen.

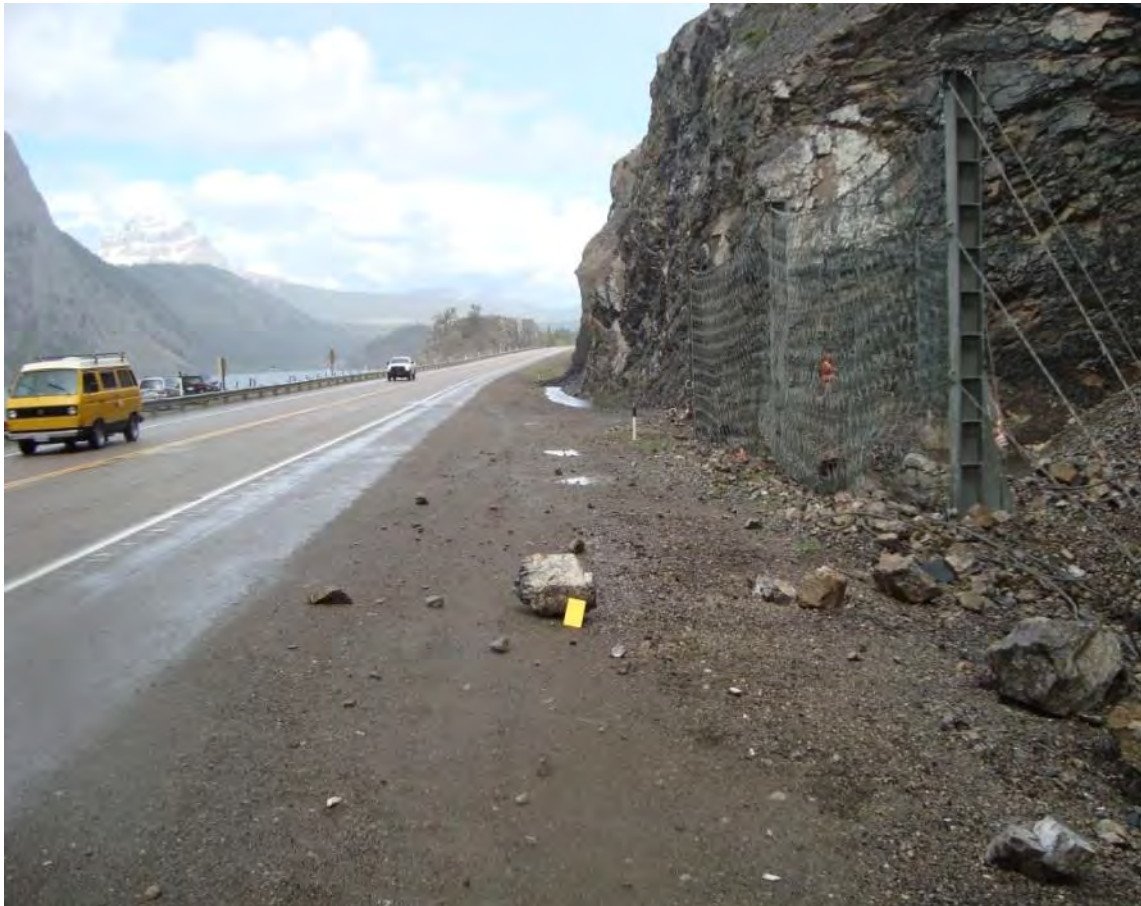
**Photo S15-8 (May 2103)-**

Looking towards the east at the largest rock that outflanked the west edge of the net into the south ditch. The rock measured approximately 0.6 m x 0.4 m x 0.4 m.
