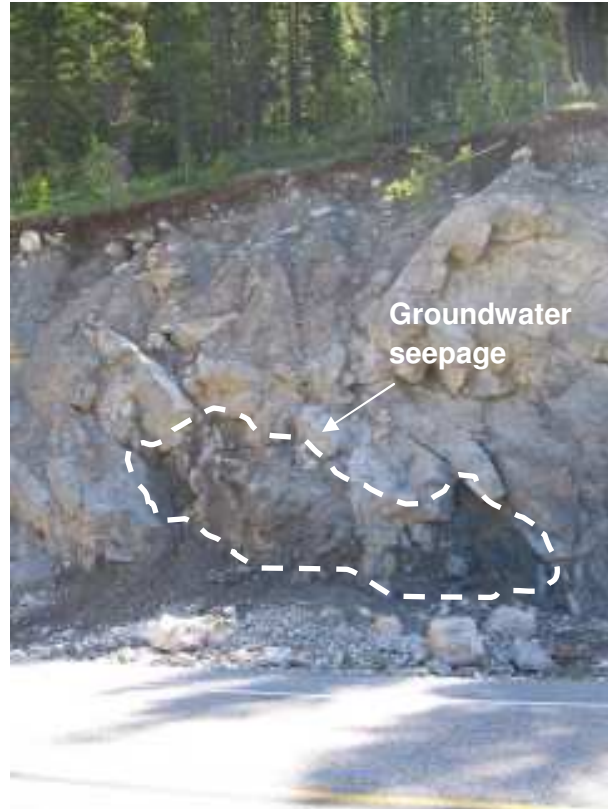
Photo S17-1 – June 2007 (upper left)

Rockfall debris accumulated in the east ditch. Rocks with a maximum dimension in the order of 1 m had fallen to within 0.5 m of the edge of the pavement. Groundwater seepage was observed coming out of the lower portion of the cut slope in the area where there was the most accumulation of rockfall debris in the ditch. Also note the oversteepened to near-vertical layer of soil above the crest of the rock cut. Rocks of up to boulder size are exposed in this soil layer and are ravelling out and falling into the ditch as erosion of the soil layer progresses over time.

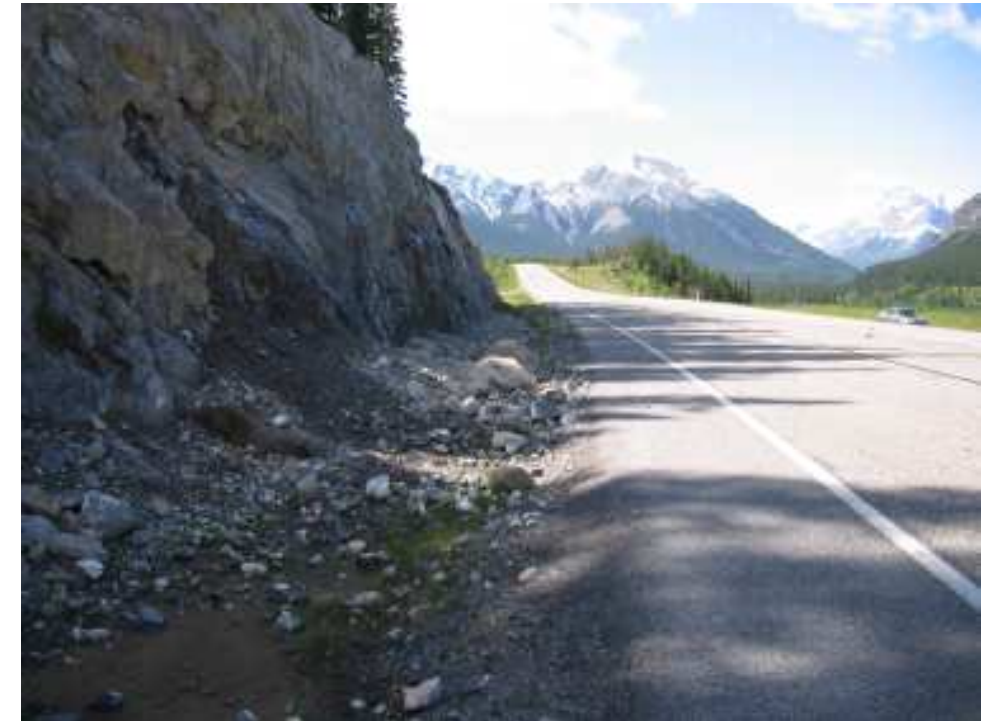
Photo S17-2 – June 2007 (upper right)

Facing south along the east ditch. Note the proximity of the accumulated rockfall debris to the edge of the pavement.

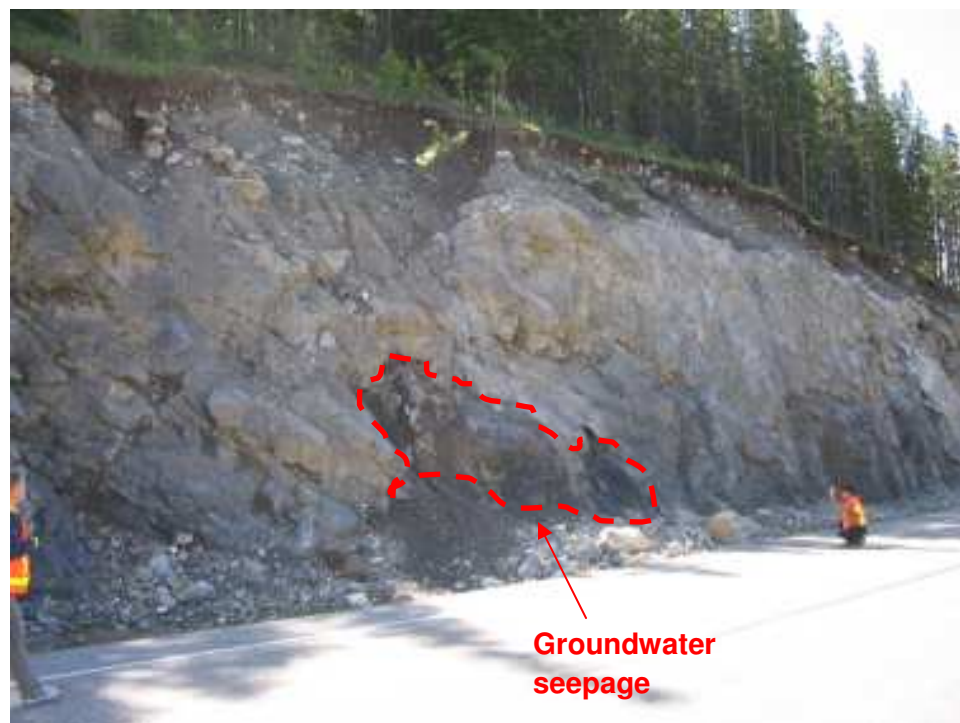
Photo S17-3 – June 2007 (lower left)

Facing southeast towards the rock cut along the east side of the highway.

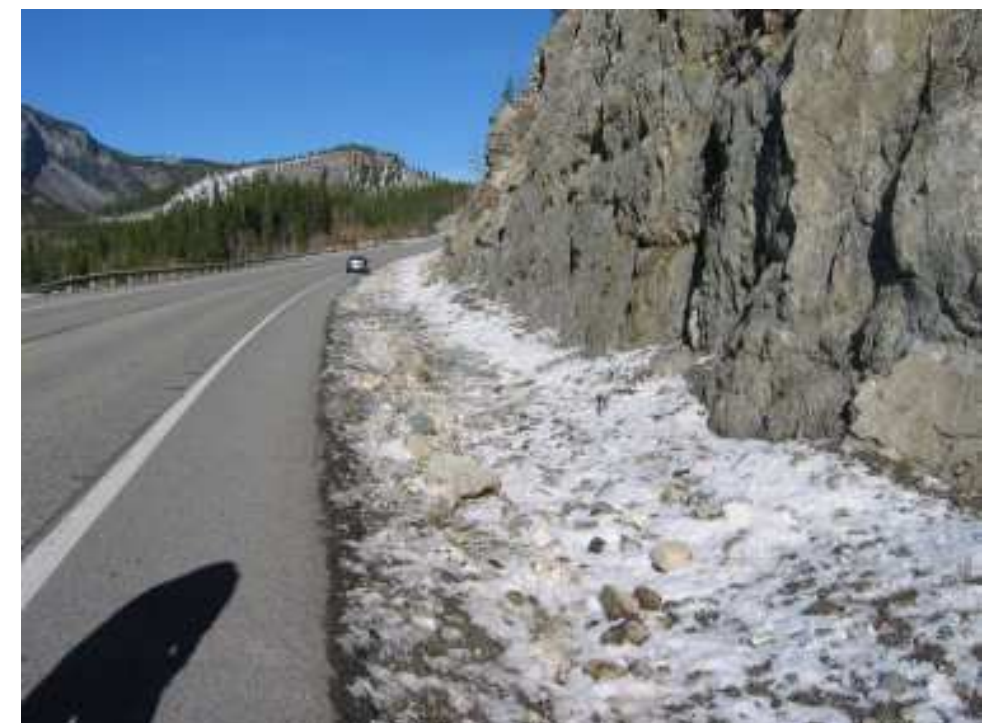
Photo S17-4 – October 2005 (lower right)

Rockfall accumulation in the east ditch at the time of the October 2005 site inspection. Compare with the amount of debris accumulation shown in Photos S17-1, 2 and 3.
