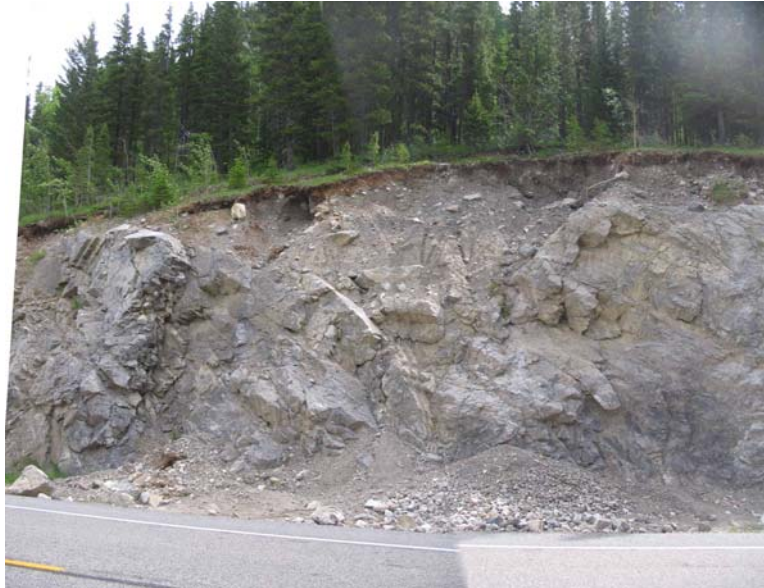
Photo S17-1 (top) – June 2008

Typical view of the Mt. Baldy rock cut slope. Note the eroding, rocky soil face that is exposed above the crest of the rock cut. It appears that the eroding soil face is generating a significant proportion of the rockfall at this site.

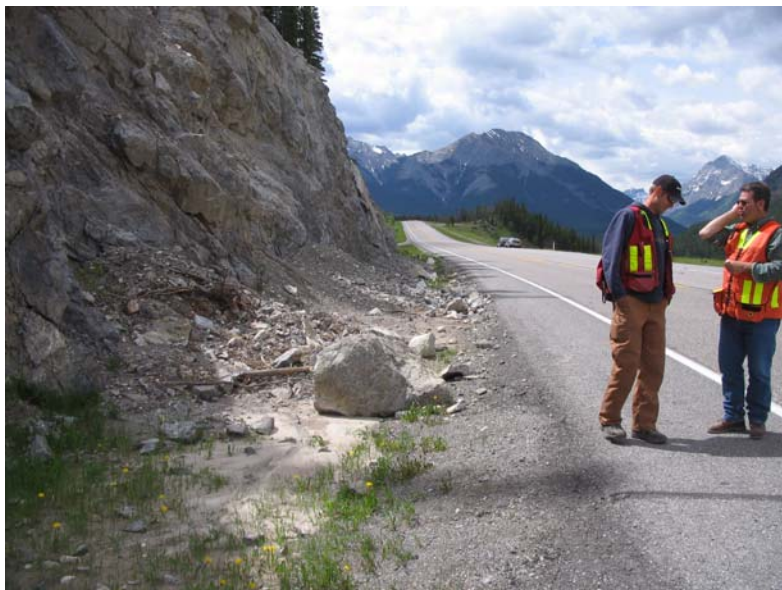
Photo S17-2 (bottom) – June 2008

Facing southbound along the east highway ditch along the toe of the Mt. Baldy rock cut. Note the boulder-sized debris that is within 1 m of the edge of the pavement.

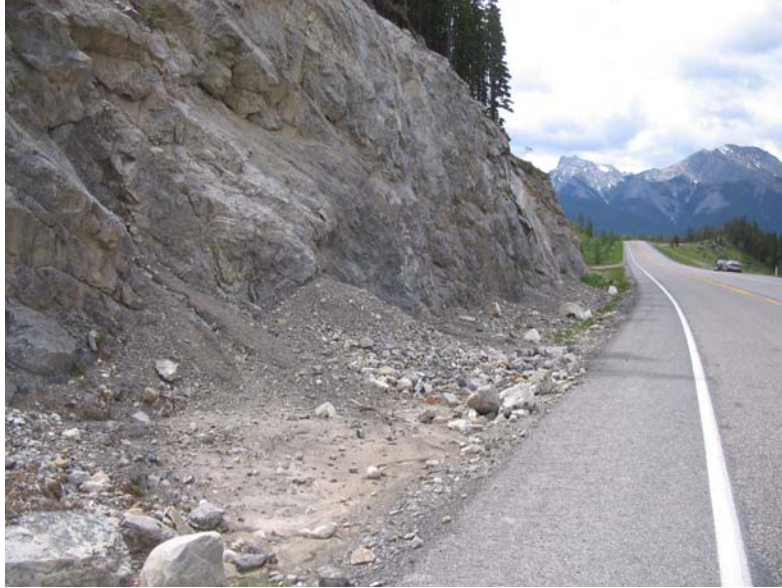
Photo S17-3 (top) – June 2008

Another view facing southbound along the east highway ditch. Note the accumulation of rockfall debris which has reduced the effective capacity of the ditch.

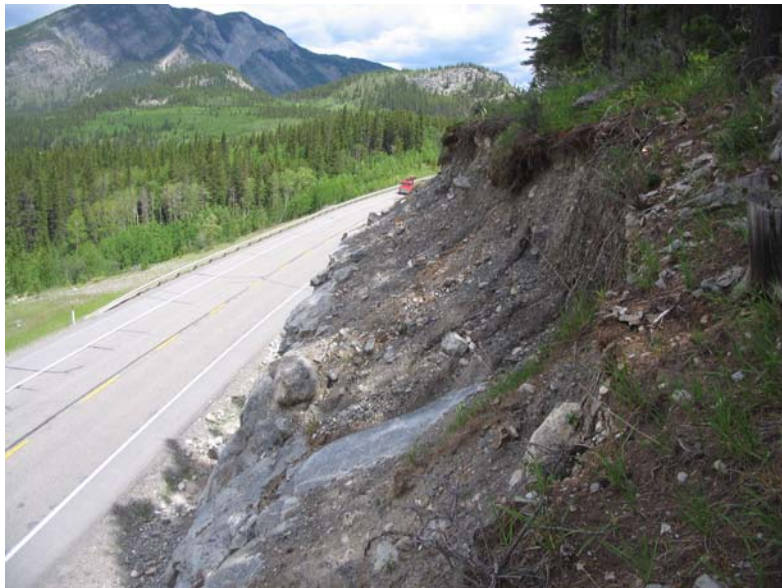
Photo S17-4 (bottom) – June 2008

Facing north along the exposed rocky soil face immediately above the crest of the rock cut slope.
