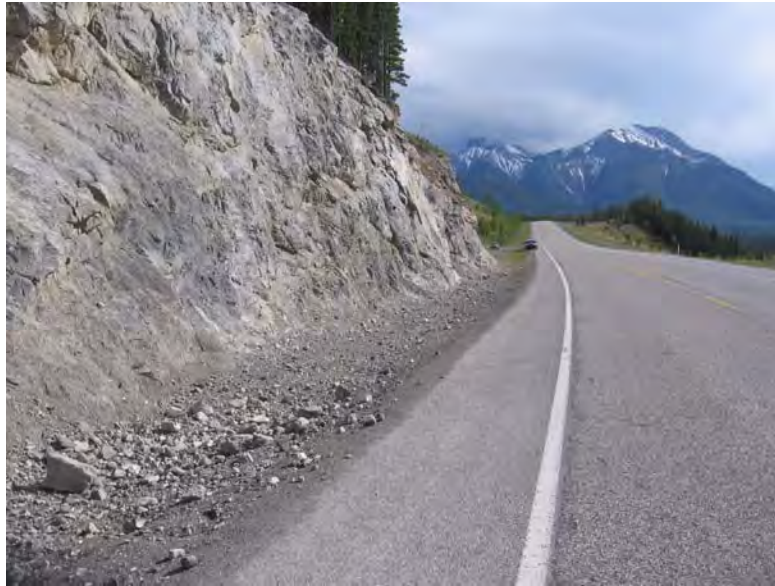
Photo 1 (top) – June 2009

Facing southbound along the east highway ditch adjacent to the cut slope, at the south end of the site. The rockfall debris is generally contained within the ditch, however some gravel sized pieces were on the pavement at the time of the June 2009 inspection.

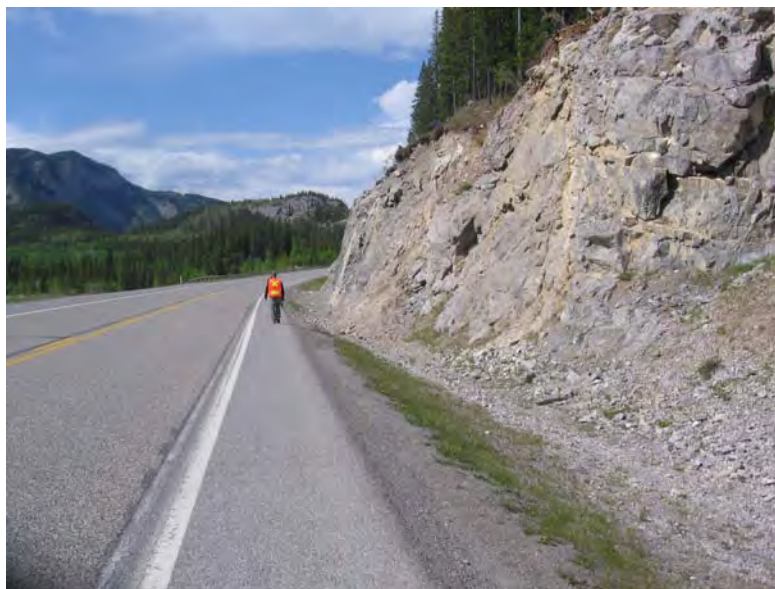
Photo 2 (bottom) – June 2009

Facing northbound across the central and northern end of the site.

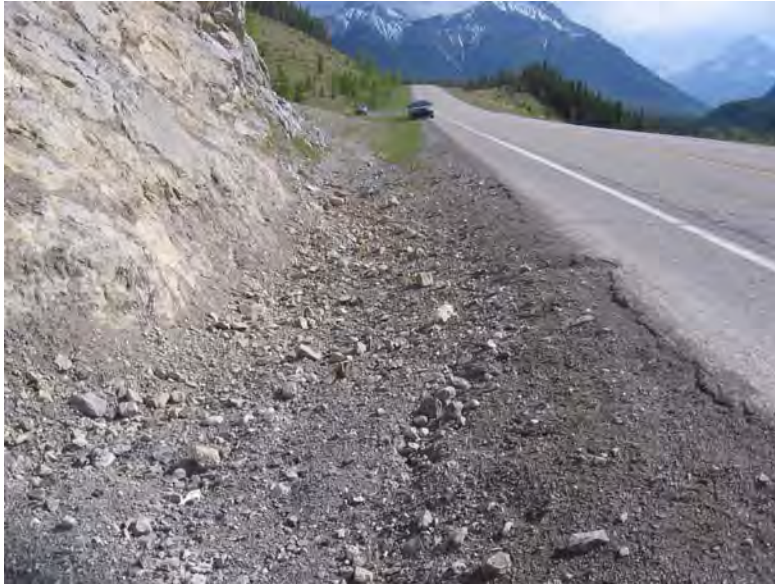
Photo 3 (top) – June 2009

Closer view of the accumulation and distribution of rockfall debris in the ditch at the south end of the site.
