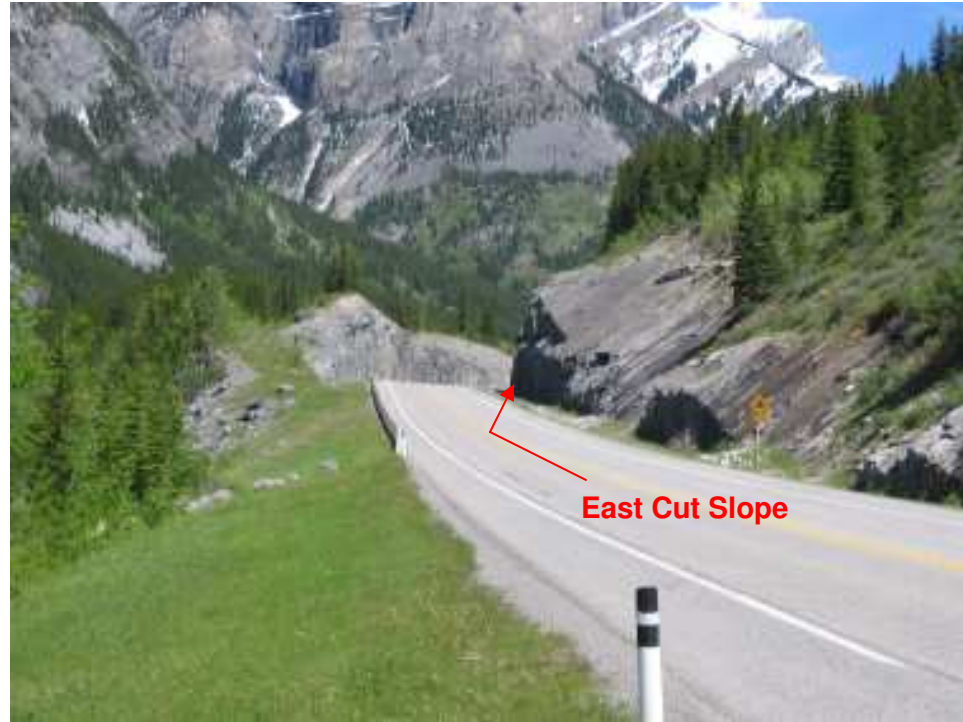
Photo S18-1 – June 2007 (upper left)
 Facing northbound along Highway 40 towards the Galatea Creek Through-Cut. Note the unfavourable orientation of the bedrock structure (from a slope stability perspective) along the East Cut Slope on the east side of the highway (right hand side as viewed in this photo).

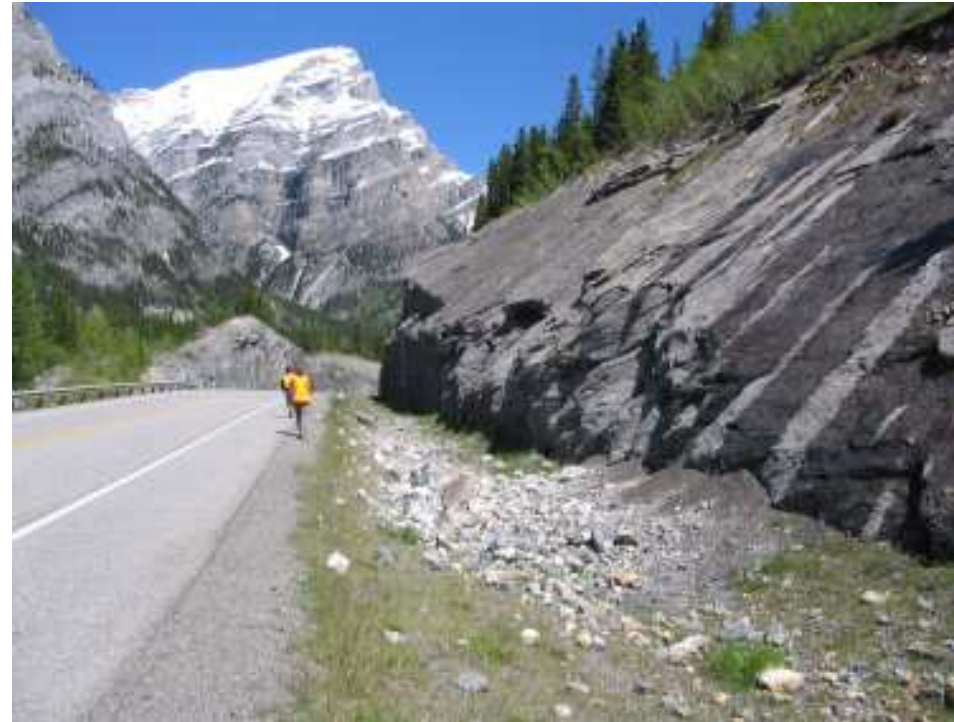
Photo S18-2 – June 2007 (upper right)
 Facing northbound along the east side of Highway 40 at the south end of the East Cut Slope. Note the accumulated rockfall debris in the ditch. The ditch in this area is appropriately sized to capture the rockfall debris, however further northbound the height of the East Cut Slope increases and the ditch width and depth decrease below the recommended sizing criteria.

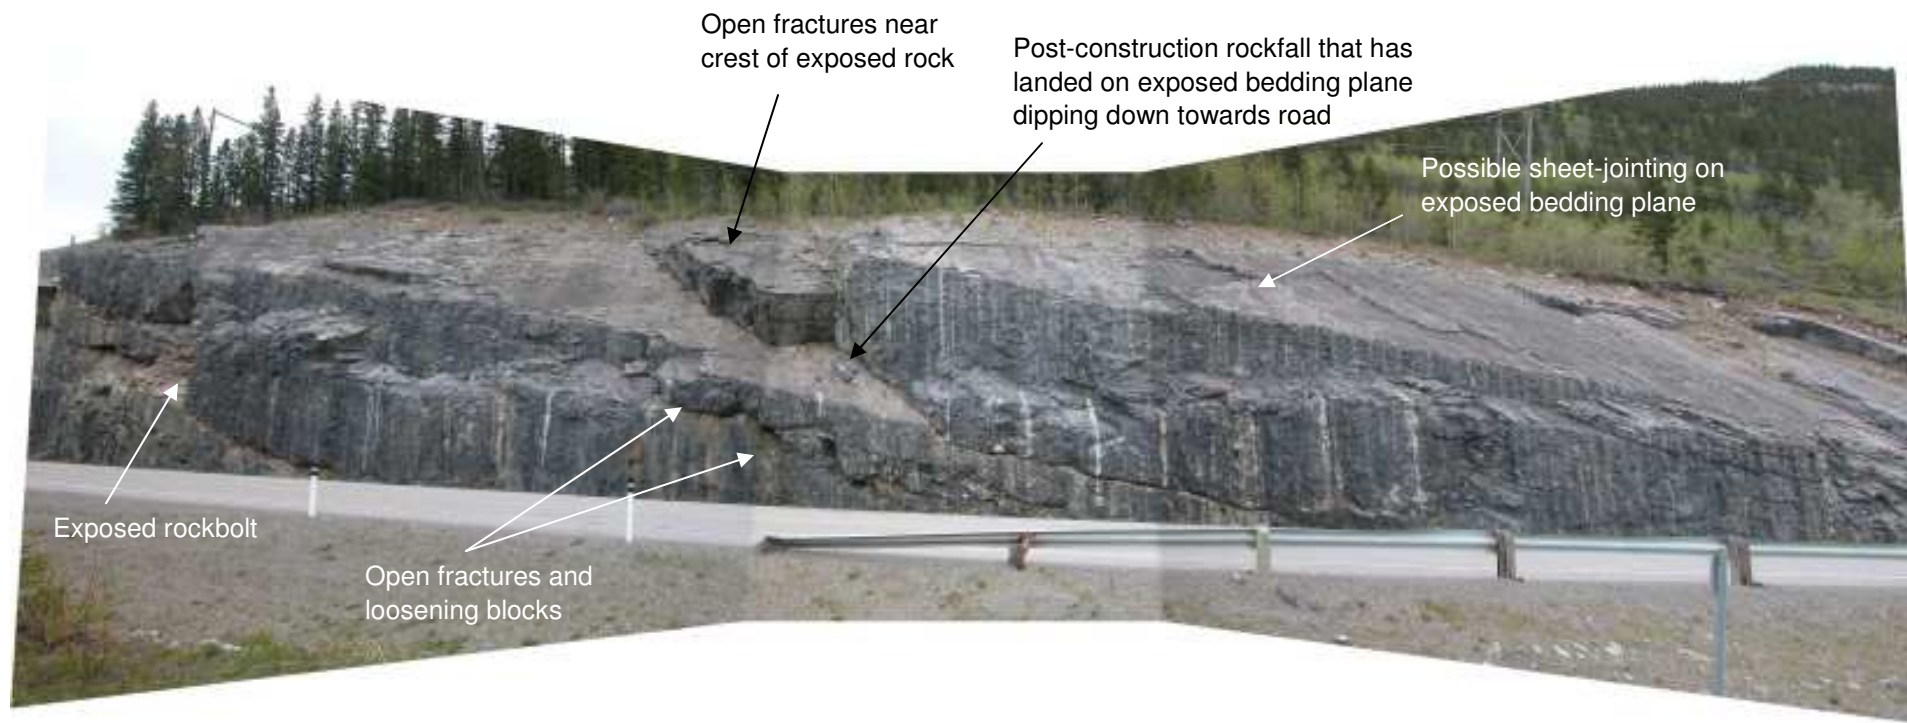
Photo S18-3 – June 2004 (bottom)
 Overview of the central portion of the East Cut Slope, as seen during the June 2004 site inspection. The rockfall hazard at this site is due to weathering of the exposed rock and the orientation of the bedding relative to the cut slope face. These hazards are partially mitigated by the east ditch along the road and by numerous rockbolts installed across the cut slope. Rockfall debris has rolled into the northbound lane of the road in the past. Also, the faceplates of some of the rockbolts appear to no longer be in tight contact with the slope face.

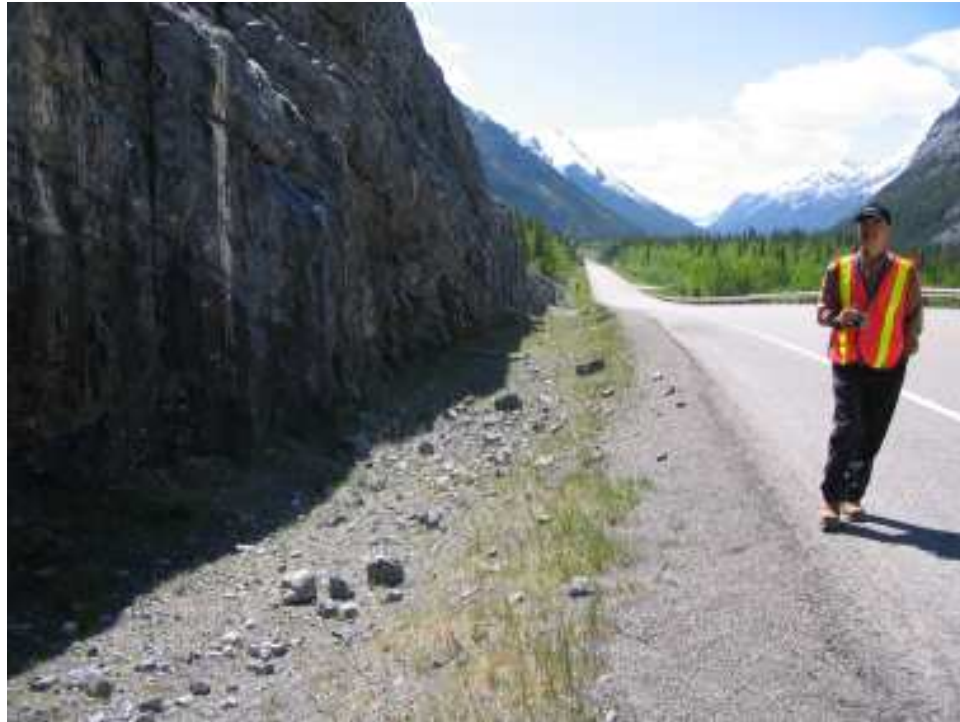
Photo S18-4 – June 2007 (upper left)
Facing southbound along the east edge of Highway 40 in the southern/central portion of the East Cut Slope. Note the accumulation of rockfall debris in the ditch and the proximity of some of the rocks to the east edge of the pavement.

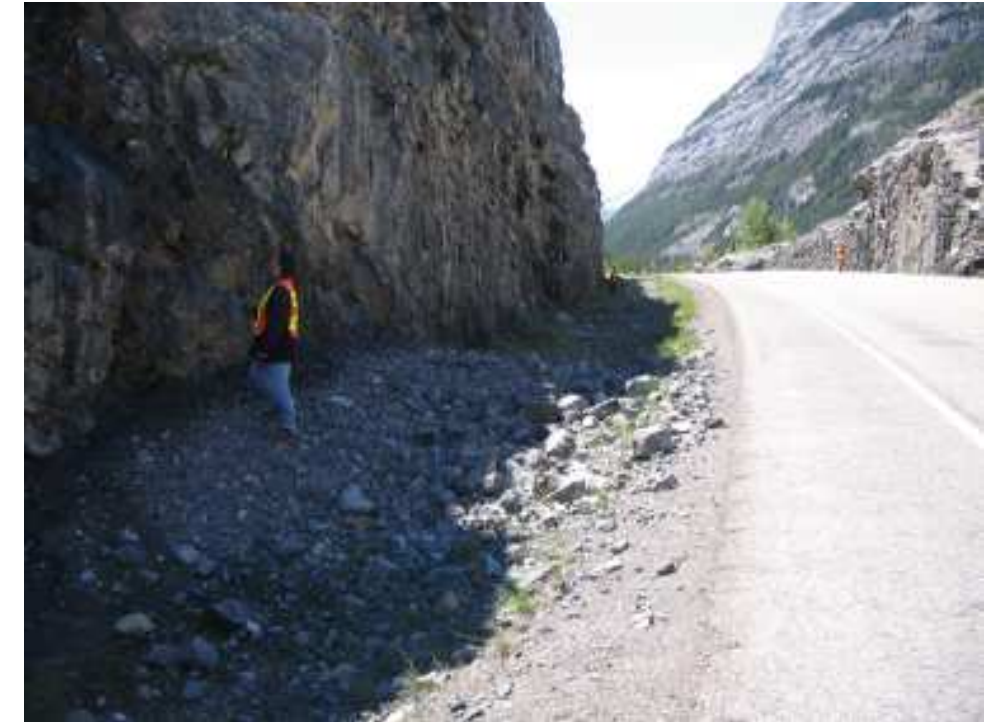
Photo S18-5 – June 2007 (upper right)
Facing southbound along the east edge of Highway 40 in the central/northern portion of the East Cut Slope. Note the relatively greater accumulation of rockfall debris in this area compared to the segment of the ditch further south (Photo S18-4). Some of the rocks have been deposited along the edge of the pavement. A few gravel-sized pieces of rock were noted on the pavement at the time of the inspection, and cobble-sized rocks were noted near the centerline of the road in the June 2004 inspection.

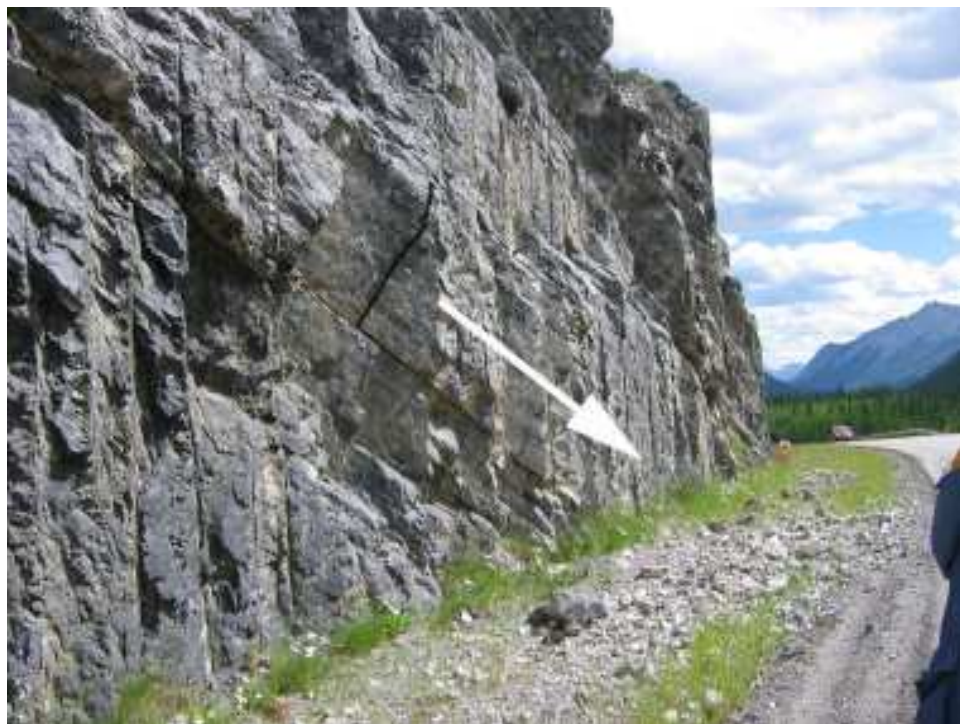
Photo S18-6 – 2005 (lower left)
This photo from a 2005 site recon during the highway corridor geohazard review illustrates one of several locations along the East Cut Slope where large rockfalls are developing due to weathering and freeze/thaw effects in open cracks. At this location, the large boulder in front of this open crack will break free in the future and fall outwards into the ditch. If this large piece of rock falls out as one piece, the resulting debris could encroach onto the road and/or cause subsequent debris to bounce and roll onto the road.

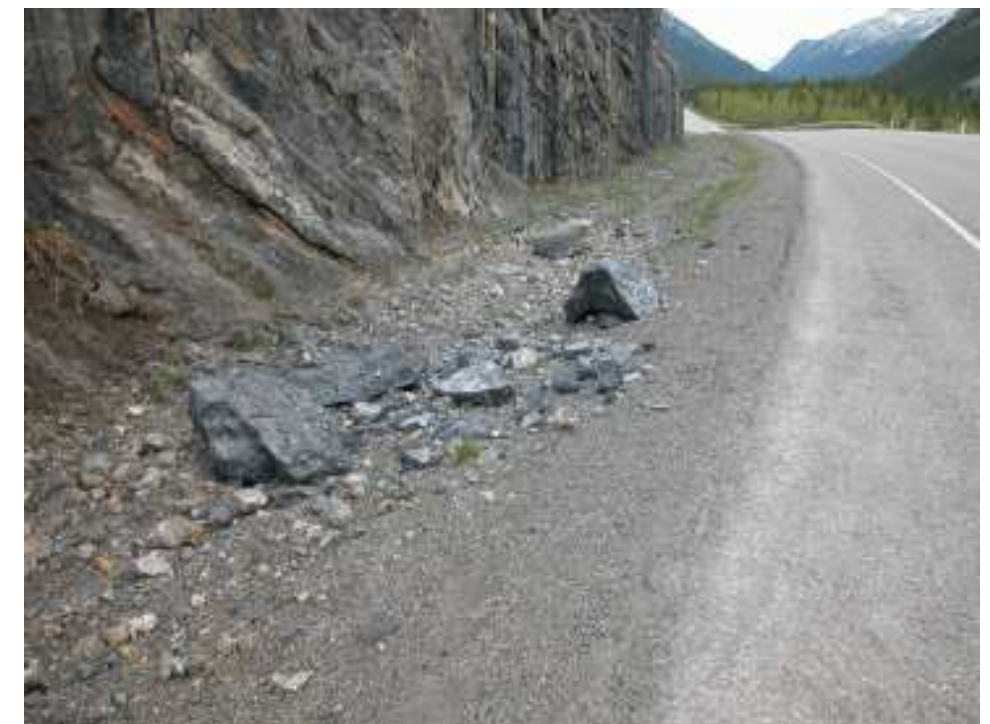
Photo S18-7 – June 2004 (lower right)
Boulder-sized rockfall debris in the ditch near the central portion of the East Cut Slope as seen during the June 2004 site inspection. The ditch in this area is typically 4 m or less in width and 0.5 to 0.75 m in depth, which does not meet the recommended ditch sizing criteria.

The East Cut is near its maximum height of approximately 16 m in this area, and the position of this debris shows that rockfall from this segment of the cut slope could land or roll onto the paved surface.

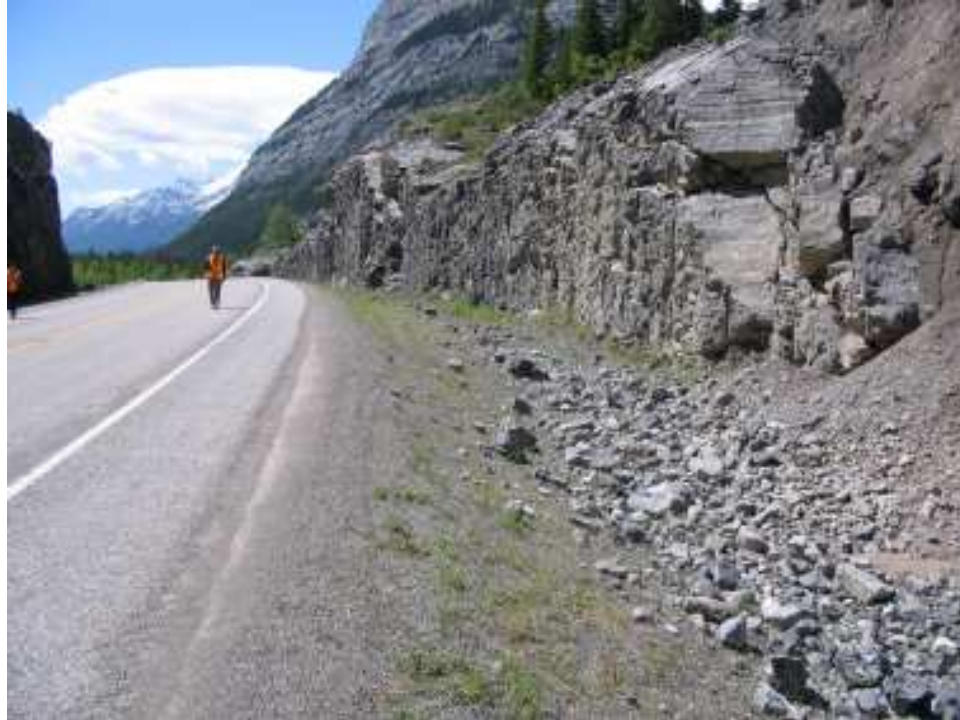
Photo S18-8 – June 2007 (upper left)

Typical view of the west ditch, facing southbound along West Cut Slope. Note the accumulated rockfall debris in the ditch. No rockfall debris from the west ditch has been observed on the road during any of the site inspections. This ditch meets the recommended ditch sizing criteria.
