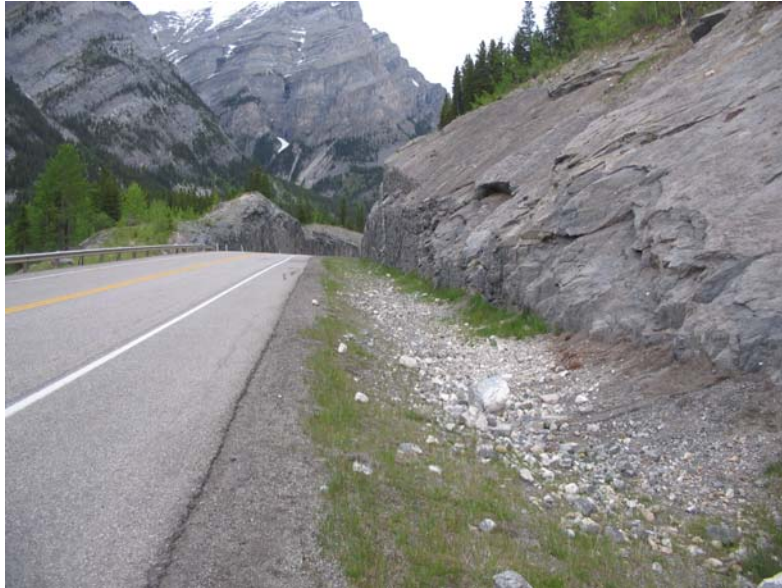
**Photo S18-1 (top) – June 2008**  
Facing northbound along the east highway ditch from the south end of the site. The ditch is of sufficient size in this area to keep the rockfall debris from the East Cut Slope from impacting the road.

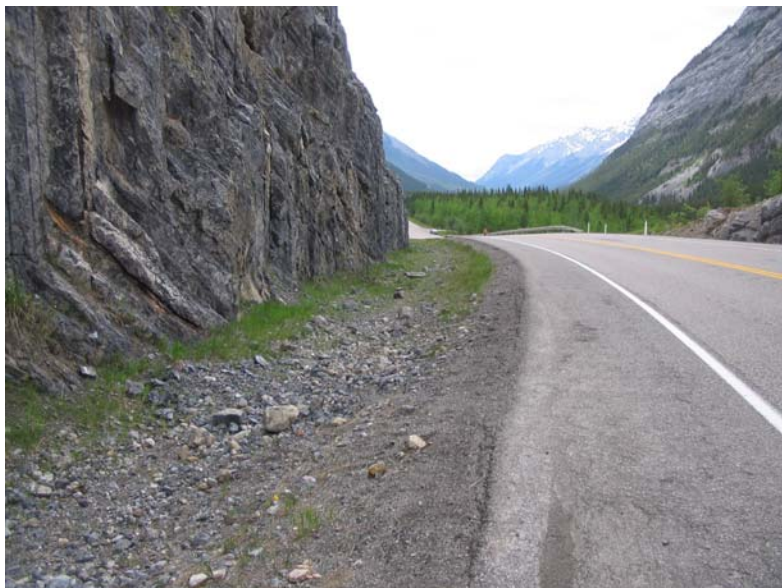
**Photo S18-2 (bottom) – June 2008**  
Facing southbound along the east highway ditch from the central portion of the site. The rockfall debris from the East Cut Slope is generally contained within the ditch in this area, however some gravel sized particles were noted on the road. This ditch does not meet the ditch sizing guidelines on the Ritchie ditch chart.

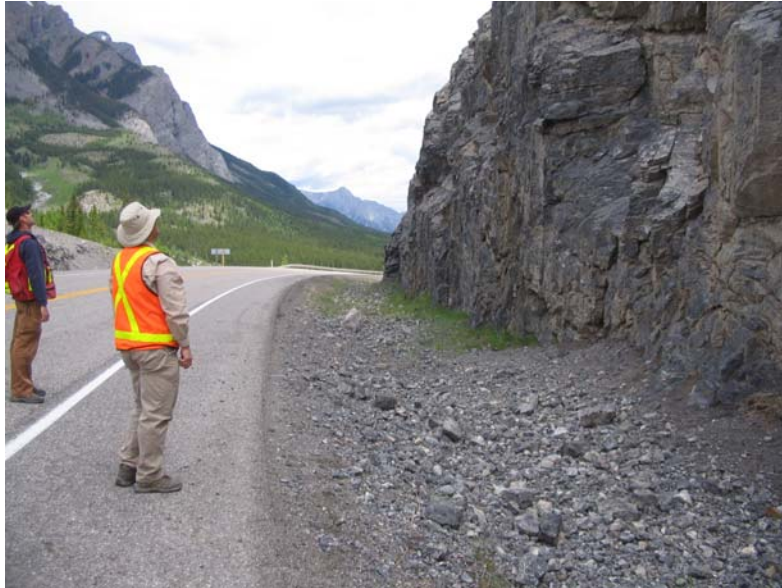
**Photo S18-3 (top) – June 2008**  
Facing northbound along the east highway ditch in the north end of the site. There was a considerable accumulation of rockfall debris from the East Cut Slope in the ditch in this area, with gravel to cobble sized particles onto the edge of the pavement.

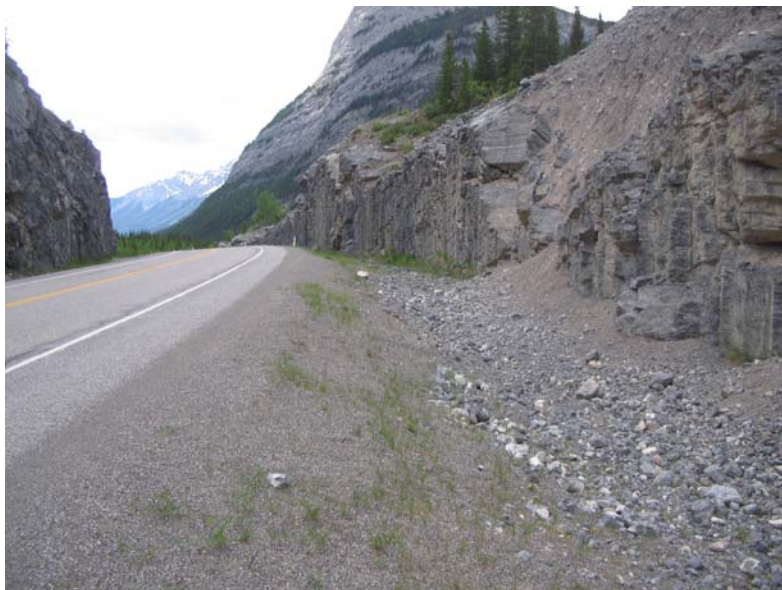
**Photo S18-4 (bottom) – June 2008**  
Facing southbound along the west highway ditch in the north end of the site. The west ditch is sufficiently sized to contain rockfall debris from the West Cut Slope.
