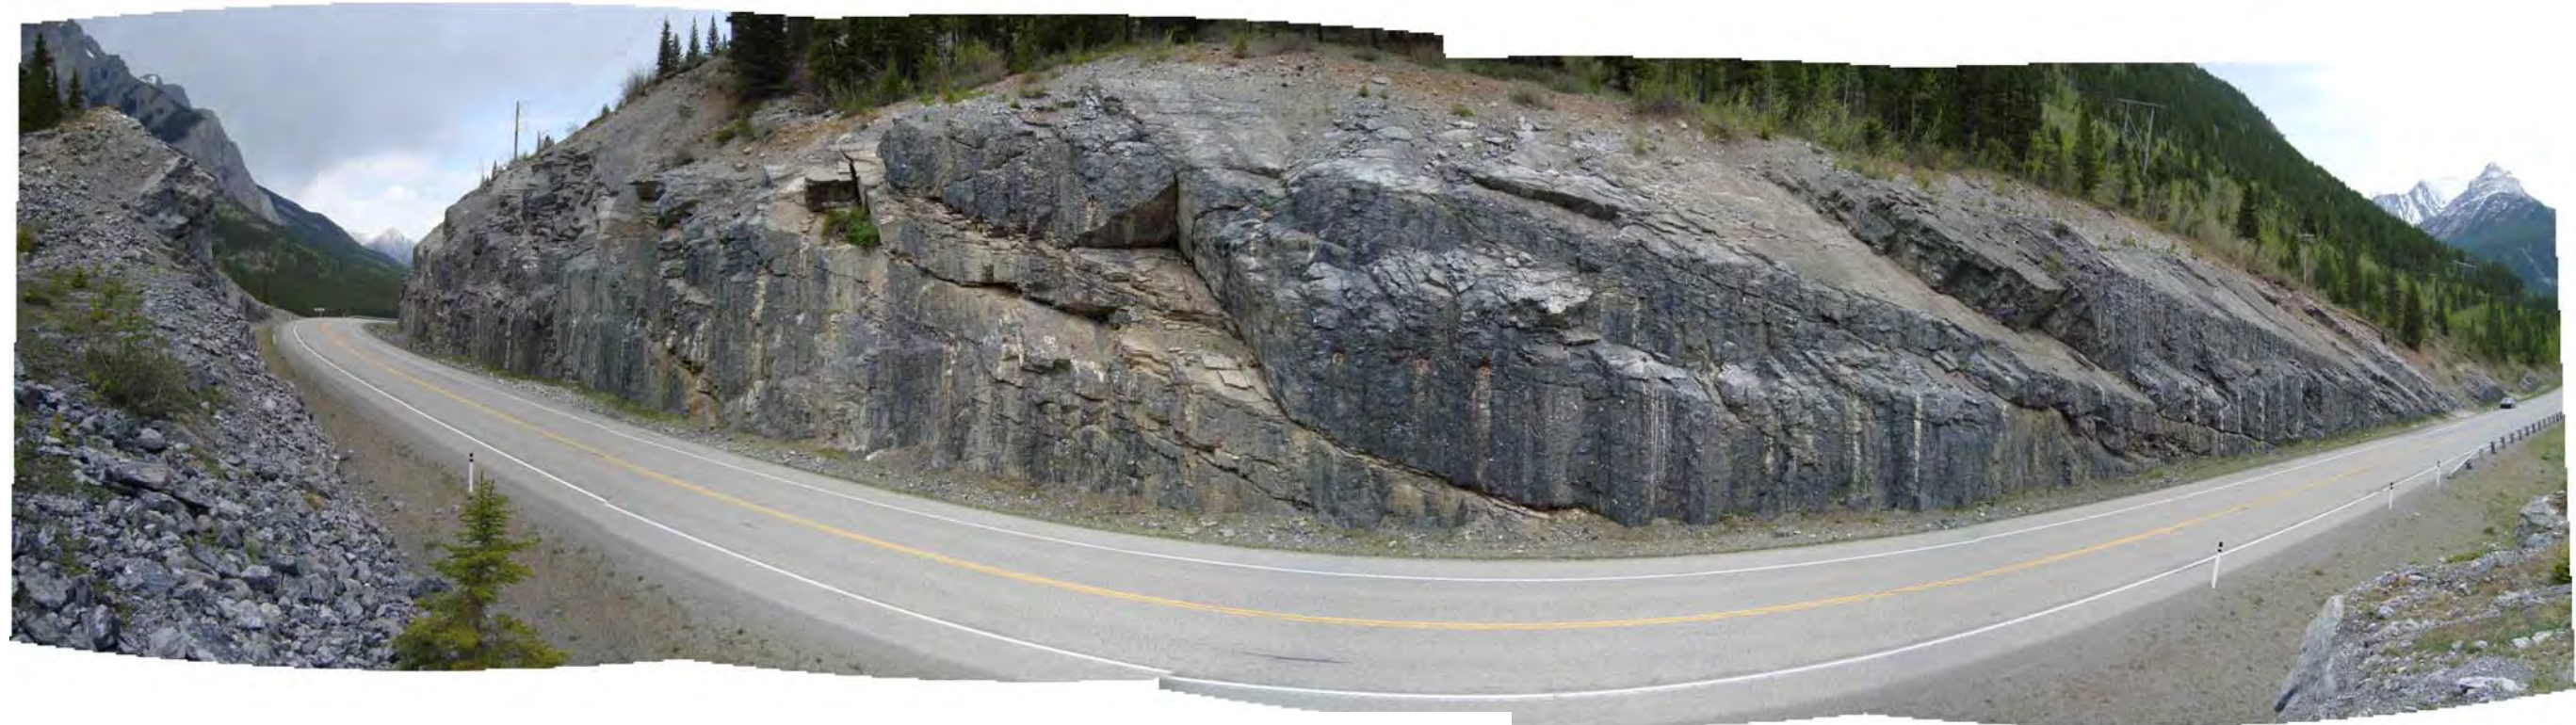
**Photo S18-1 (top) – June 2009**

A stitched panoramic image of the east rock cut slope taken from atop the west rock cut. The curvature of the highway is exaggerated due to the image processing. Clearly visible are the possible wedge, toppling, and block sliding failure modes currently supported by rock bolts.

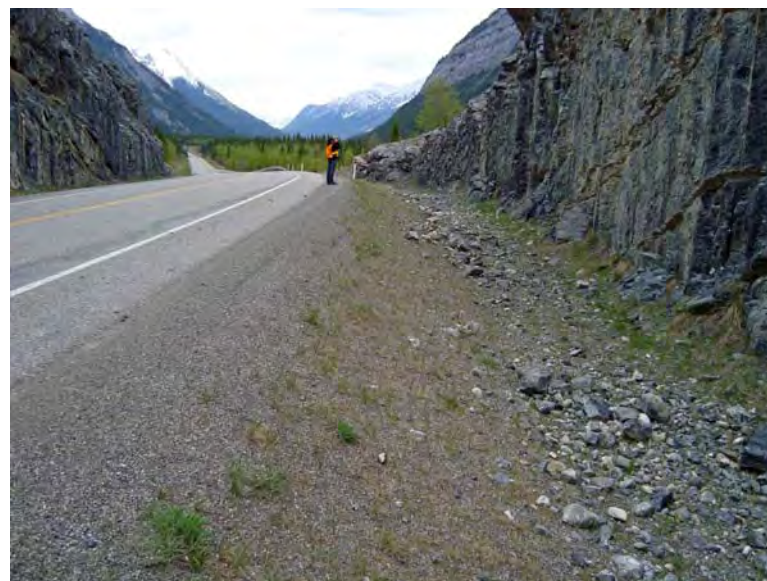
**Photo S18-2 (left) – June 2009**

Facing southbound along the west ditch. All rockfall is contained within the ditch.

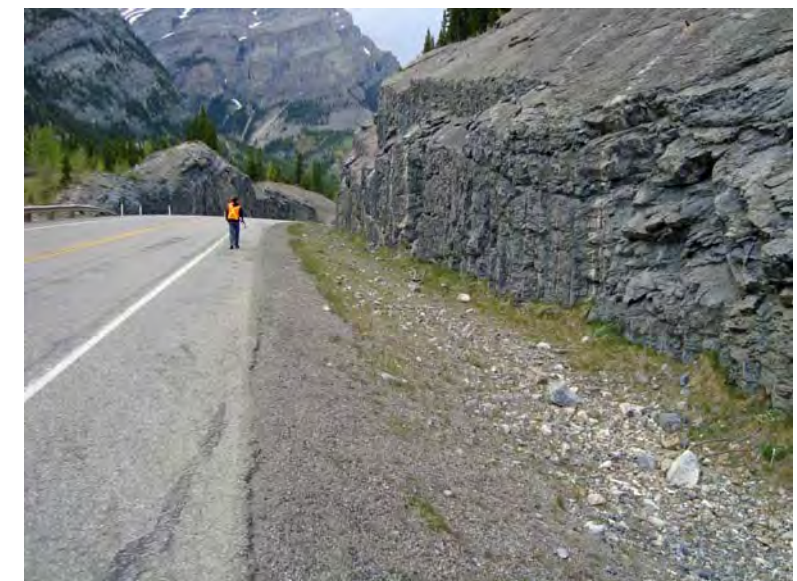
**Photo S18-3 (right) – June 2009**

Facing northbound along the east ditch near the south end of the rock cut. Minor rockfall in this area that does not appear to have landed on the road, however boulder and cobble-sized rocks have been noted onto the edge of the pavement in past inspections.

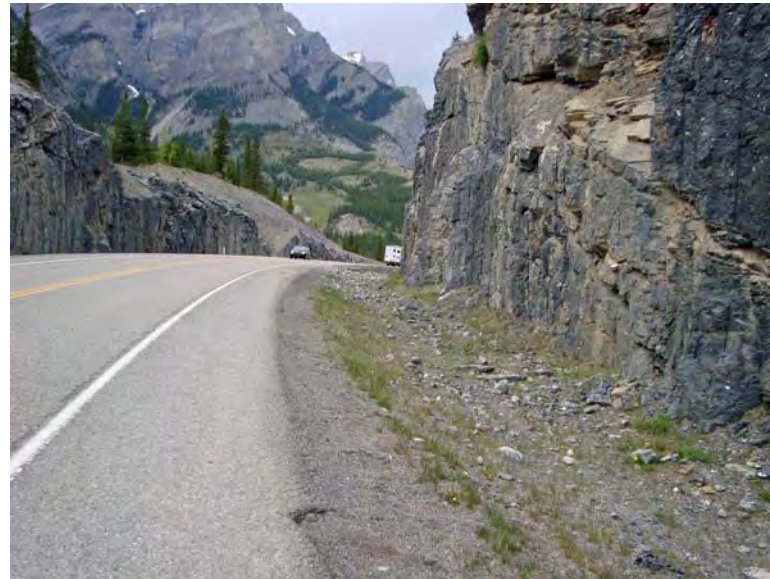
**Photo S18-4 – June 2009**  
Facing northbound along the east ditch south of the centre of the rock cut. Minor rockfall in this area has not likely landed on the road.

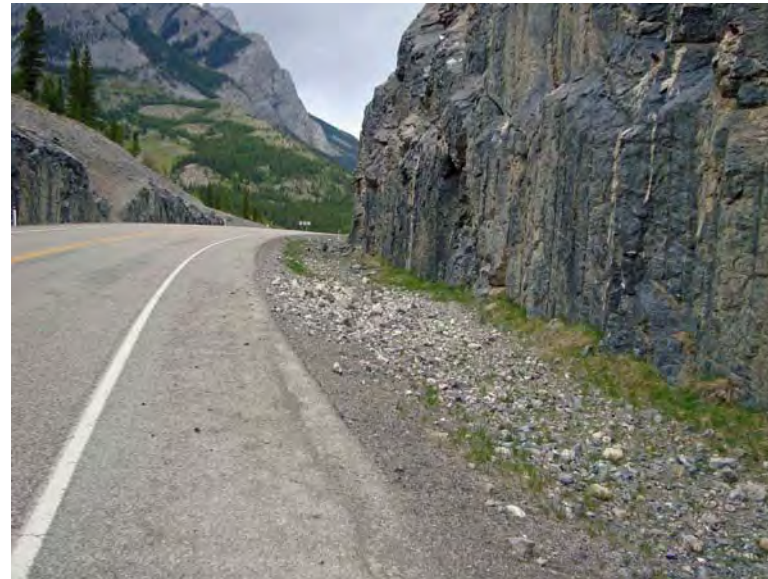
**Photo S18-5 – June 2009**  
Facing northbound along the east ditch near the centre of the rock cut. Area of greatest rockfall where rock has likely landed on the road.

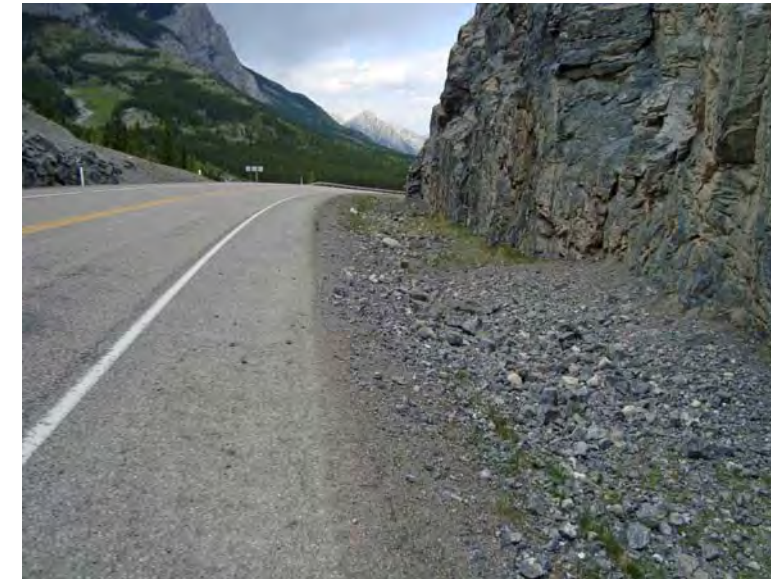
**Photo S18-6 – June 2009**  
Facing northbound along the east ditch near the north end of the rock cut. Some gravel sized rockfall on the road in this area.
