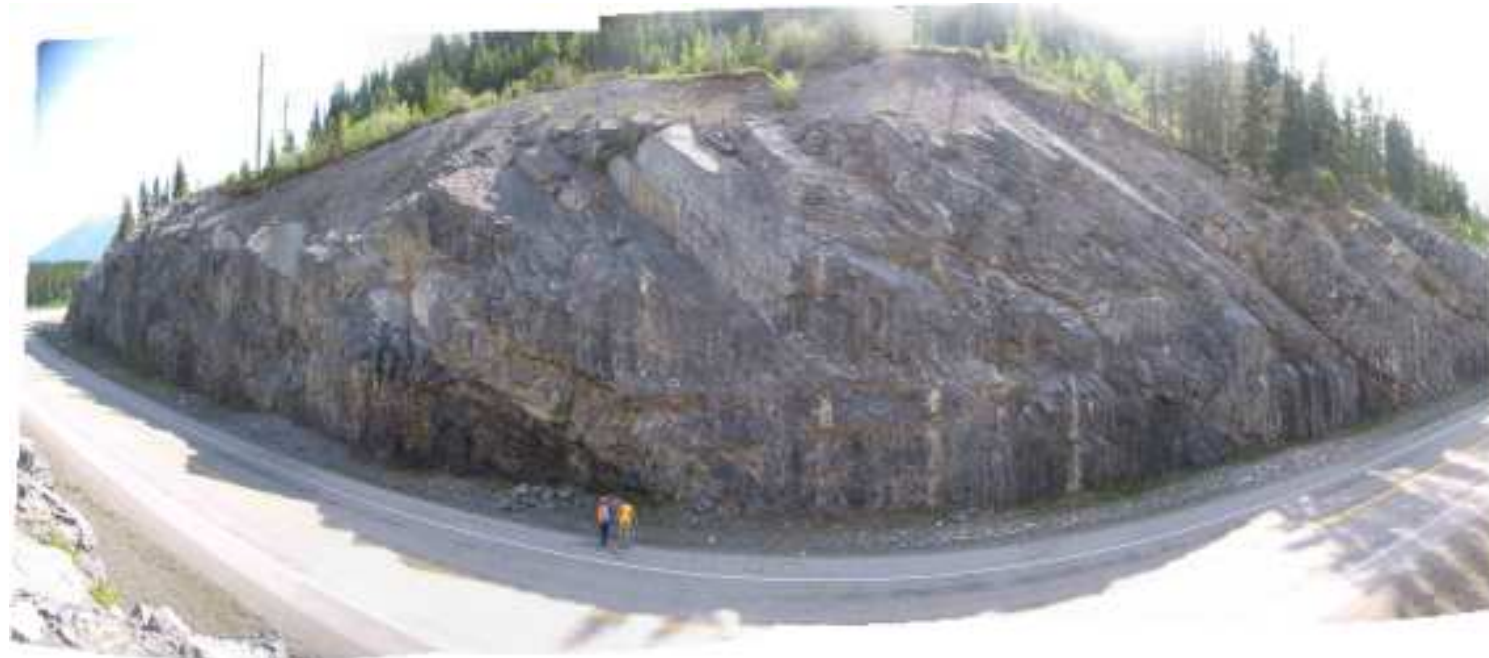
**Photo S18-1 (top) – June 2010**

A stitched panoramic image of the East Cut slope taken from atop the West Cut. The curvature of the highway is exaggerated due to the image processing. Clearly visible are the possible wedge, toppling, and block sliding failure modes currently supported by rock bolts. Also visible is the large accumulation of rock fall to the left of the people standing on the road.

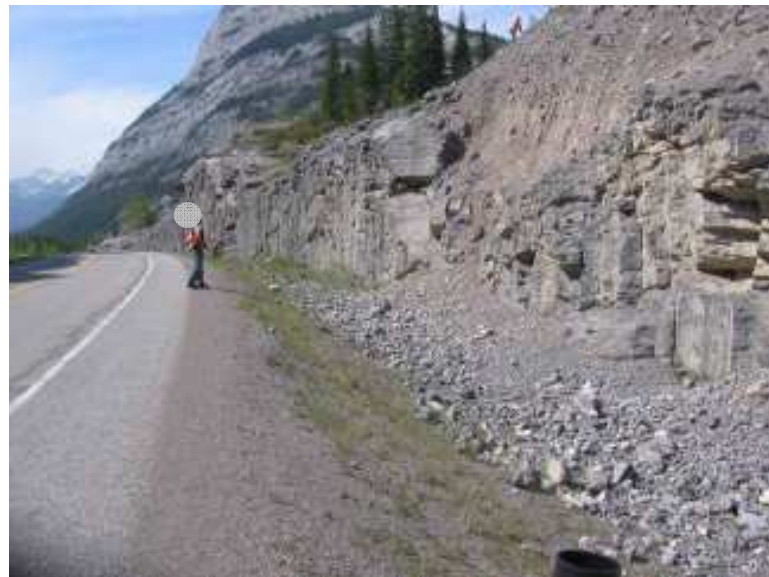
**Photo S18-2 (left) – June 2010**

Facing southbound along the west ditch. All rock fall is contained within the ditch.

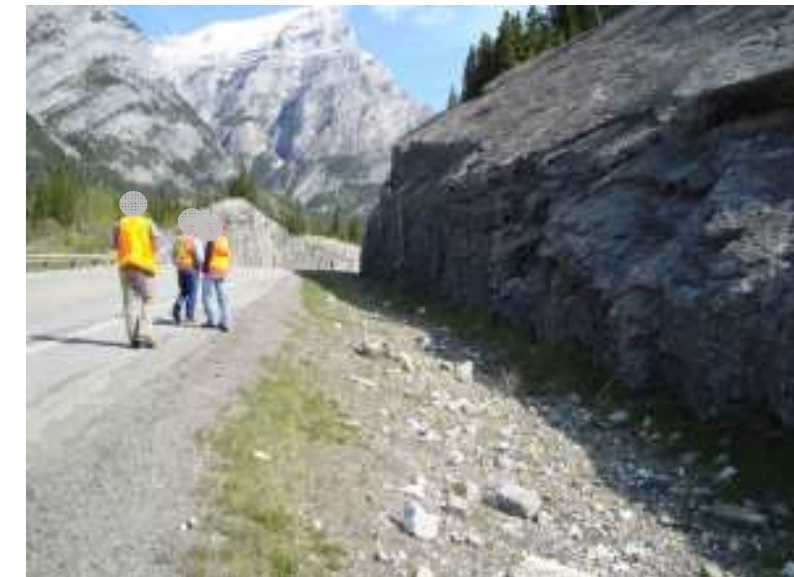
**Photo S18-3 (right) – June 2010**

Facing northbound along the east ditch near the south end of the East Cut. Minor rock fall in this area that does not appear to have landed on the road, however boulder and cobble-sized rocks have been noted onto the edge of the pavement in past inspections.

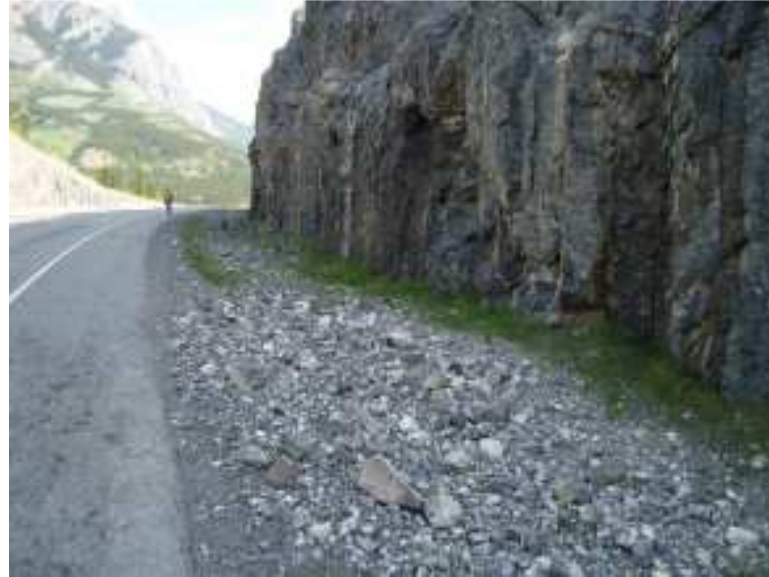
**Photo S18-4 (left) – June 2010**

Facing northbound along the east ditch. Increased accumulation of rock fall is noted in this area since the 2009 inspection.

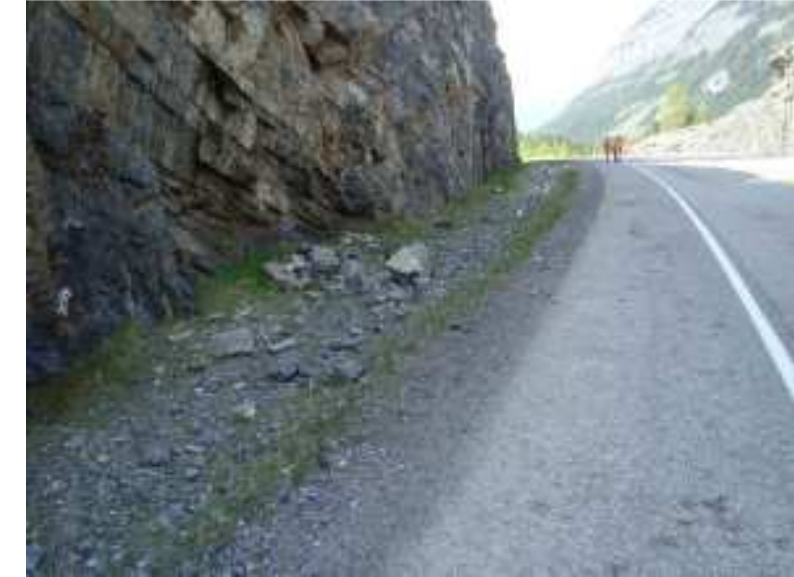
**Photo S18-5 (right) – June 2010**

Facing southbound along the east ditch. Some large boulders have fallen into the ditch. The boulders may be part of a larger wedge failure or may be due to continued unravelling of the rock face.

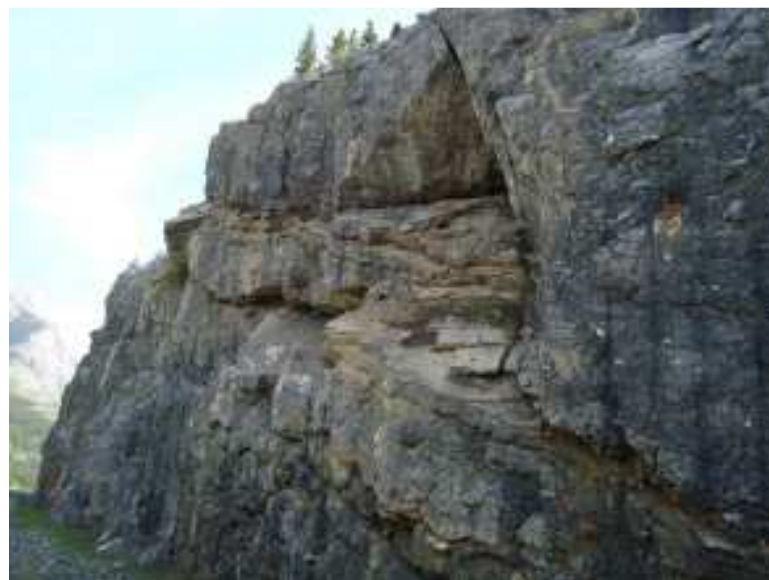
**Photo S18-6 (left) – June 2010**

Evidence of large wedge failure from the East Cut in the past. Some blocks in the area appear unstable.
