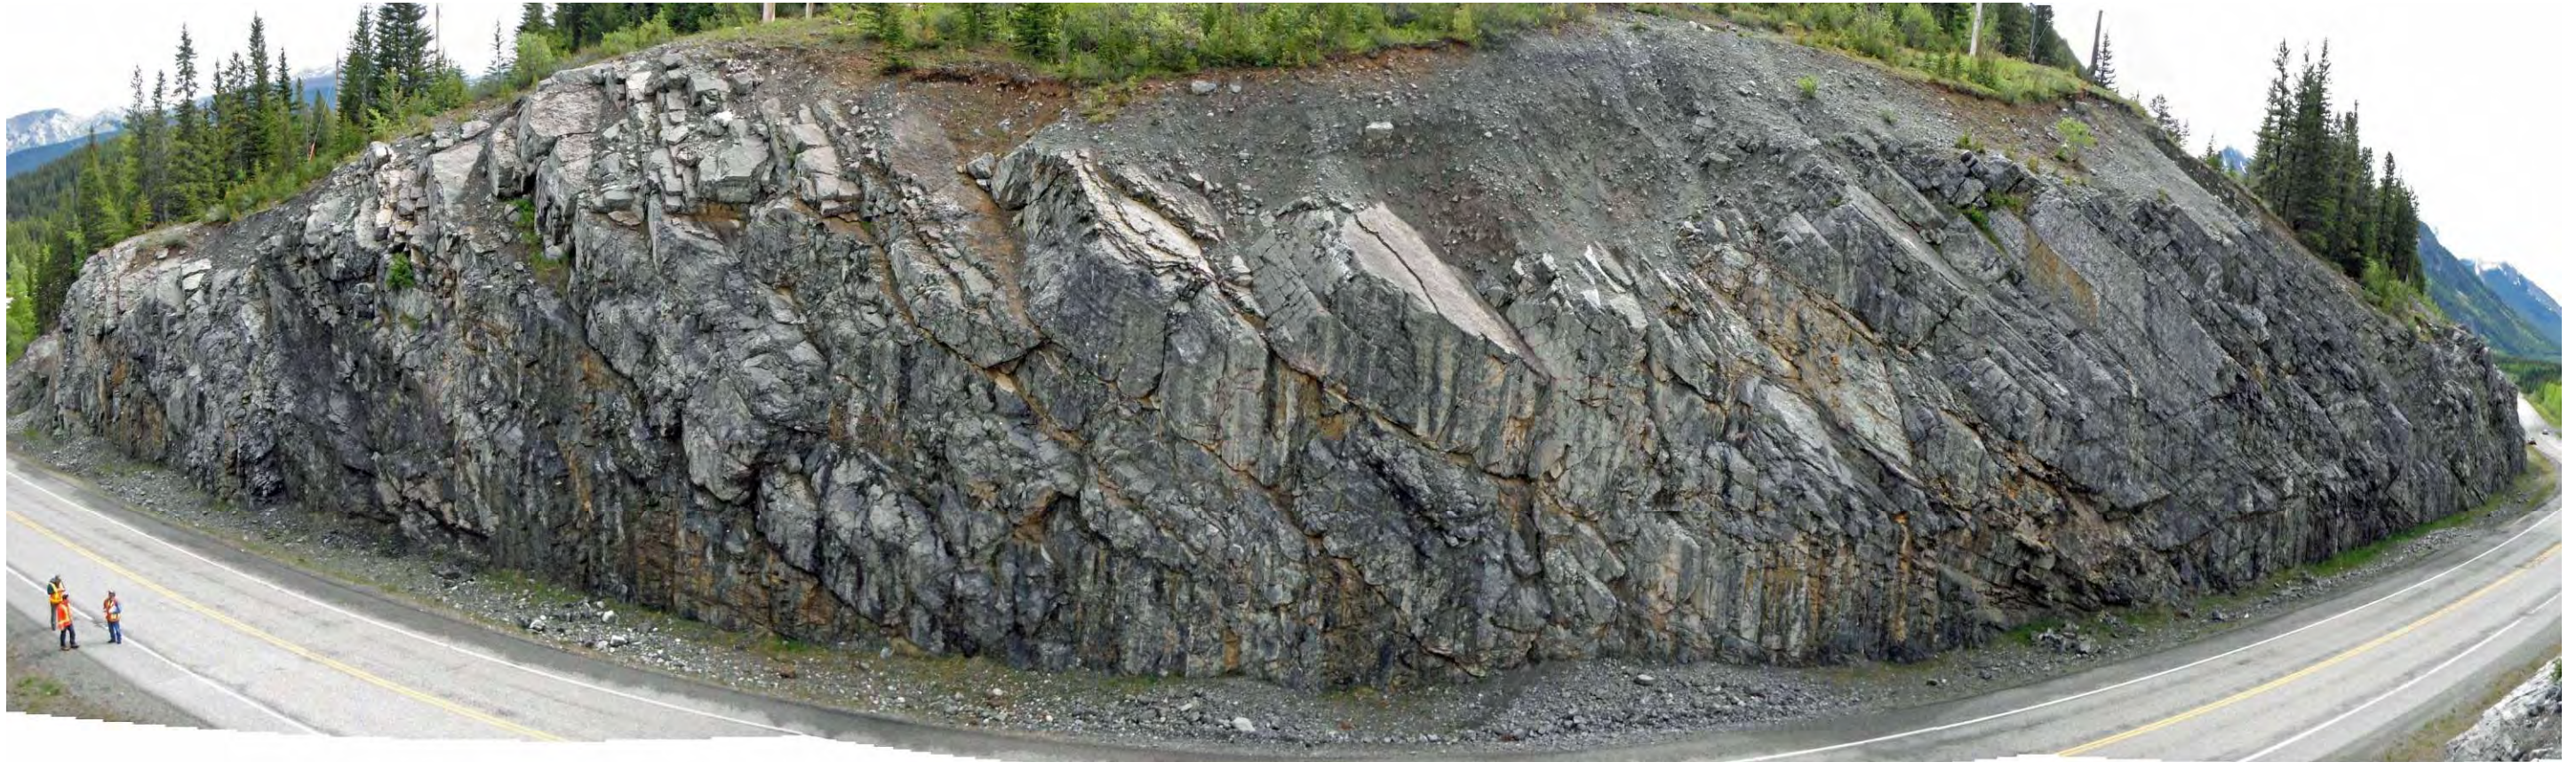
**Photo S18-1 – June 2012**

A stitched panoramic image of the East Cut slope taken from atop the West Cut. The curvature of the highway is exaggerated due to the image processing. Clearly visible are the possible wedge, toppling, and block sliding failure modes currently supported by rock bolts.

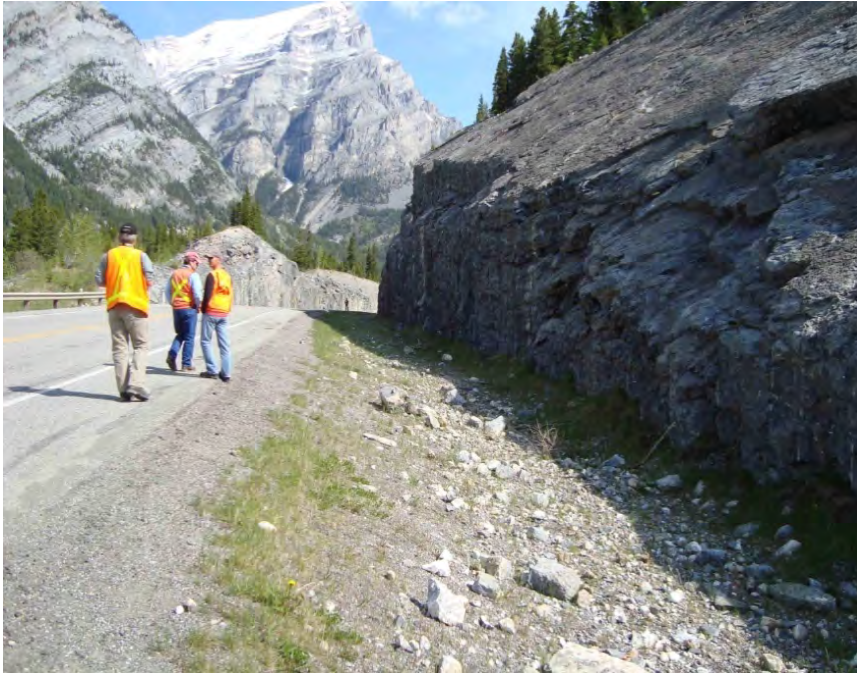
**Photo S18-2 – June 2010**  
Facing northbound along the east ditch near the south end of the East Cut. Minor rock fall in this area that does not appear to have landed on the road; however boulder and cobble-sized rocks have been noted onto the edge of the pavement in past inspections.

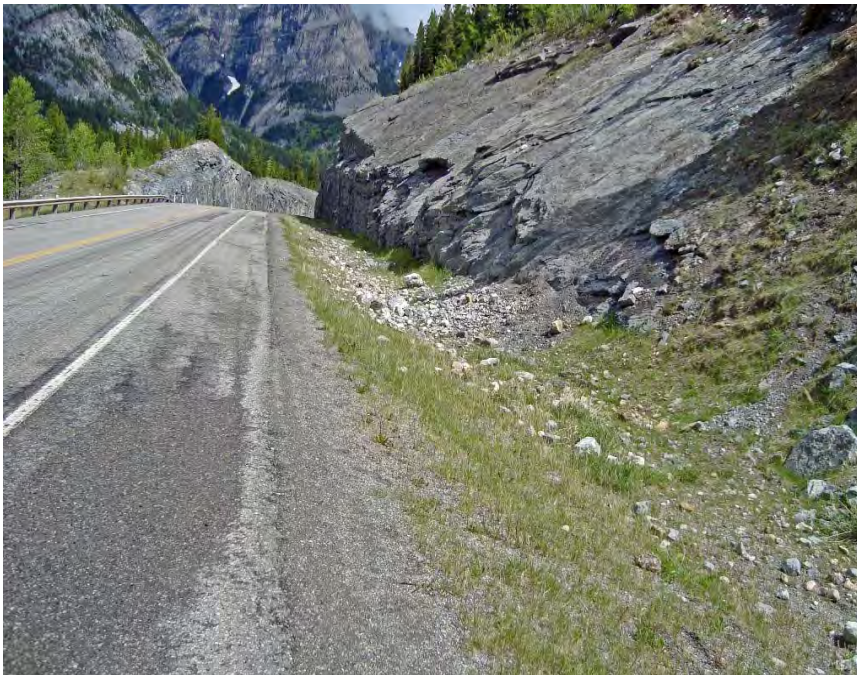
**Photo S18-3 – June 2012**  
From the same location as the previous photo approximately 20 m further south. The volume and size of the rock accumulation in the ditch is similar to previous years.

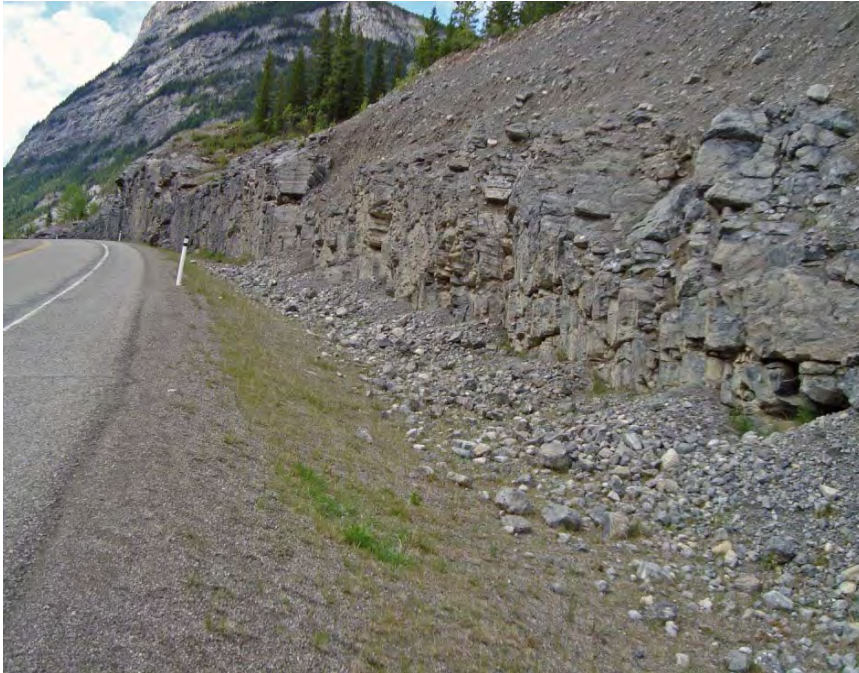
**Photo S18-4 – June 2012**  
Facing southbound along the west ditch. All rock fall is contained within the ditch.

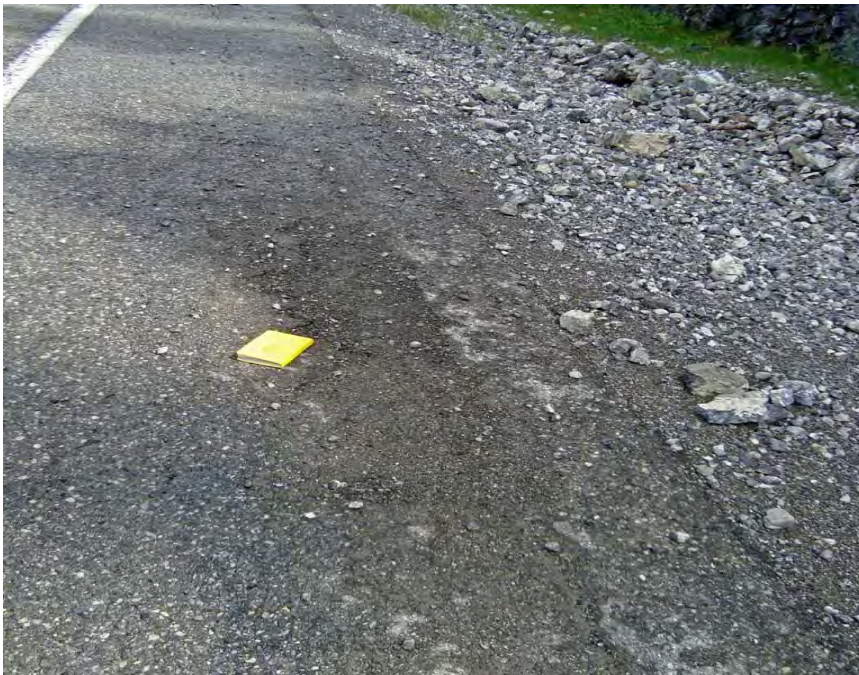
**Photo S18-5 – June 2012**  
Standing at approximately the center of the site on the west side of the road looking northbound. There is apparent damage to the west road shoulder from current rock falls and/or a gravel slide that occurred during the 2011/2012 winter season.

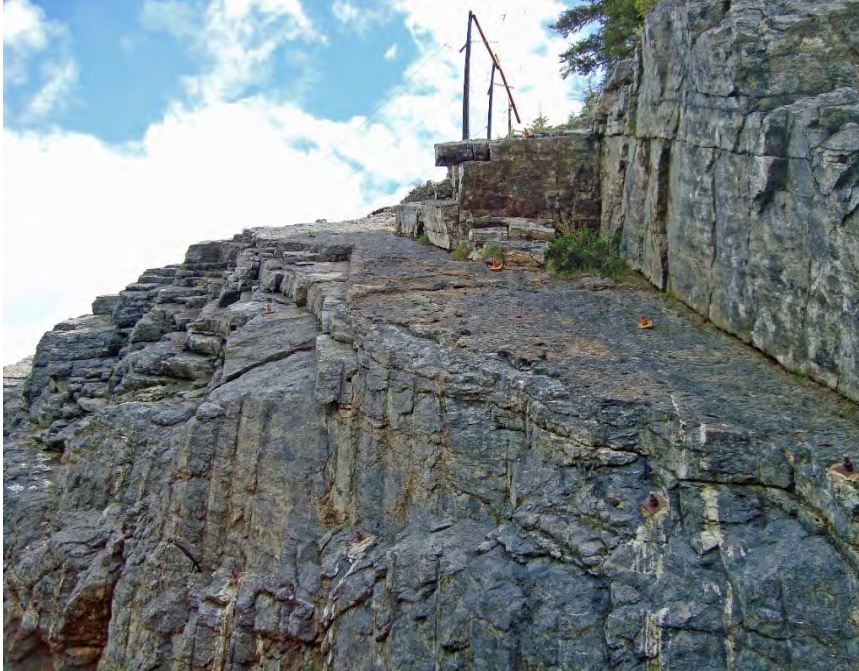
**Photo S18-6 – June 2012**

Standing at near the north end of the site looking up to the top of the East Slope cut. A previous rock wedge likely failed or was removed in this area. Rock bolts help support the lower blocks but several unsupported rocks above them are poised to potentially fall.
