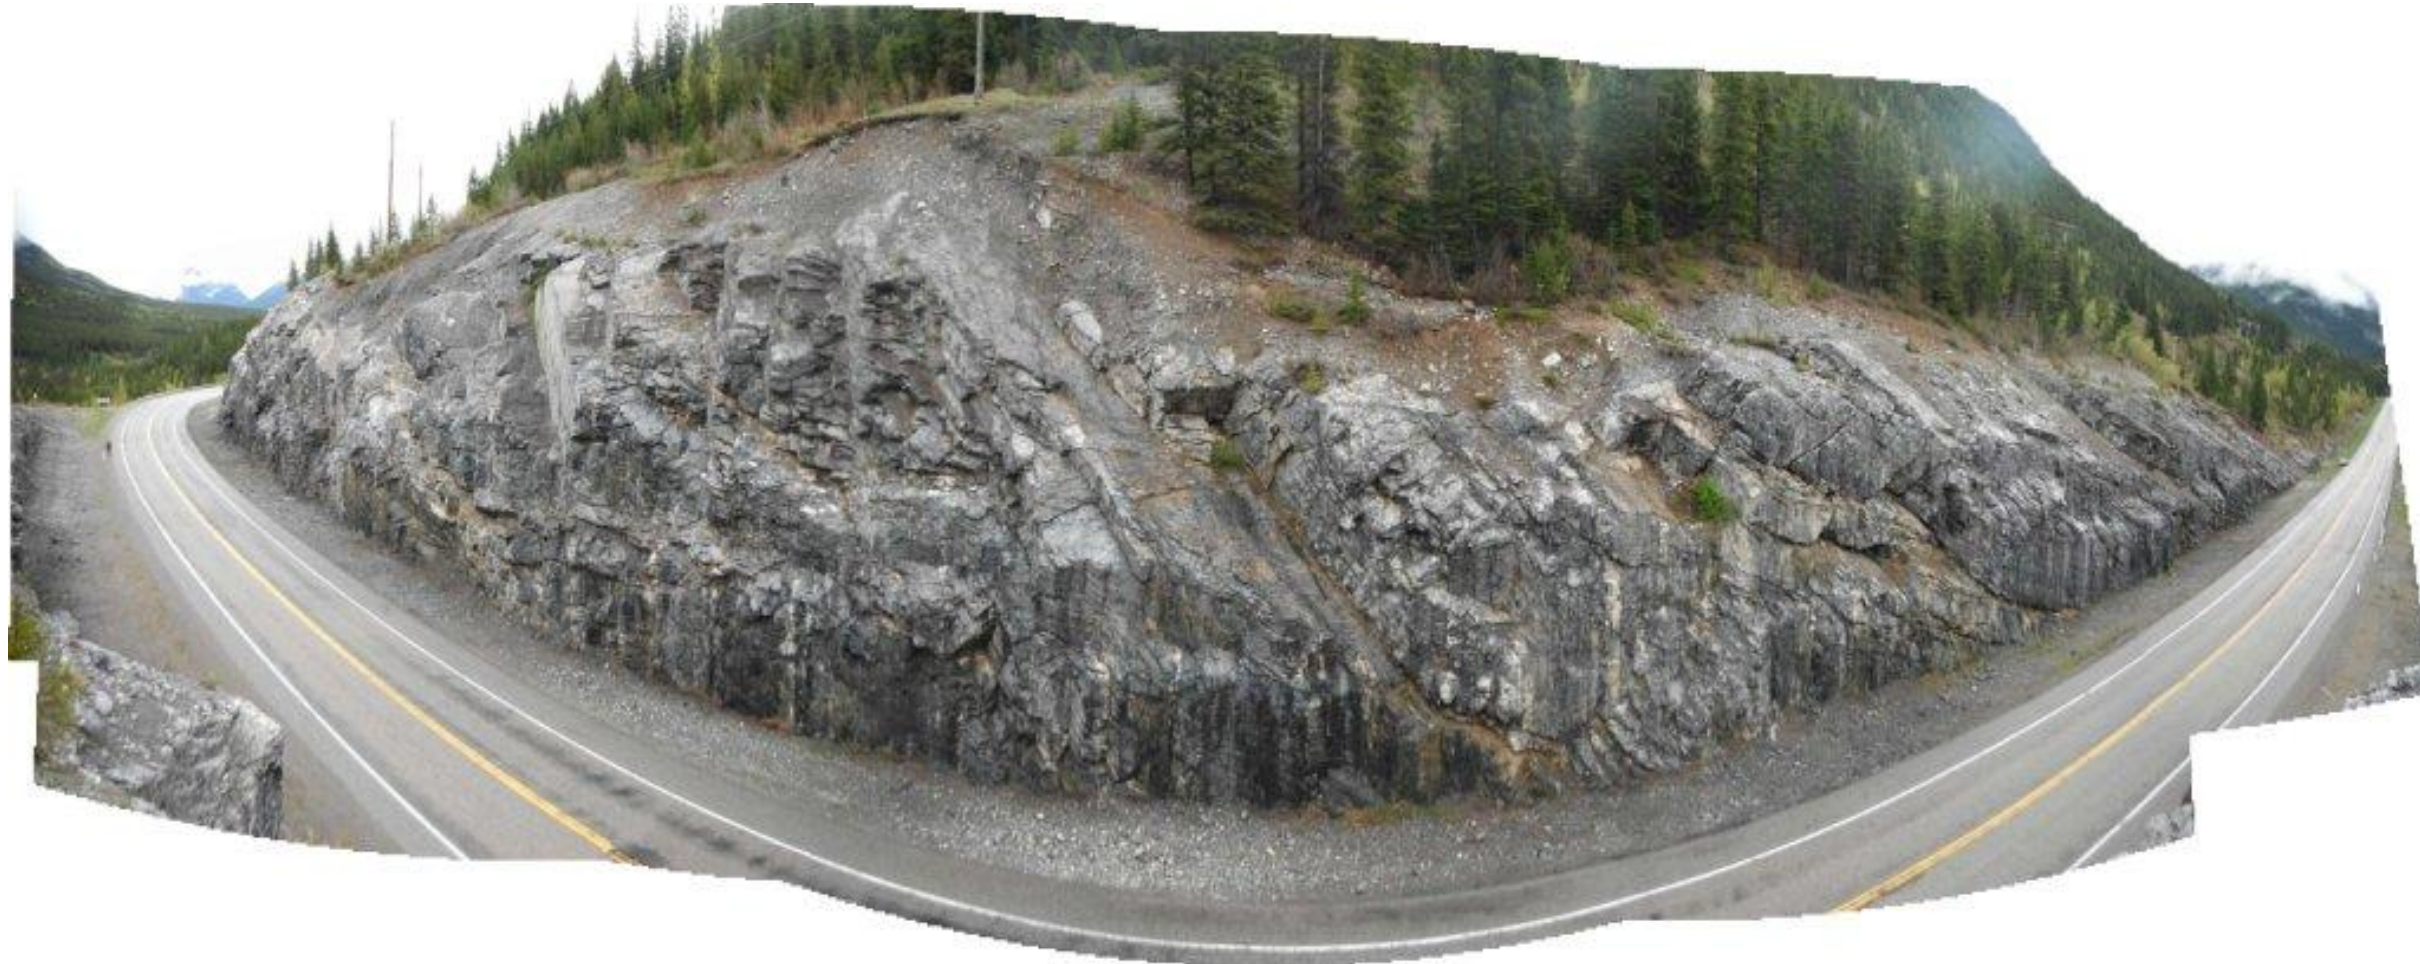
**Photo S18-1 – May 2013**

A stitched panoramic image of the East Cut Slope taken from atop the West Cut. The curvature of the highway is exaggerated due to the image processing. Visible are the possible wedge, toppling, and block sliding failure modes supported by rock bolts.

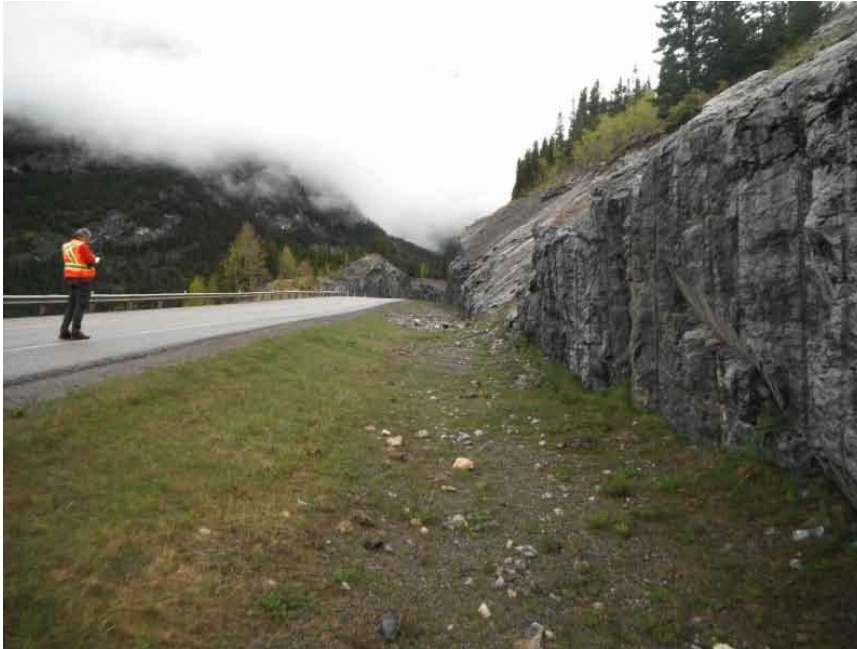
**Photo S18-2 – May 2013**  
Facing northbound along the east ditch near the south end of the East Cut. Minor rock fall was observed in this area that did not appear to have landed on the road.

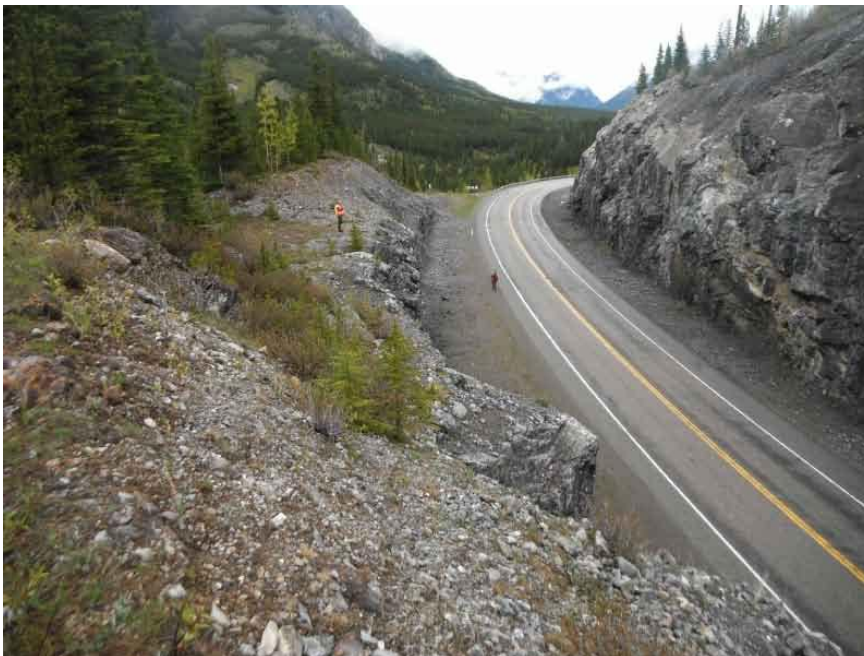
**Photo S18-3 – May 2013**  
Facing northbound from the top of the West Cut Slope. All rock fall was contained within the ditch.

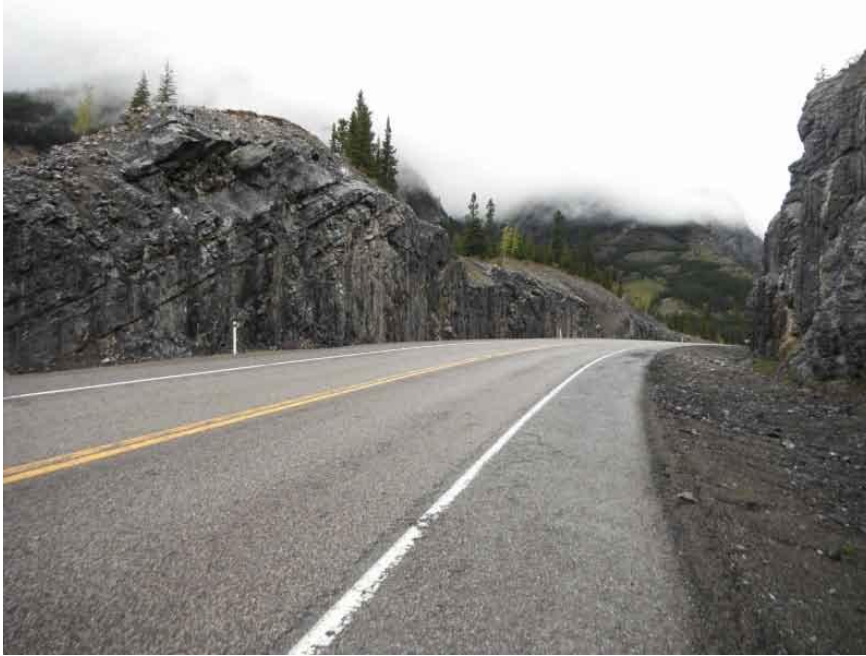
**Photo S18-4 – May 2013**  
Standing at approximately the center of the site on the east side of the road facing northbound. Rock fall impacts were observed on the east road shoulder.
