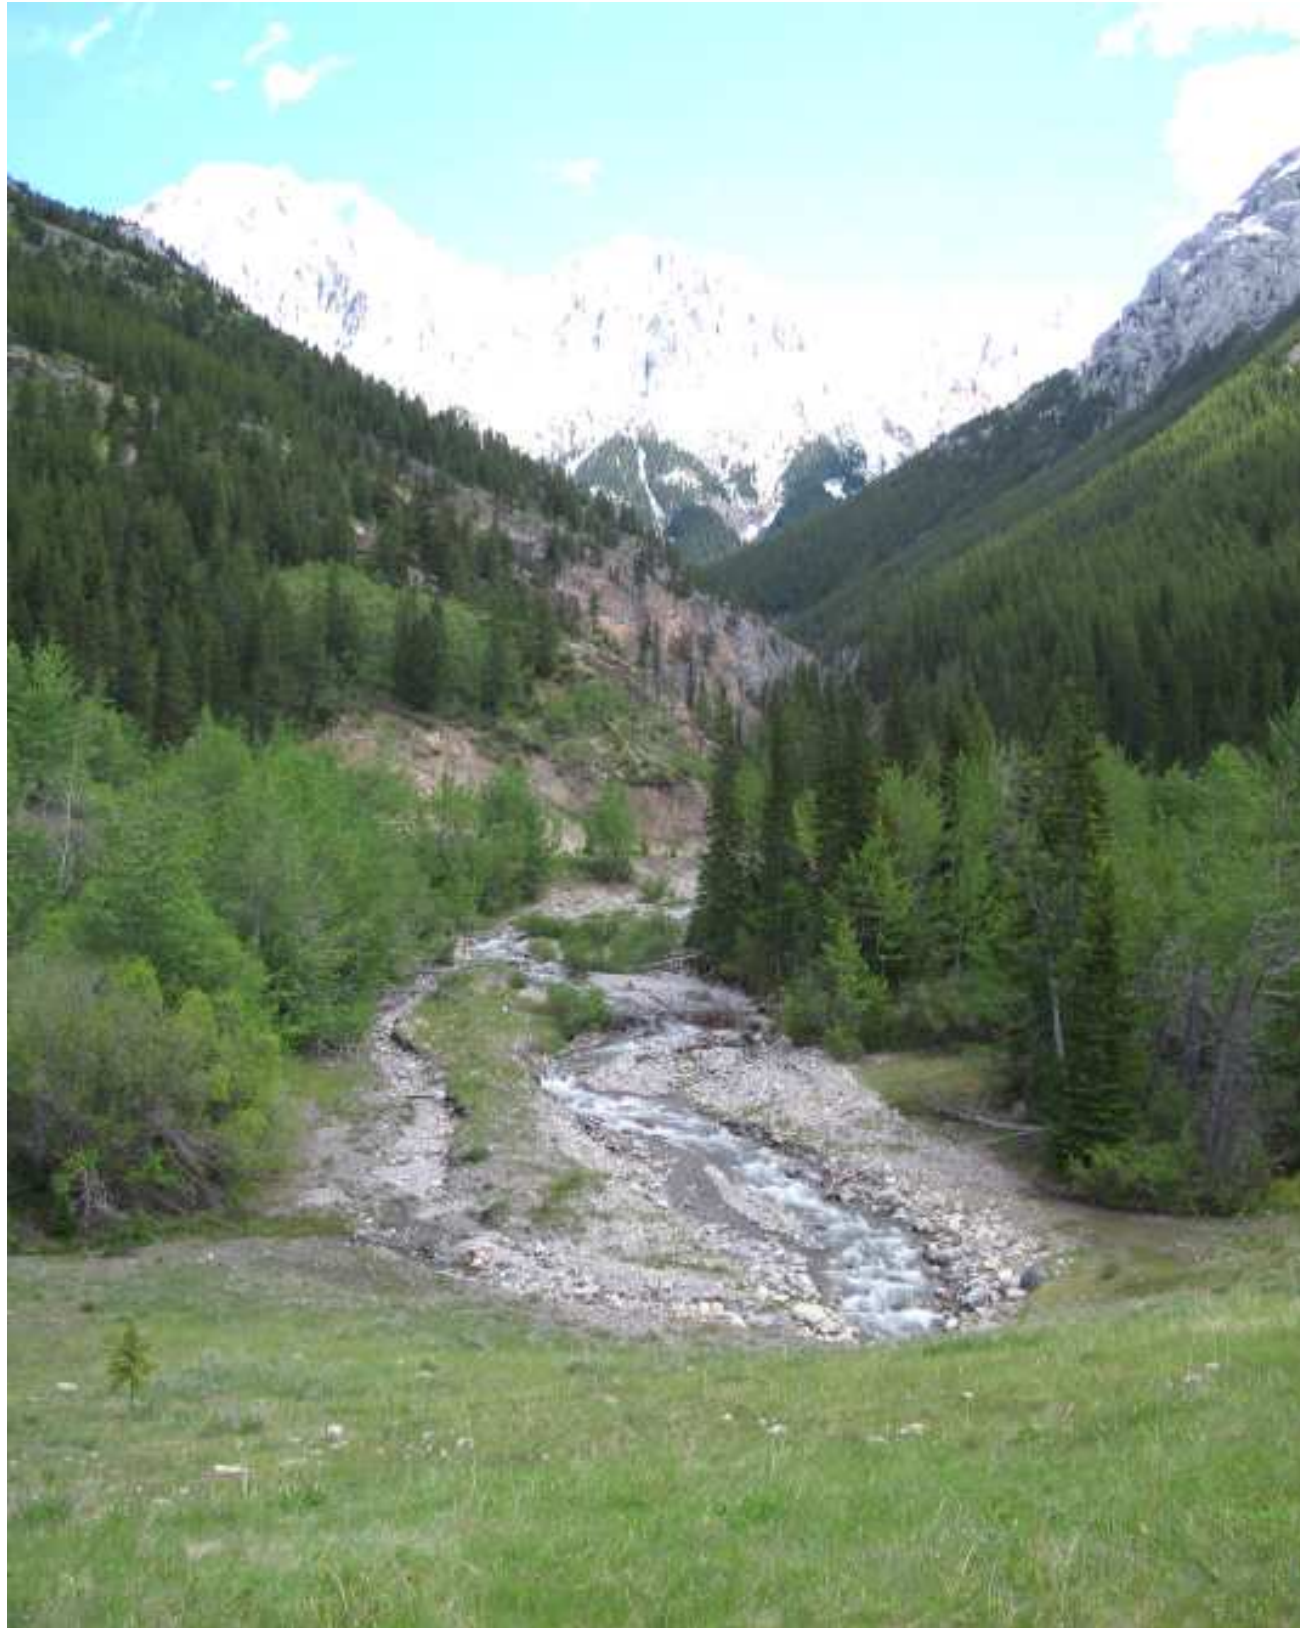
Photo S19-1 – June 2007 (left)

Facing upstream along King Creek from the Highway 40 alignment.

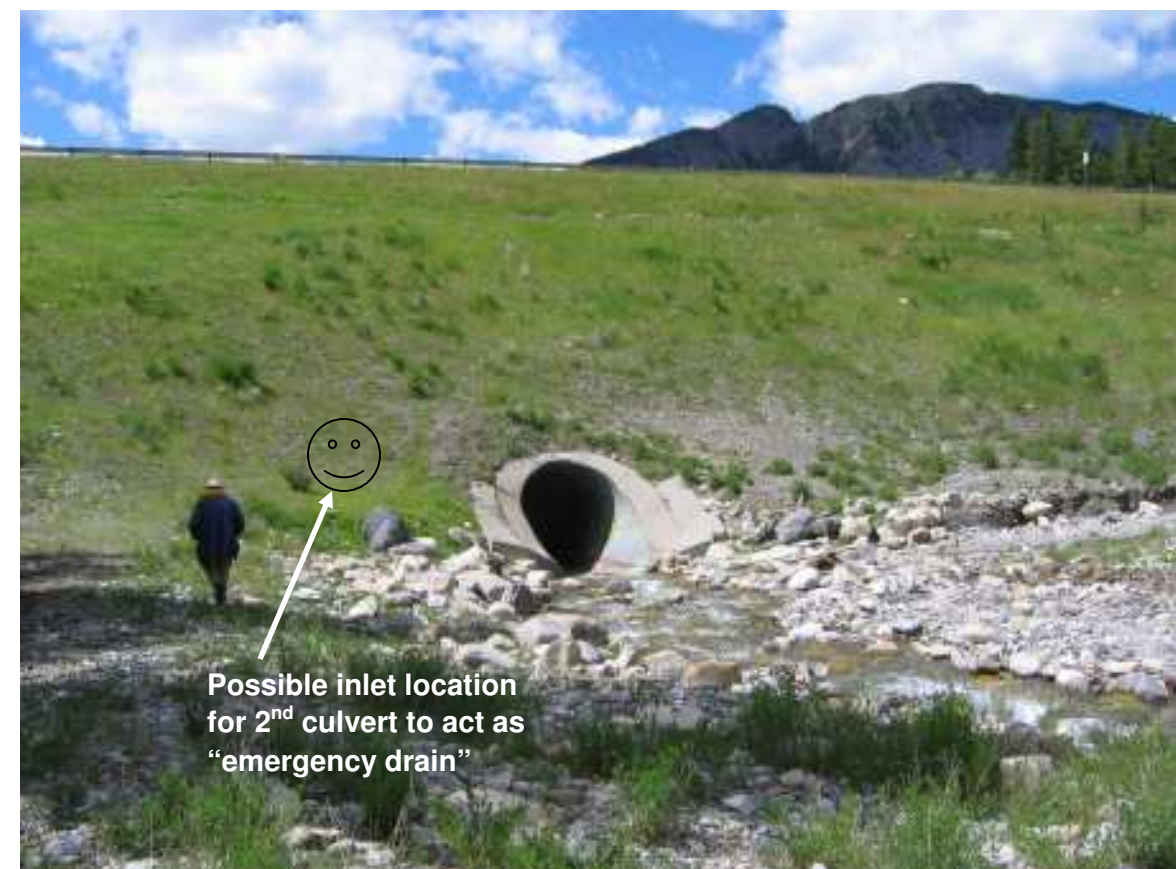
Photo S19-2 – July 2005 (left)

Culvert inlet at toe of east embankment slope. A possible location for the inlet of a second culvert is marked. The second culvert could be installed to act as an “emergency drain” for creek flow in the event that the existing culvert is blocked by debris and water begins to impound on the upstream side of the highway embankment. Construction equipment can access this area via the old access trail from the King Creek picnic area parking lot on the south side of the creek channel.
