Alberta Transportation Southern Region Landslide Monitoring Program Spring 2002 Assessment Report

Site S2 - Priddis

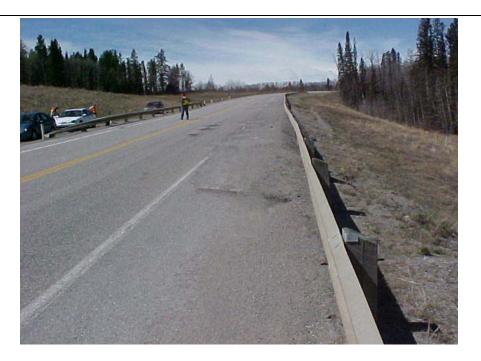
Photo 1 – Facing west along the downslope edge of the road through the slide area. The existing pile wall is located just to the left of the guardrail. Note how the guardrail has been displaced by settlement of the road, and the loss of ground downslope of the guardrail.

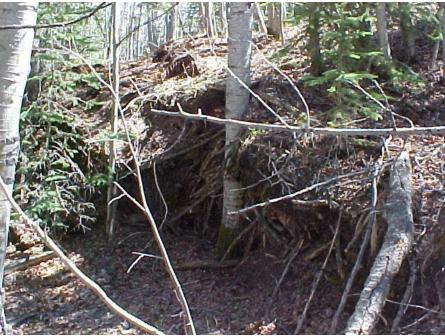
Photo 2 – Toe of the landslide below the fenceline, approximately 150 m north of the road. The spreading of the landslide has caused colluvium to override the ground surface further downslope.

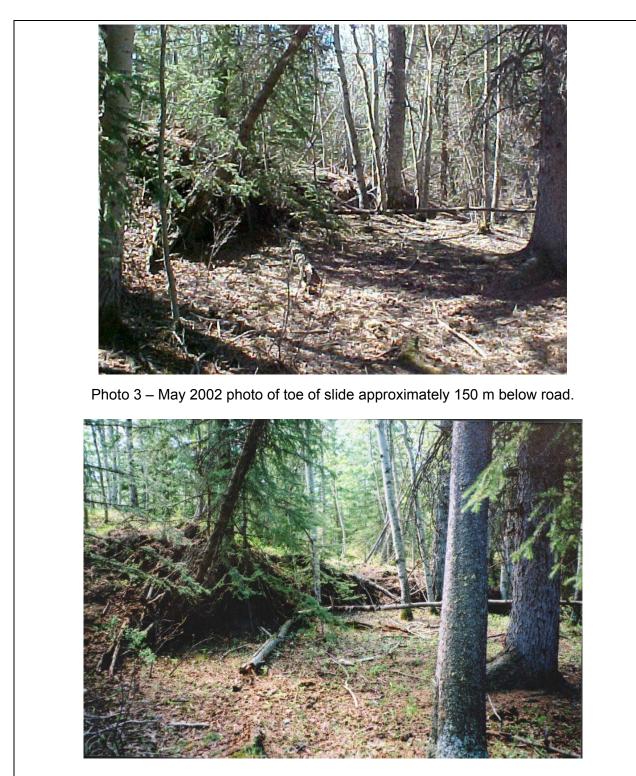
Photo 4 – May 2001 photo of toe of slide approximately 150 m below road.
